**ARBORIST REPORT  
AND  
NATIVE OAK TREE INVENTORY**

**LINCOLN MEADOWS PROJECT SITE  
City of Lincoln, California**

**October 8, 2014**

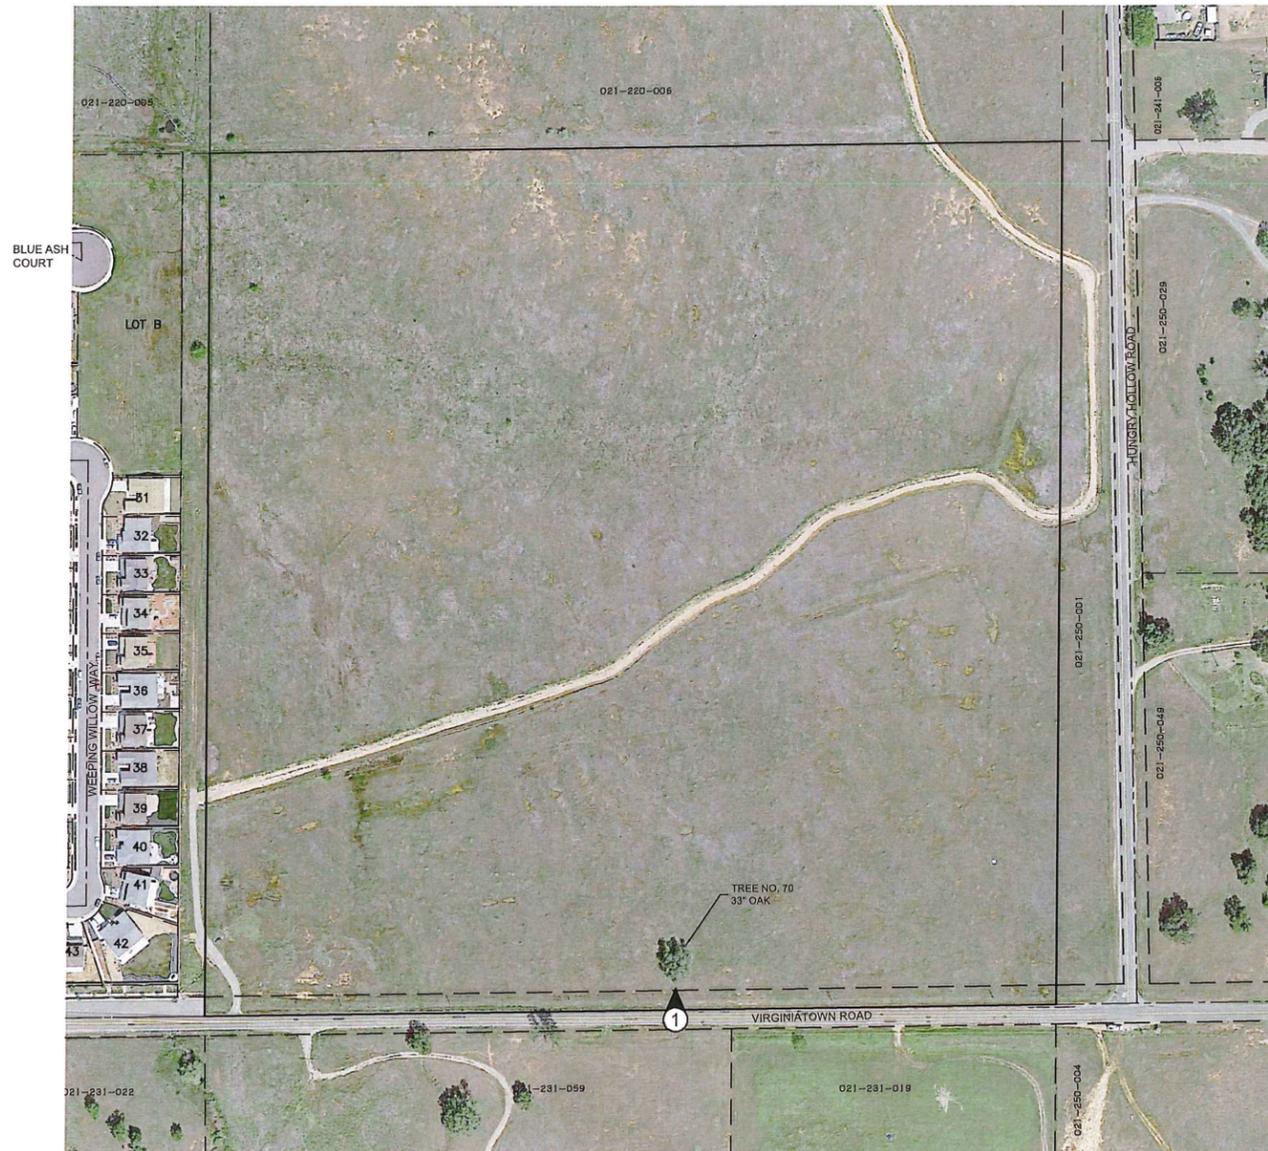
**TREE EXHIBIT**  
**LINCOLN MEADOWS**  
 CITY OF LINCOLN - PLACER COUNTY - CALIFORNIA  
 OCTOBER 8, 2014 SCALE: 1"=100'  
 BAKER-WILLIAMS ENGINEERING GROUP

Field reconnaissance revealed only one protected tree on site. The tag number for this tree has been rough plotted on the enclosed aerial exhibit for future reference.

Tree #:	70
Common Name:	Valley Oak
Species:	( <i>Quercus lobata</i> )
Total DBH (inches):	33 inches
DLR (feet):	34 feet
<b><u>Conditional Assessment:</u></b>	
Root Crown:	Fair
Trunk:	Fair
Limbs:	Fair
Foliage:	Fair
Structure:	Fair
Vigor:	Fair
Notable Characteristics:	Southerly branch arcs to the ground
Recommendation:	Clean out crown
