APPENDIX A. FLOW MONITORING SITES: DATA, GRAPHS, INFORMATION

City of Lincoln

Sanitary Sewer Flow Monitoring

Temporary Monitoring: January 23 to April 3, 2016

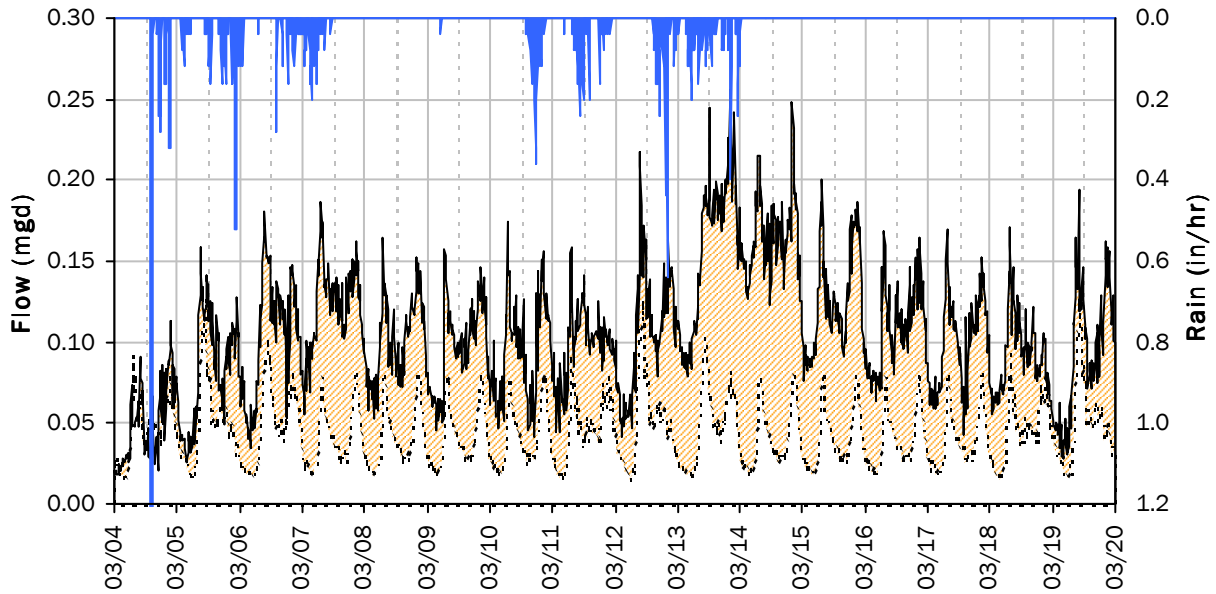
Event 1 Detail Graph

Storm Event I/I Analysis (Rain = 7.11 inches)

<u>Capacity</u>		<u>Inflow / Infiltration</u>	
Peak Flow:	0.26 <i>mgd</i>	Peak I/I Rate:	0.18 <i>mgd</i>
PF:	5.84	Total I/I:	987,000 <i>gallons</i>
Peak Level:	2.83 <i>in</i>		
d/D Ratio:	0.16

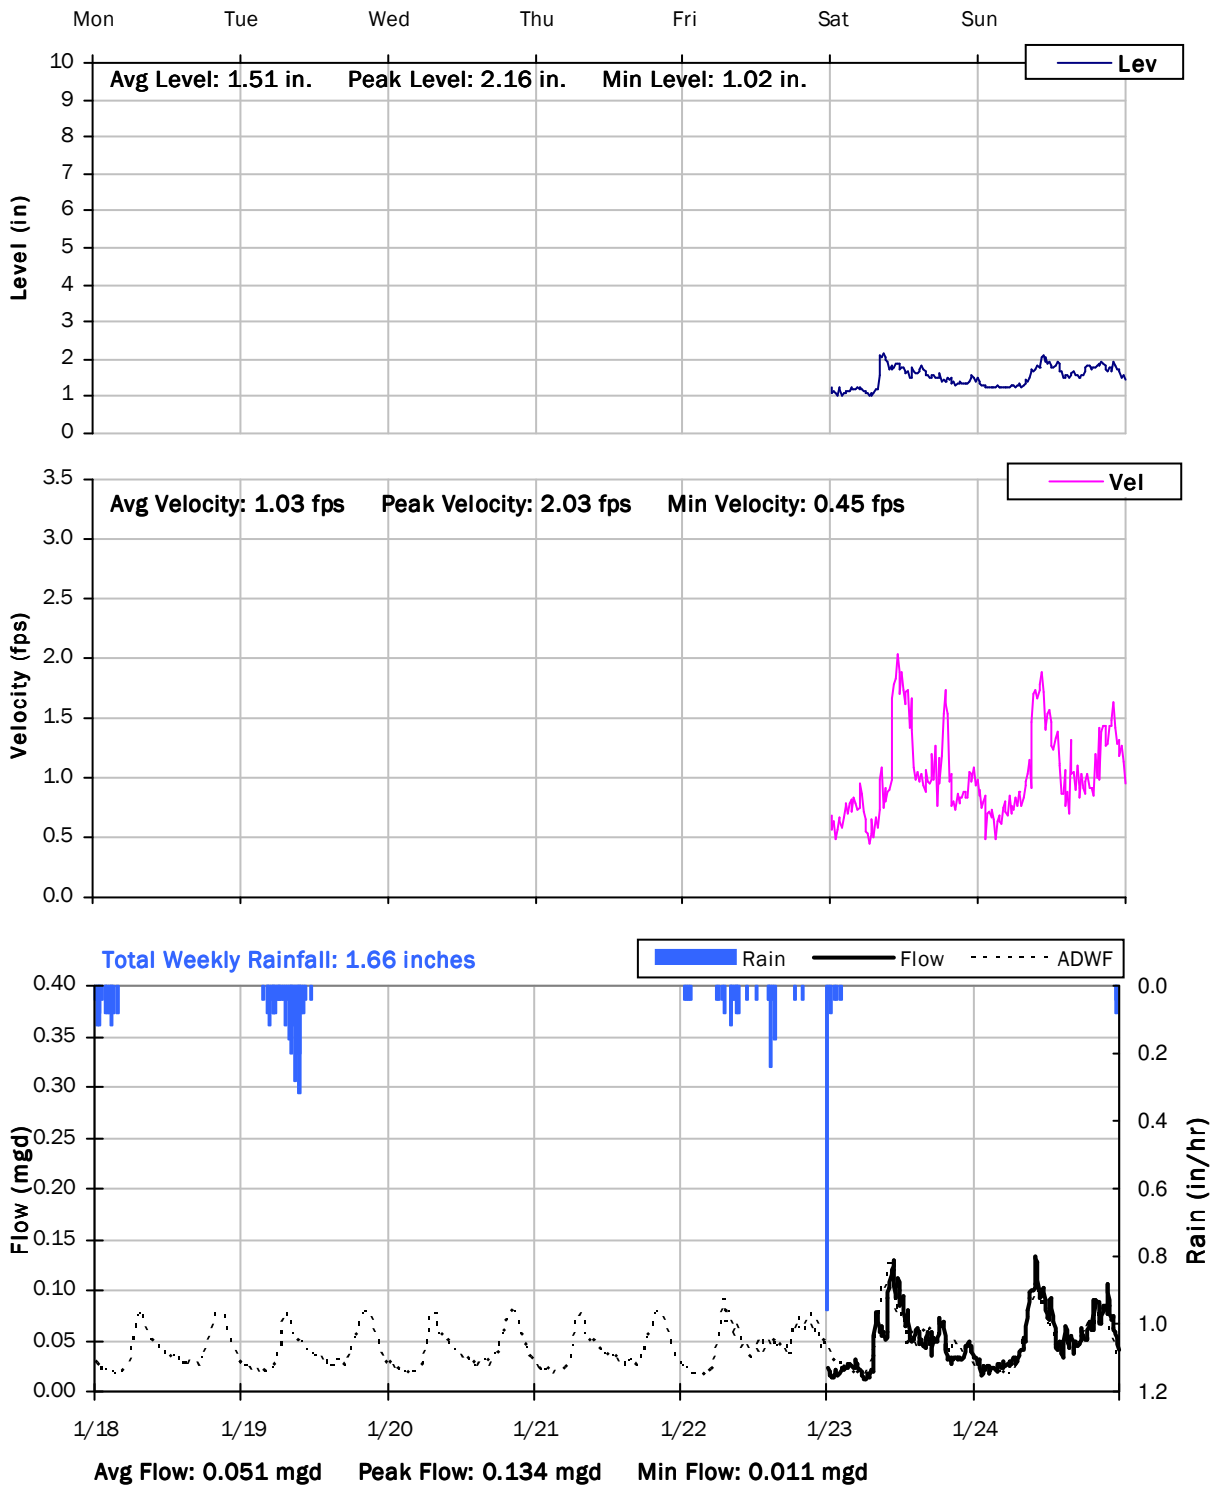
SITE 1
Weekly Level, Velocity and Flow Hydrographs
1/18/2016 to 1/25/2016

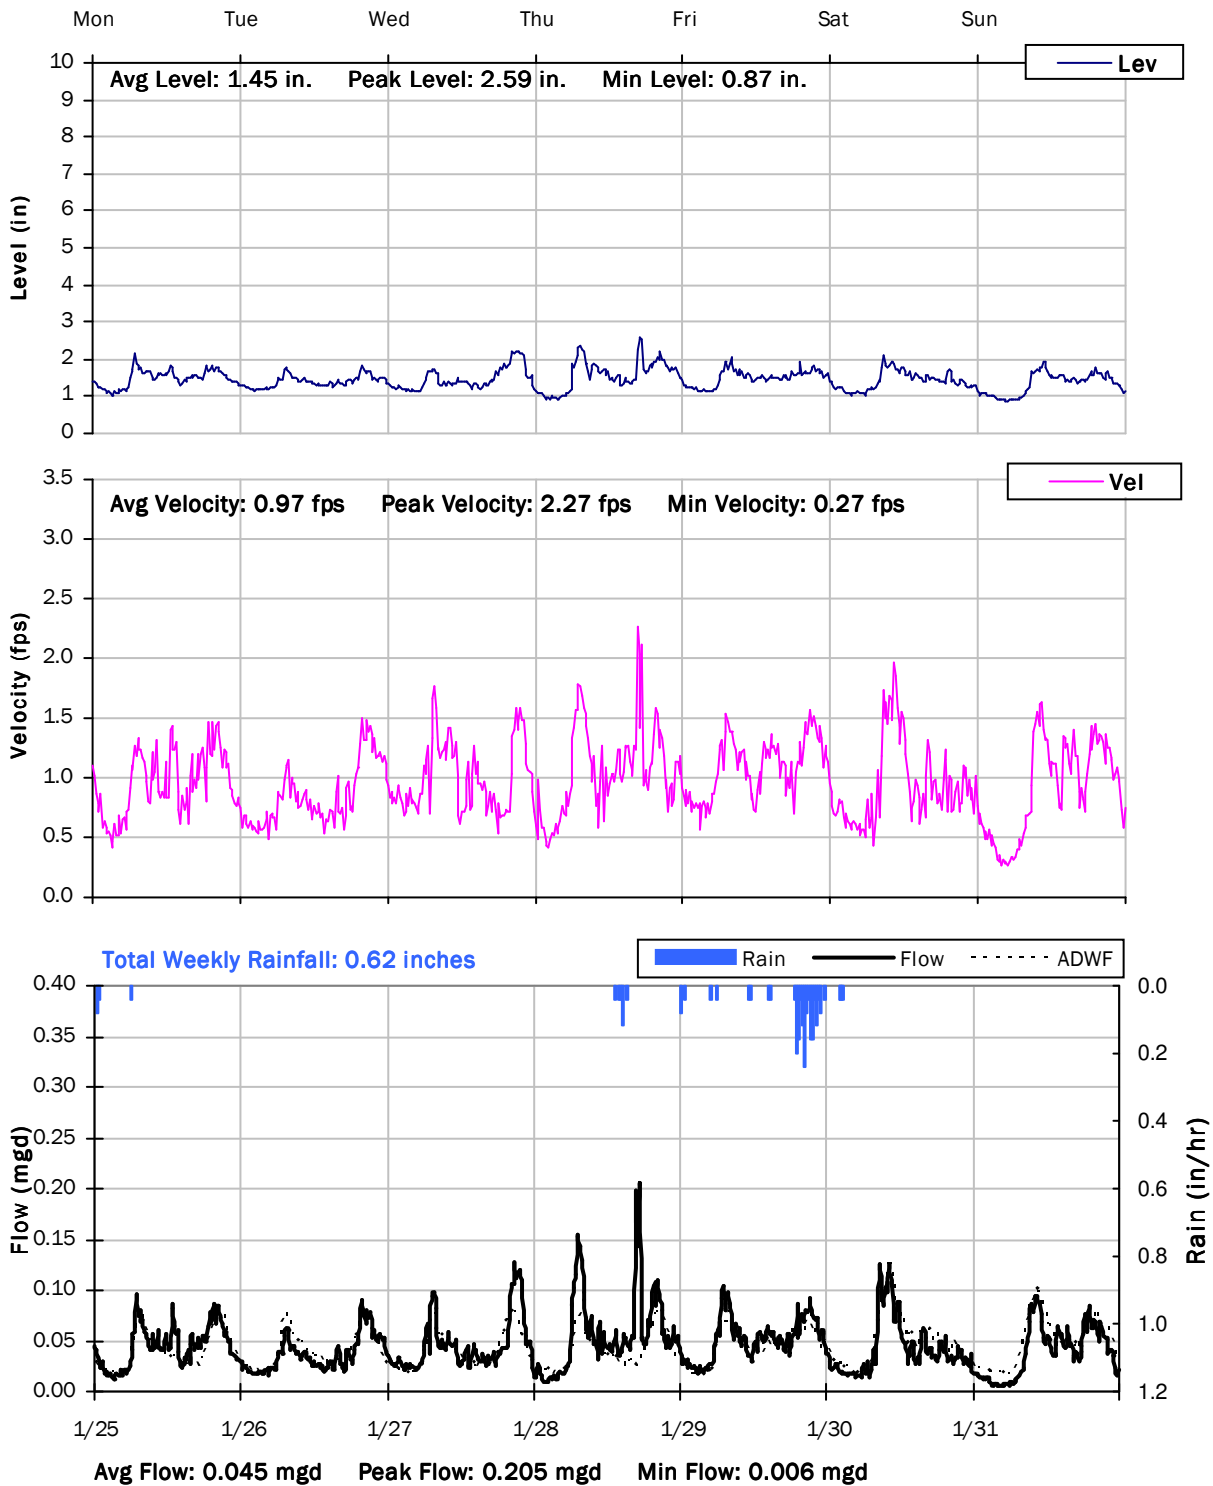
SITE 1
Weekly Level, Velocity and Flow Hydrographs
1/25/2016 to 2/1/2016

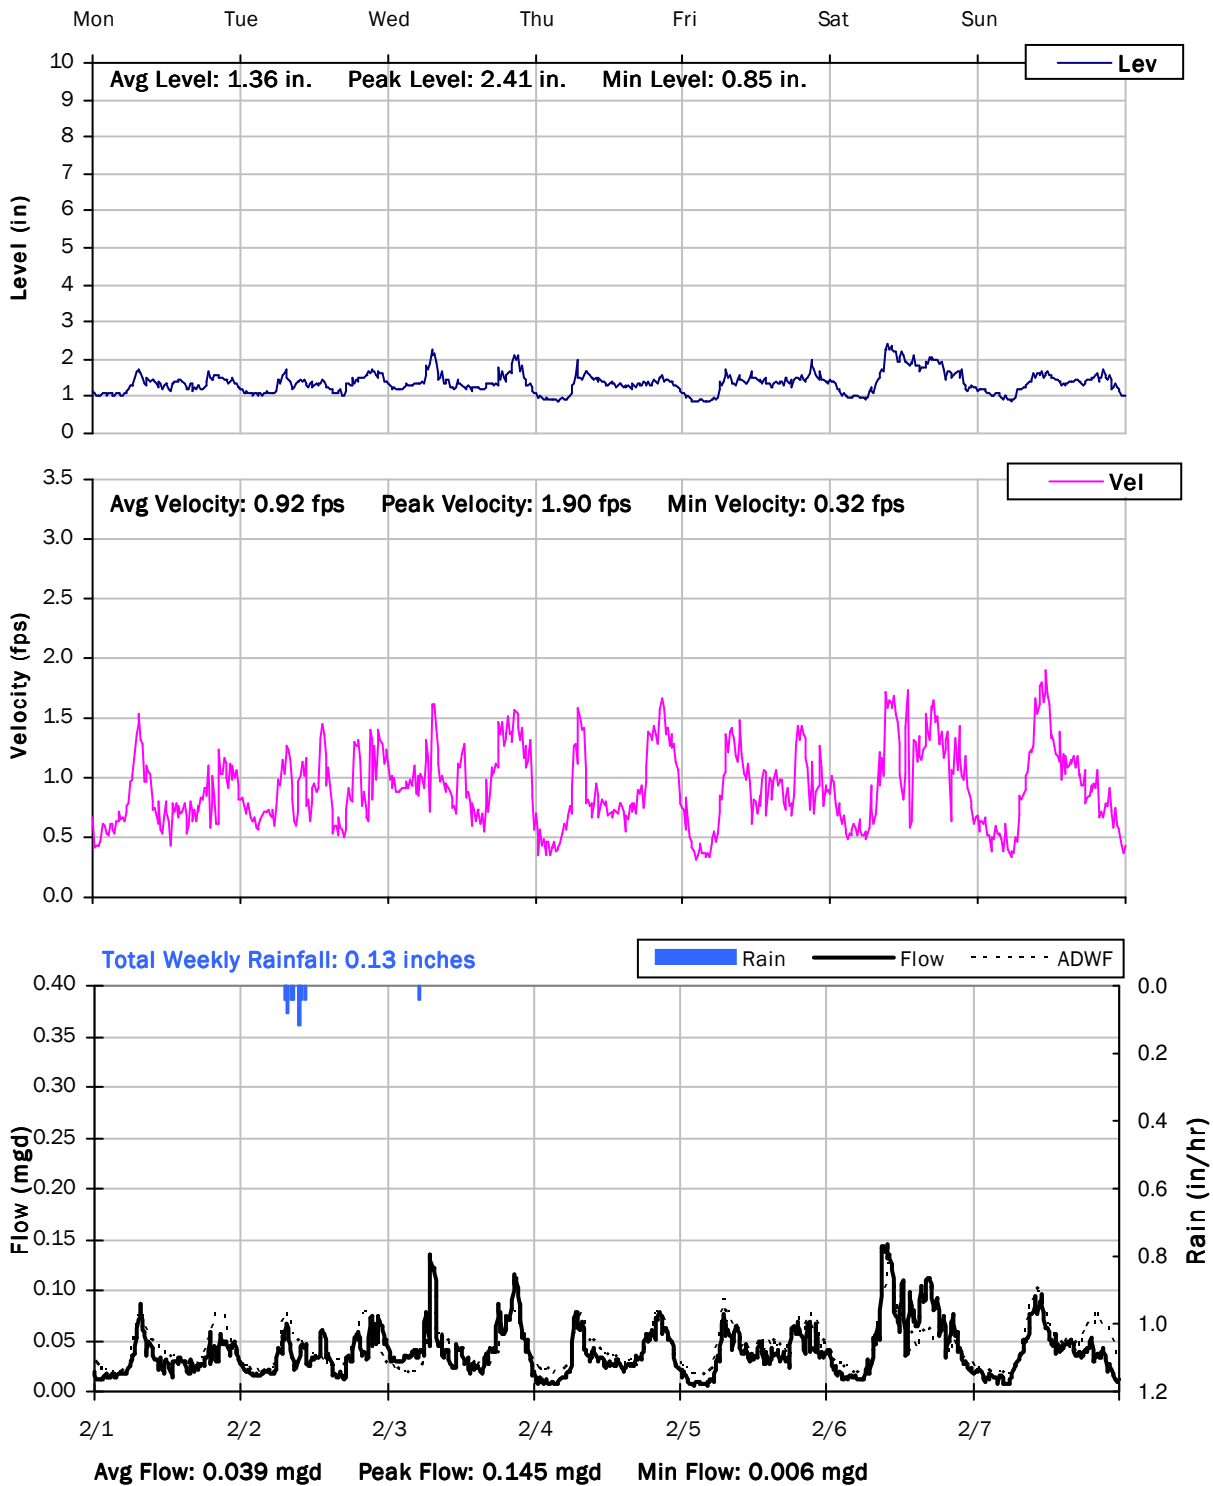
SITE 1
Weekly Level, Velocity and Flow Hydrographs
2/1/2016 to 2/8/2016

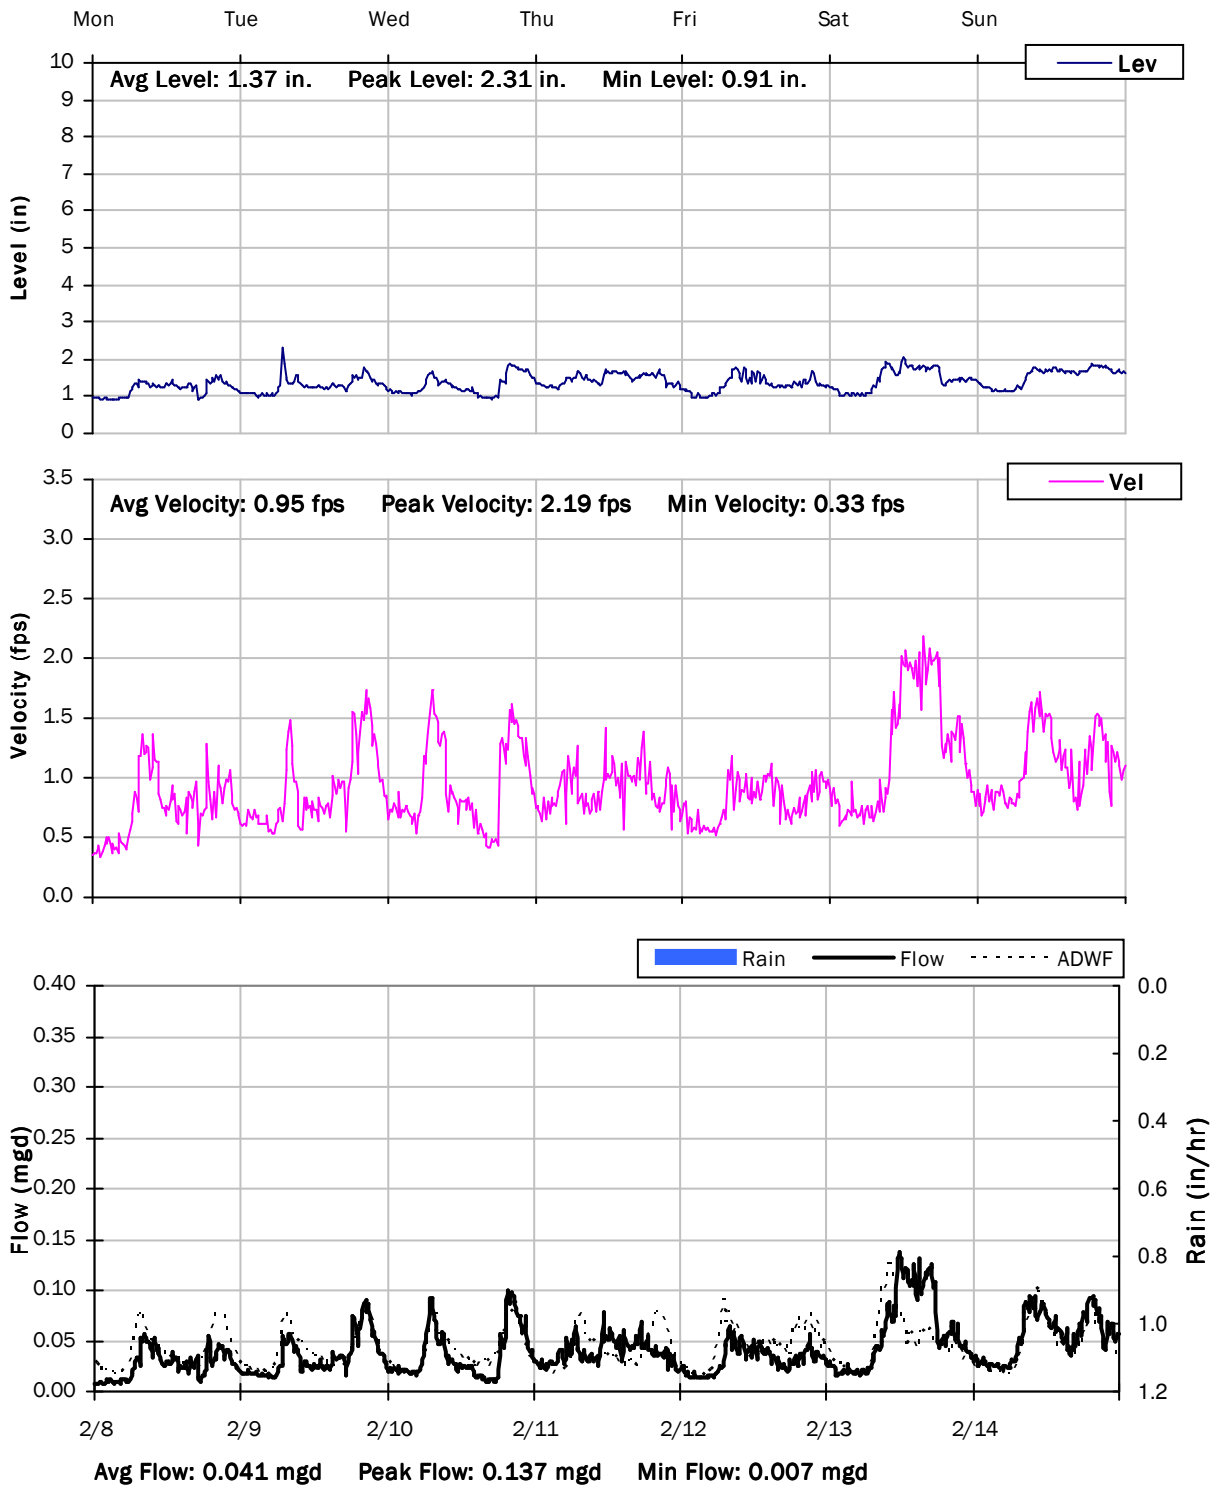
SITE 1
Weekly Level, Velocity and Flow Hydrographs
2/8/2016 to 2/15/2016

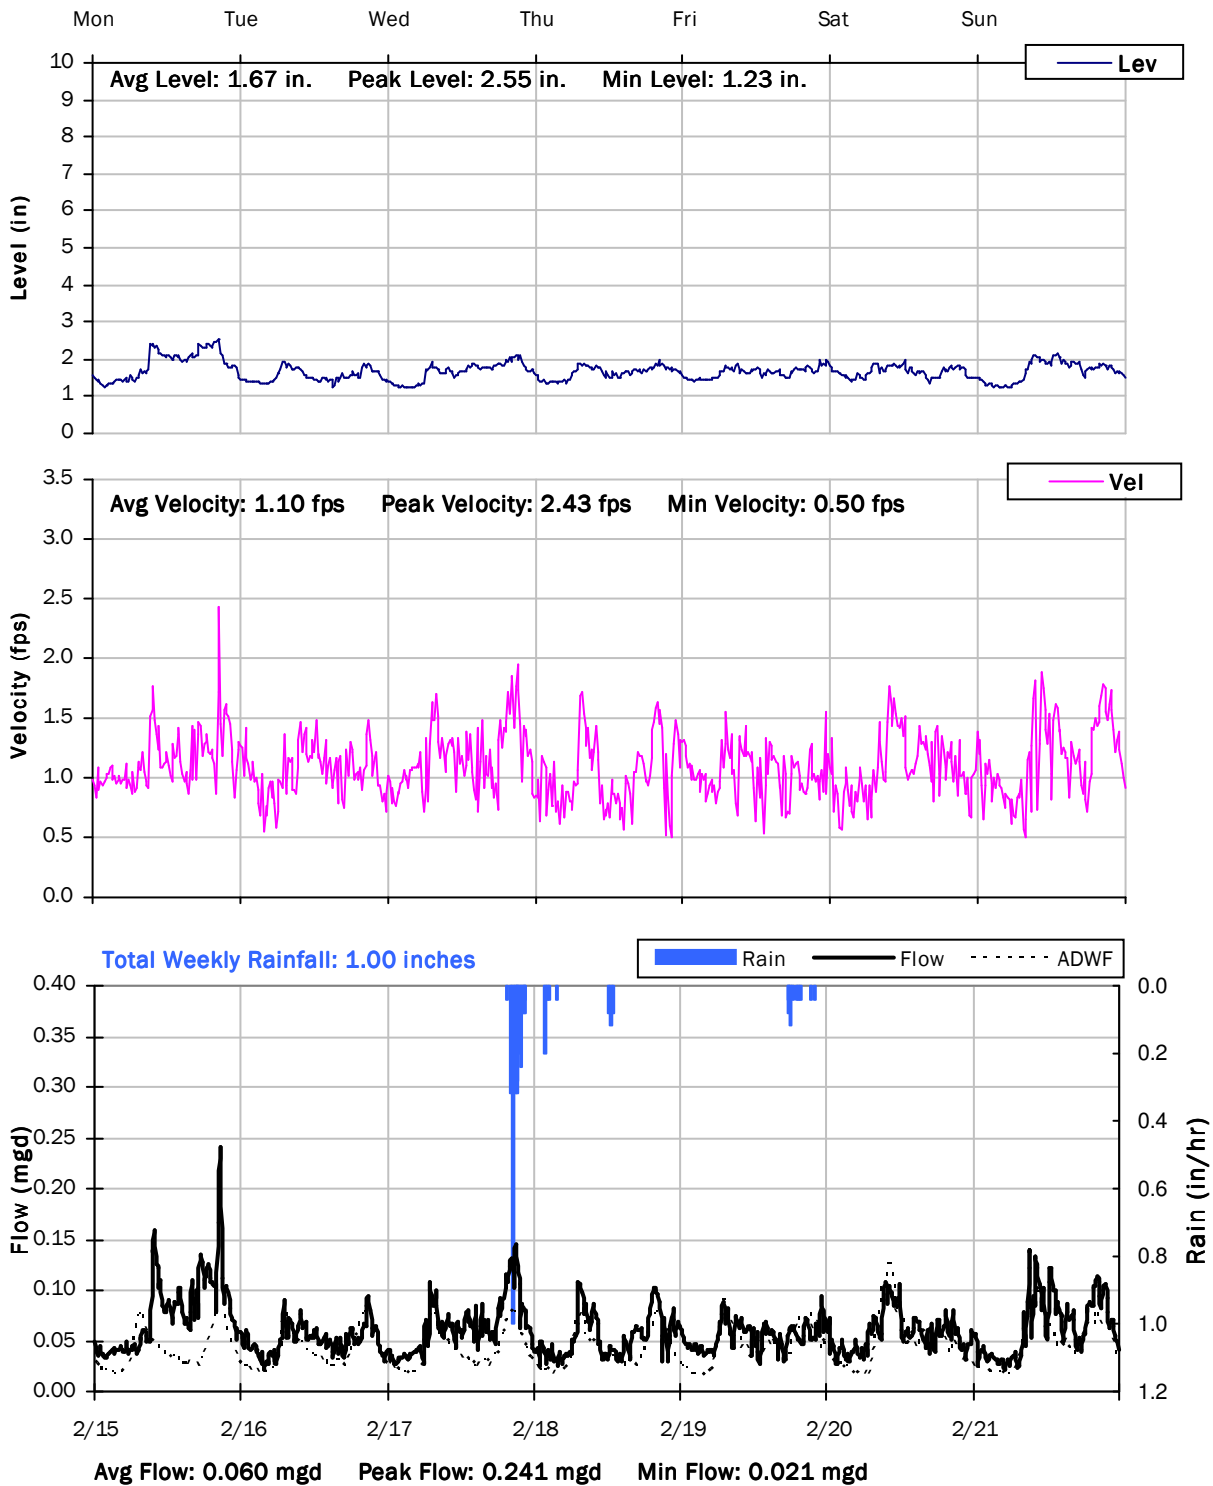
SITE 1
Weekly Level, Velocity and Flow Hydrographs
2/15/2016 to 2/22/2016

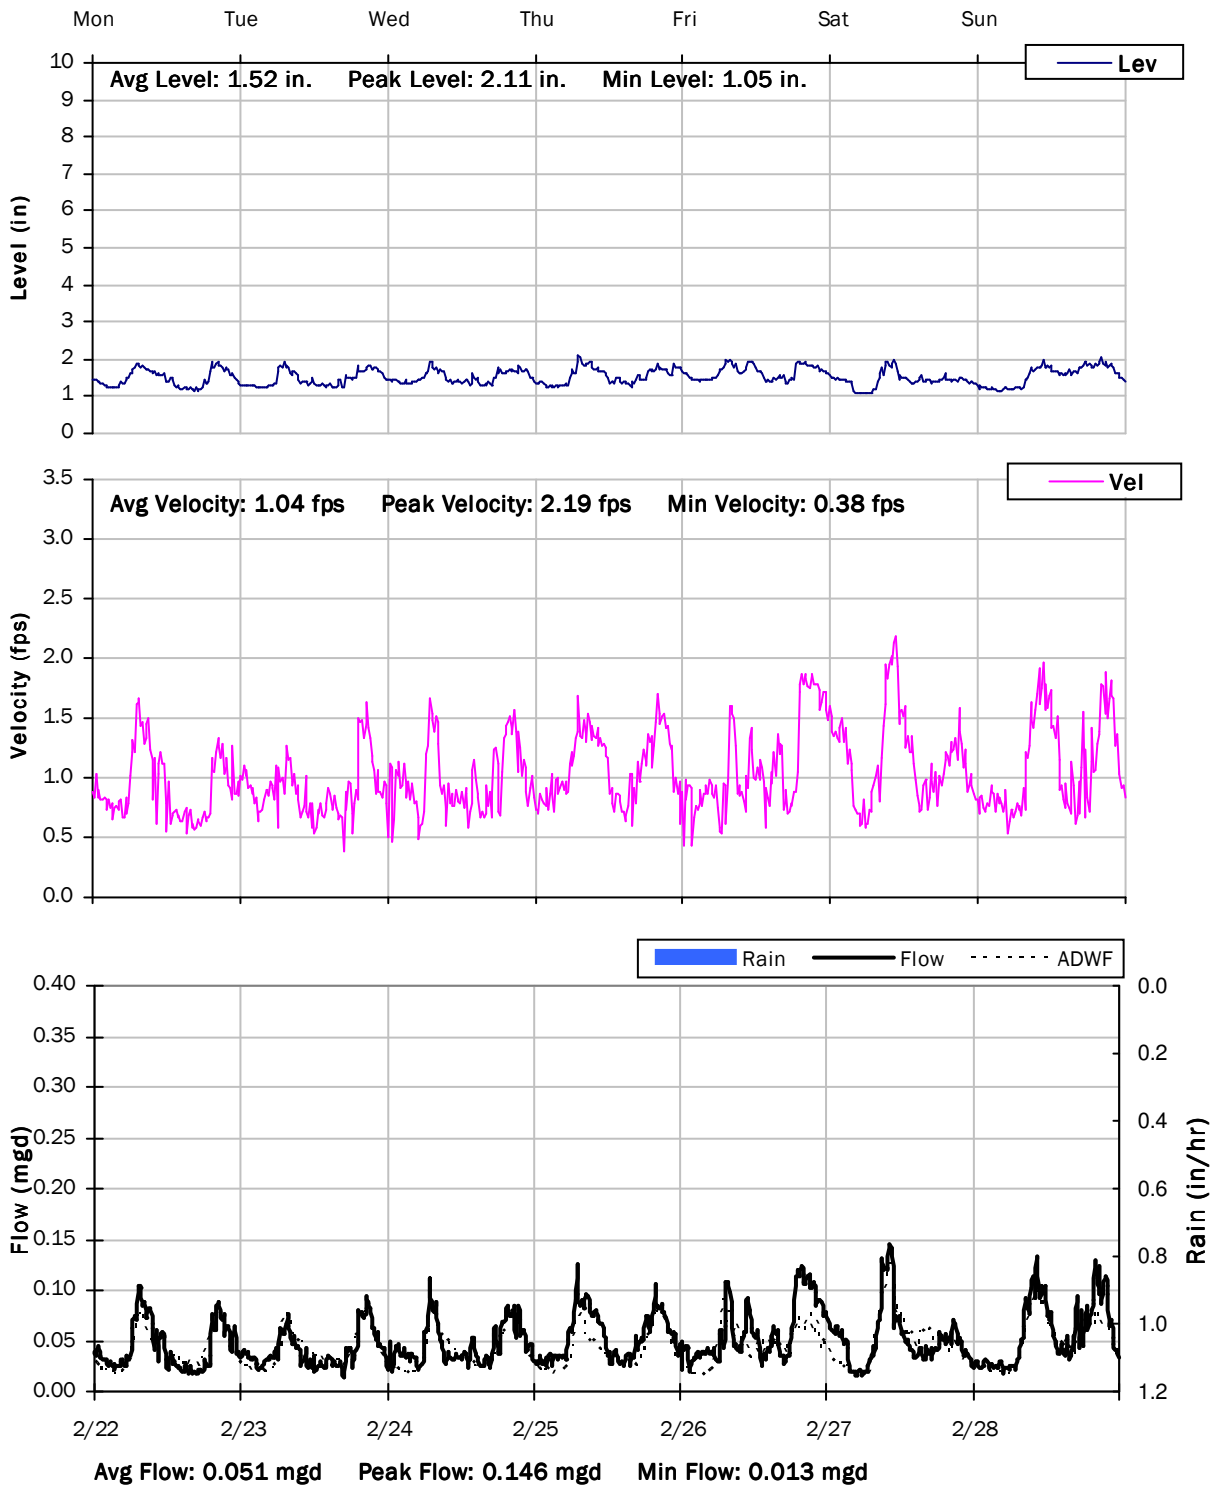
SITE 1
Weekly Level, Velocity and Flow Hydrographs
2/22/2016 to 2/29/2016

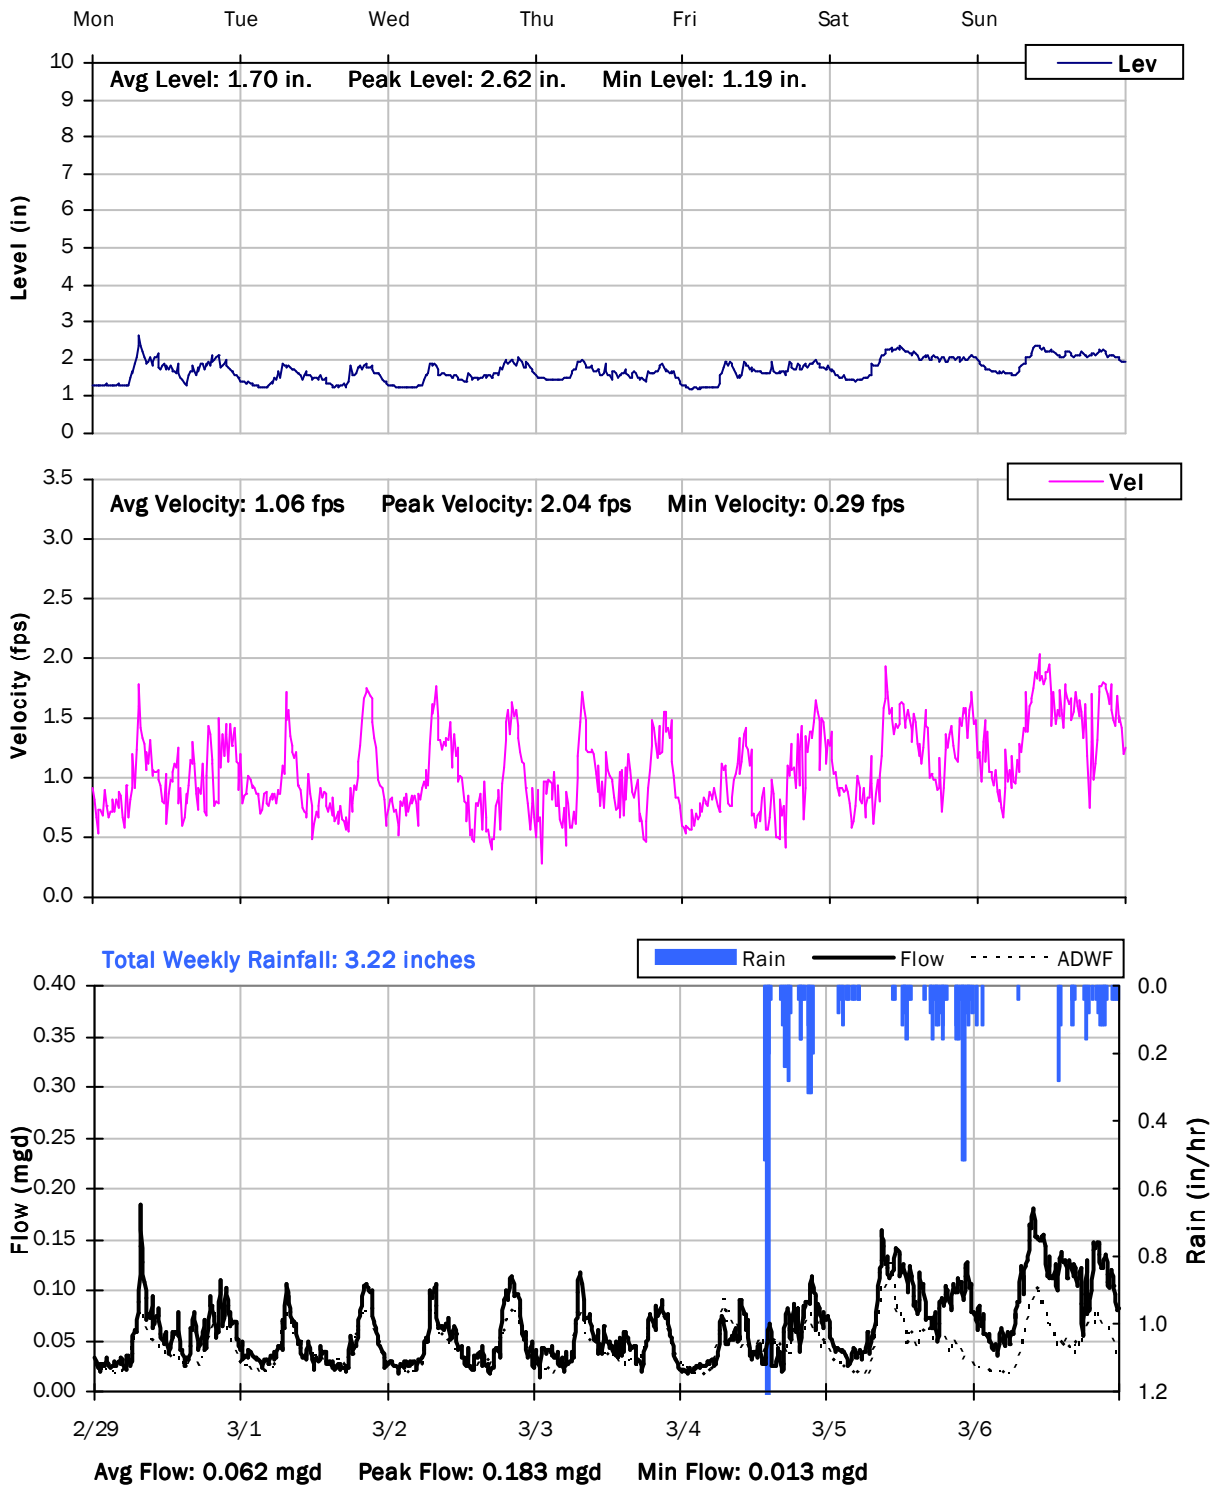
SITE 1
Weekly Level, Velocity and Flow Hydrographs
2/29/2016 to 3/7/2016

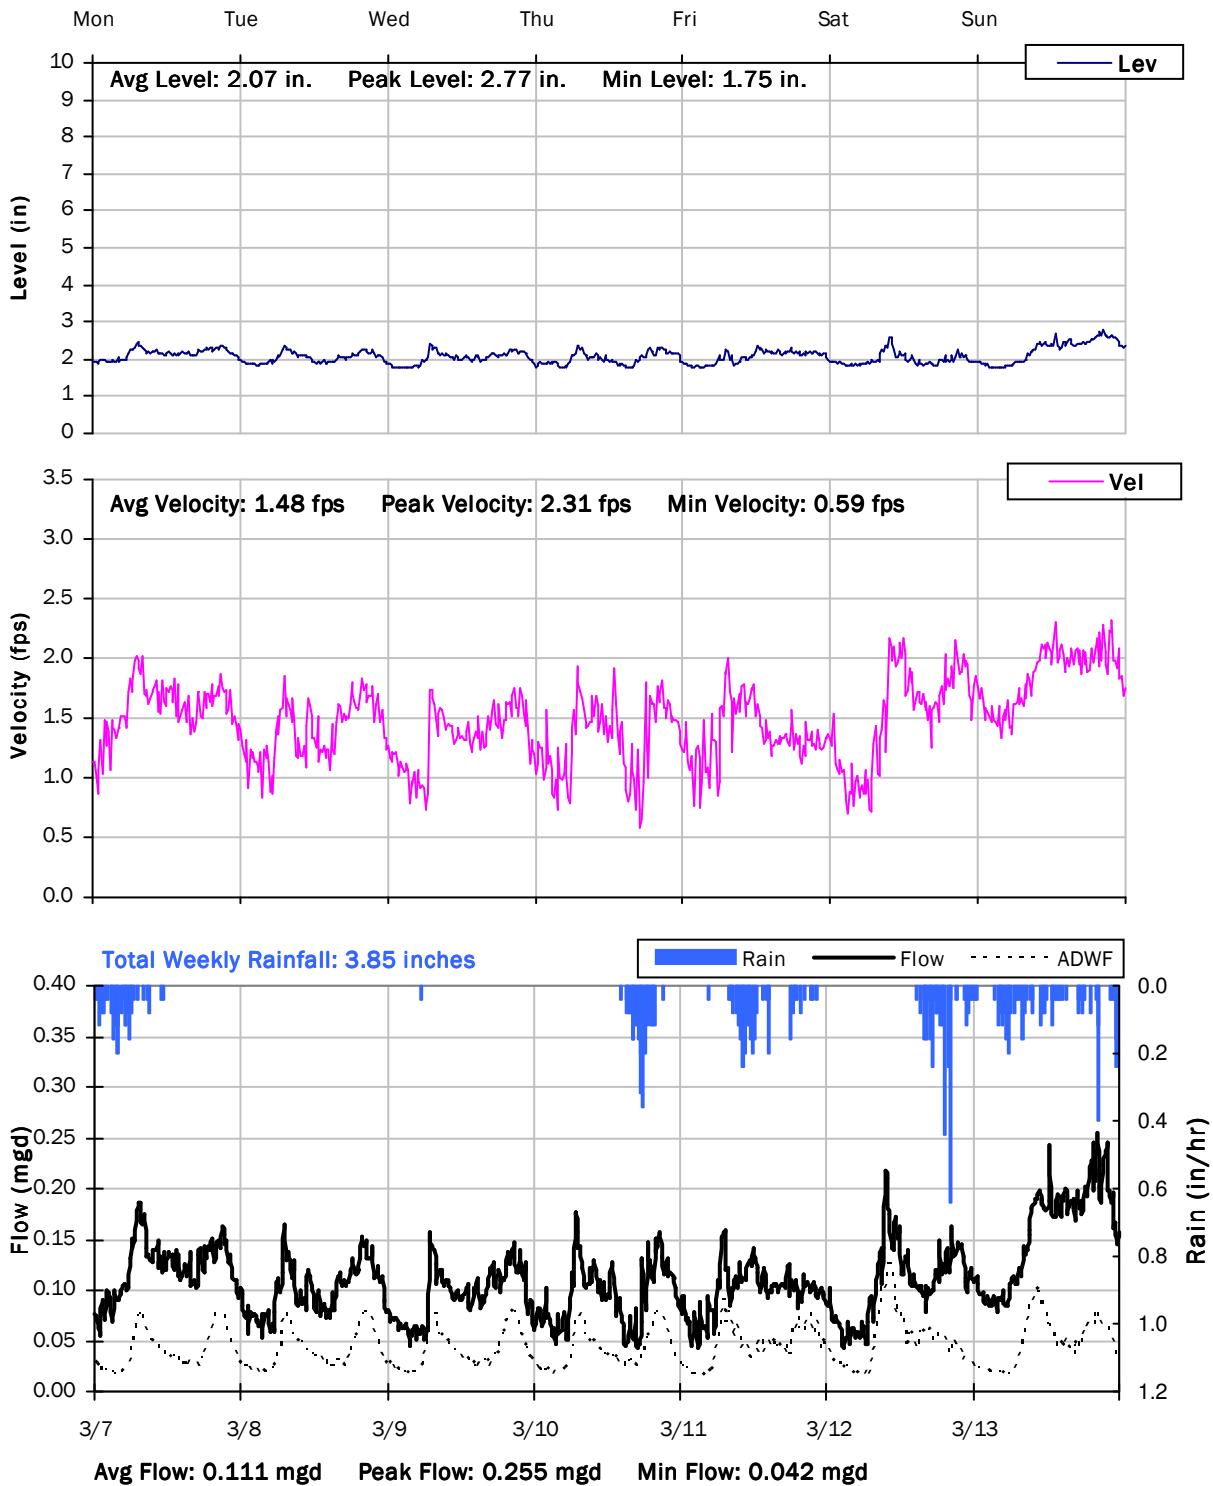
SITE 1
Weekly Level, Velocity and Flow Hydrographs
3/7/2016 to 3/14/2016

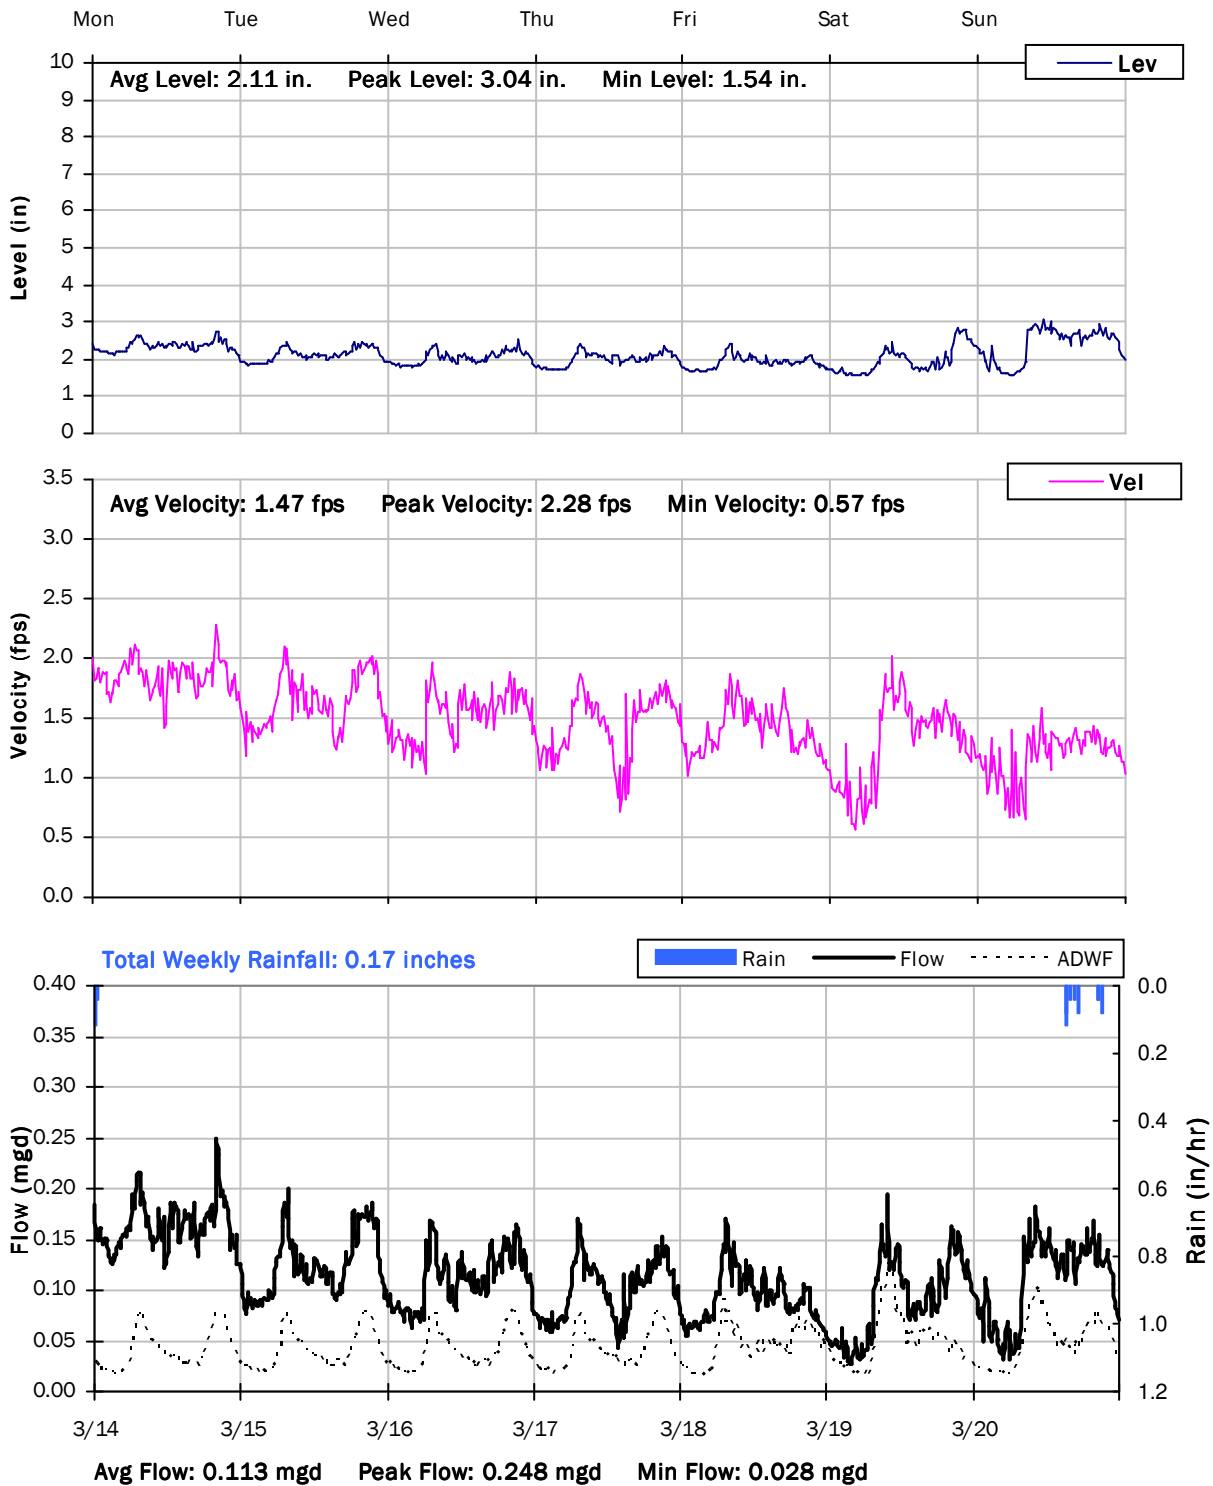
SITE 1
Weekly Level, Velocity and Flow Hydrographs
3/14/2016 to 3/21/2016

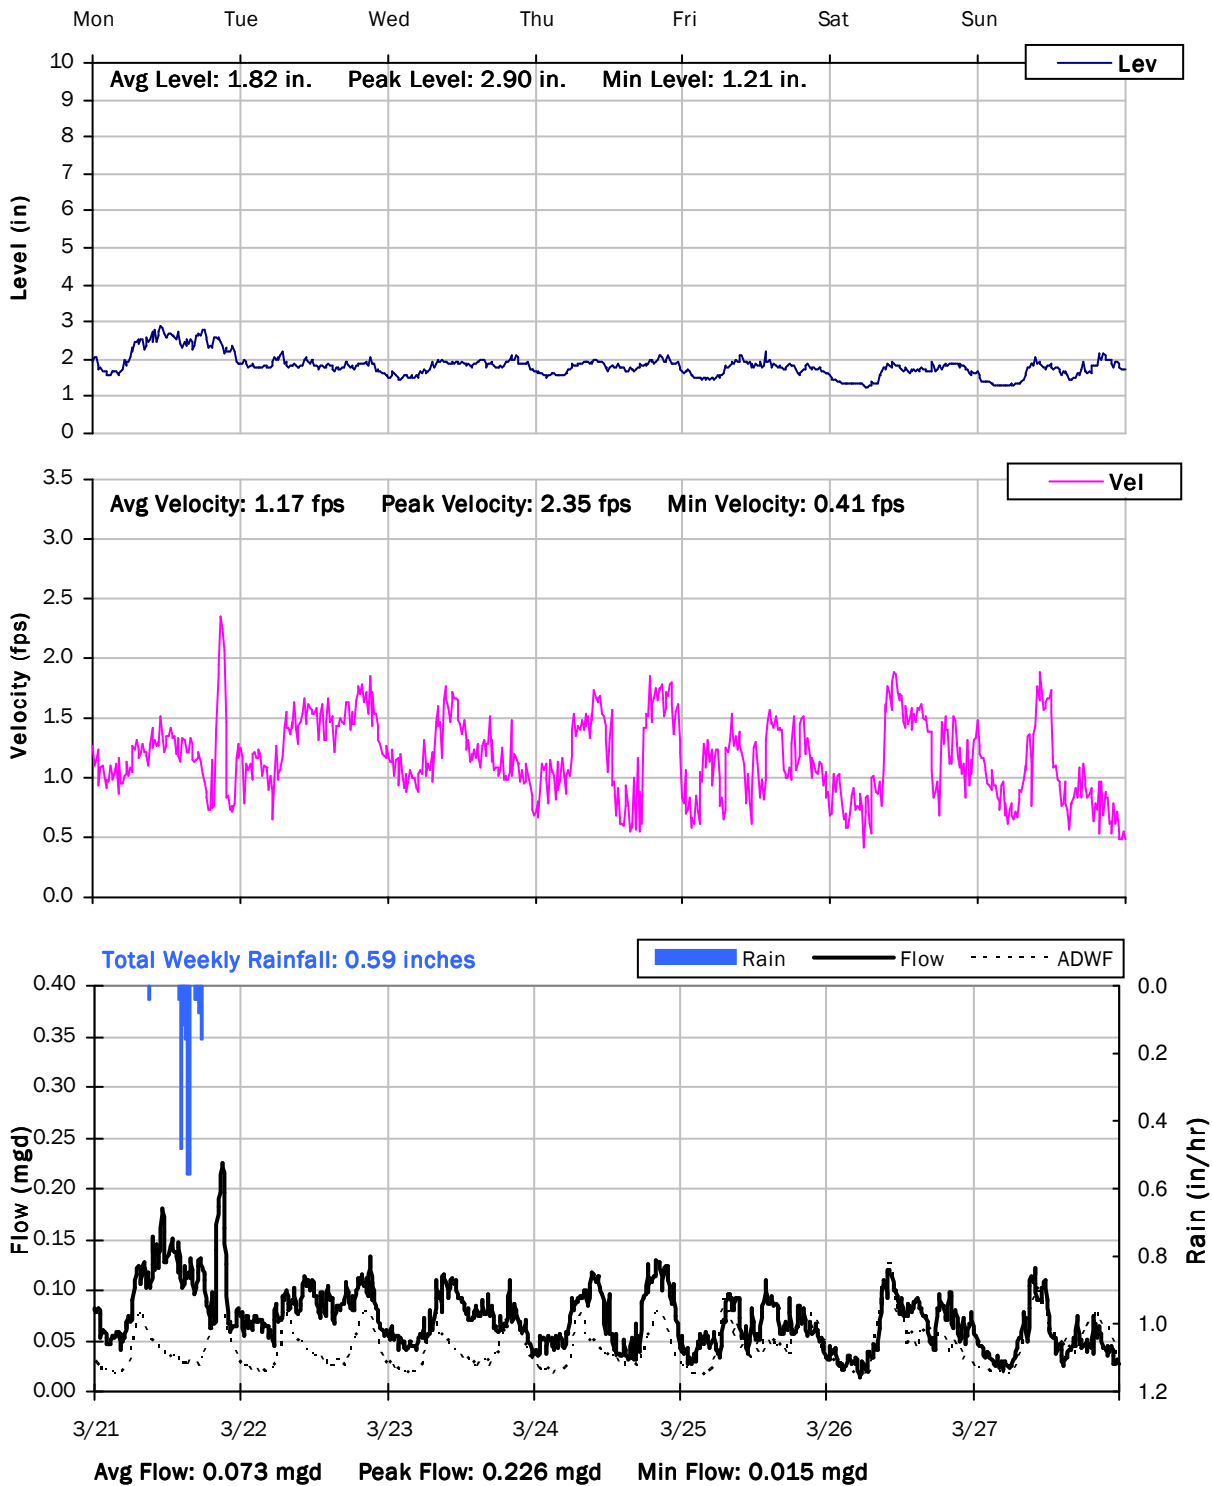
SITE 1
Weekly Level, Velocity and Flow Hydrographs
3/21/2016 to 3/28/2016

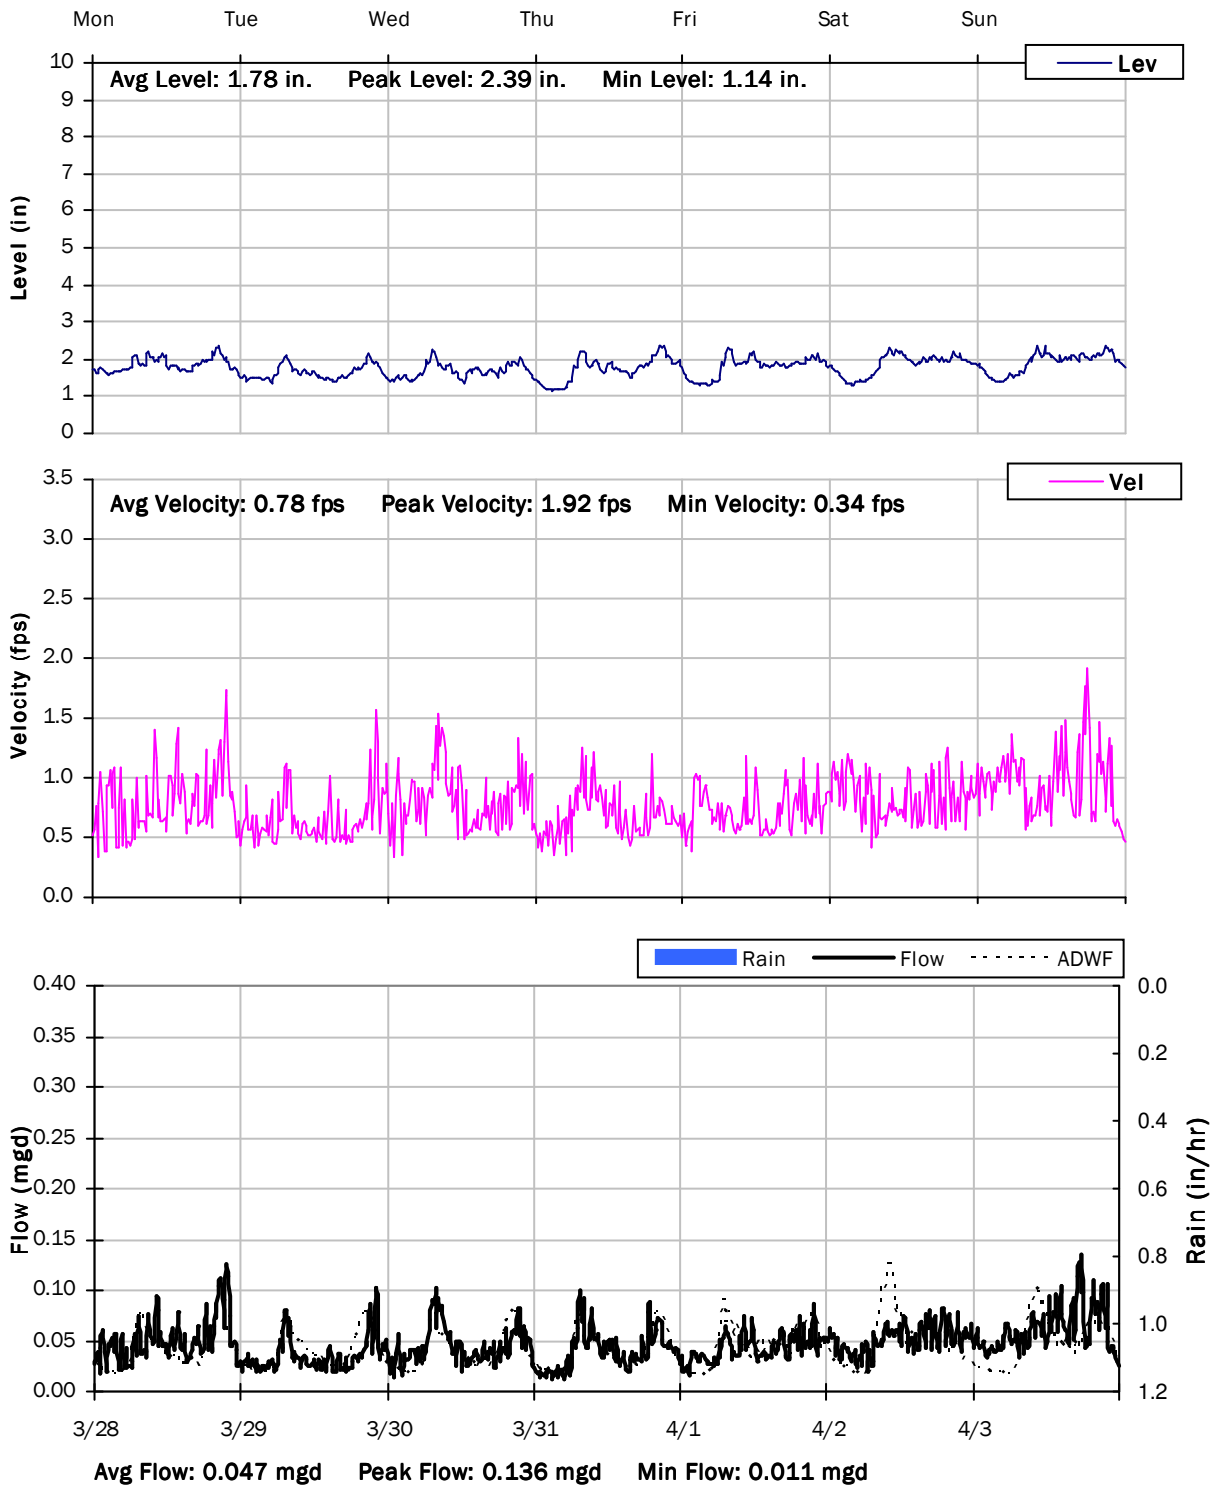
SITE 1
Weekly Level, Velocity and Flow Hydrographs
3/28/2016 to 4/4/2016

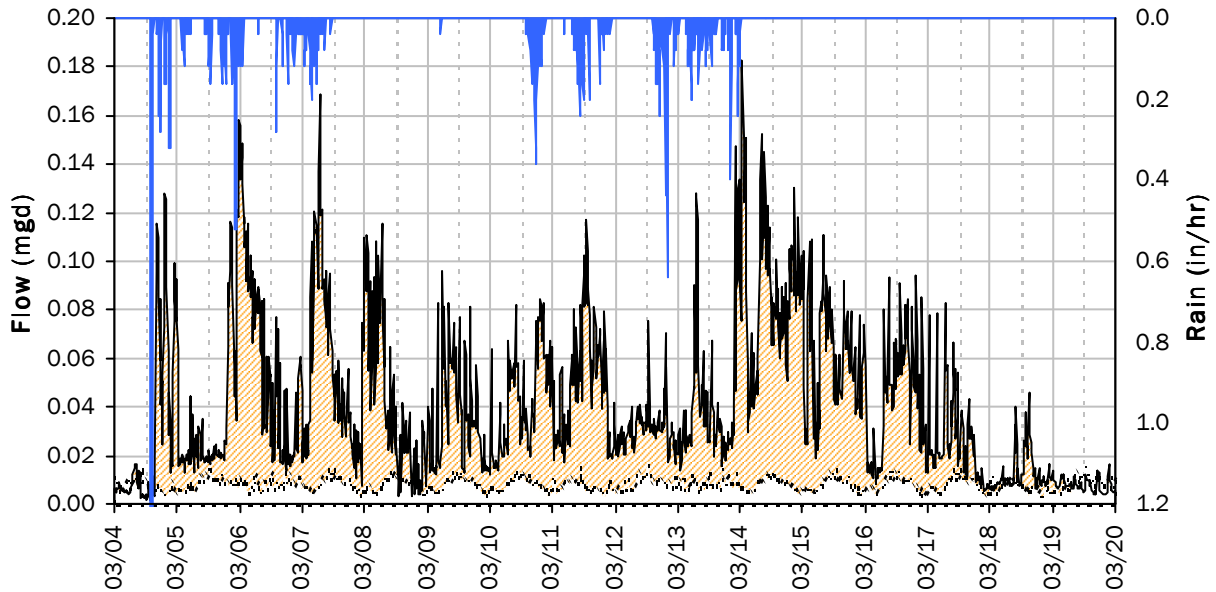
Event 1 Detail Graph

Storm Event I/I Analysis (Rain = 7.11 inches)

<u>Capacity</u>		<u>Inflow / Infiltration</u>	
Peak Flow:	0.18 <i>mgd</i>	Peak I/I Rate:	0.18 <i>mgd</i>
PF:	22.73	Total I/I:	536,000 <i>gallons</i>
Peak Level:	2.26 <i>in</i>		
d/D Ratio:	0.23
