APPENDIX A. FLOW MONITORING SITES: DATA, GRAPHS, INFORMATION

City of Lincoln

Sanitary Sewer Flow Monitoring

Temporary Monitoring: January 23 to April 3, 2016

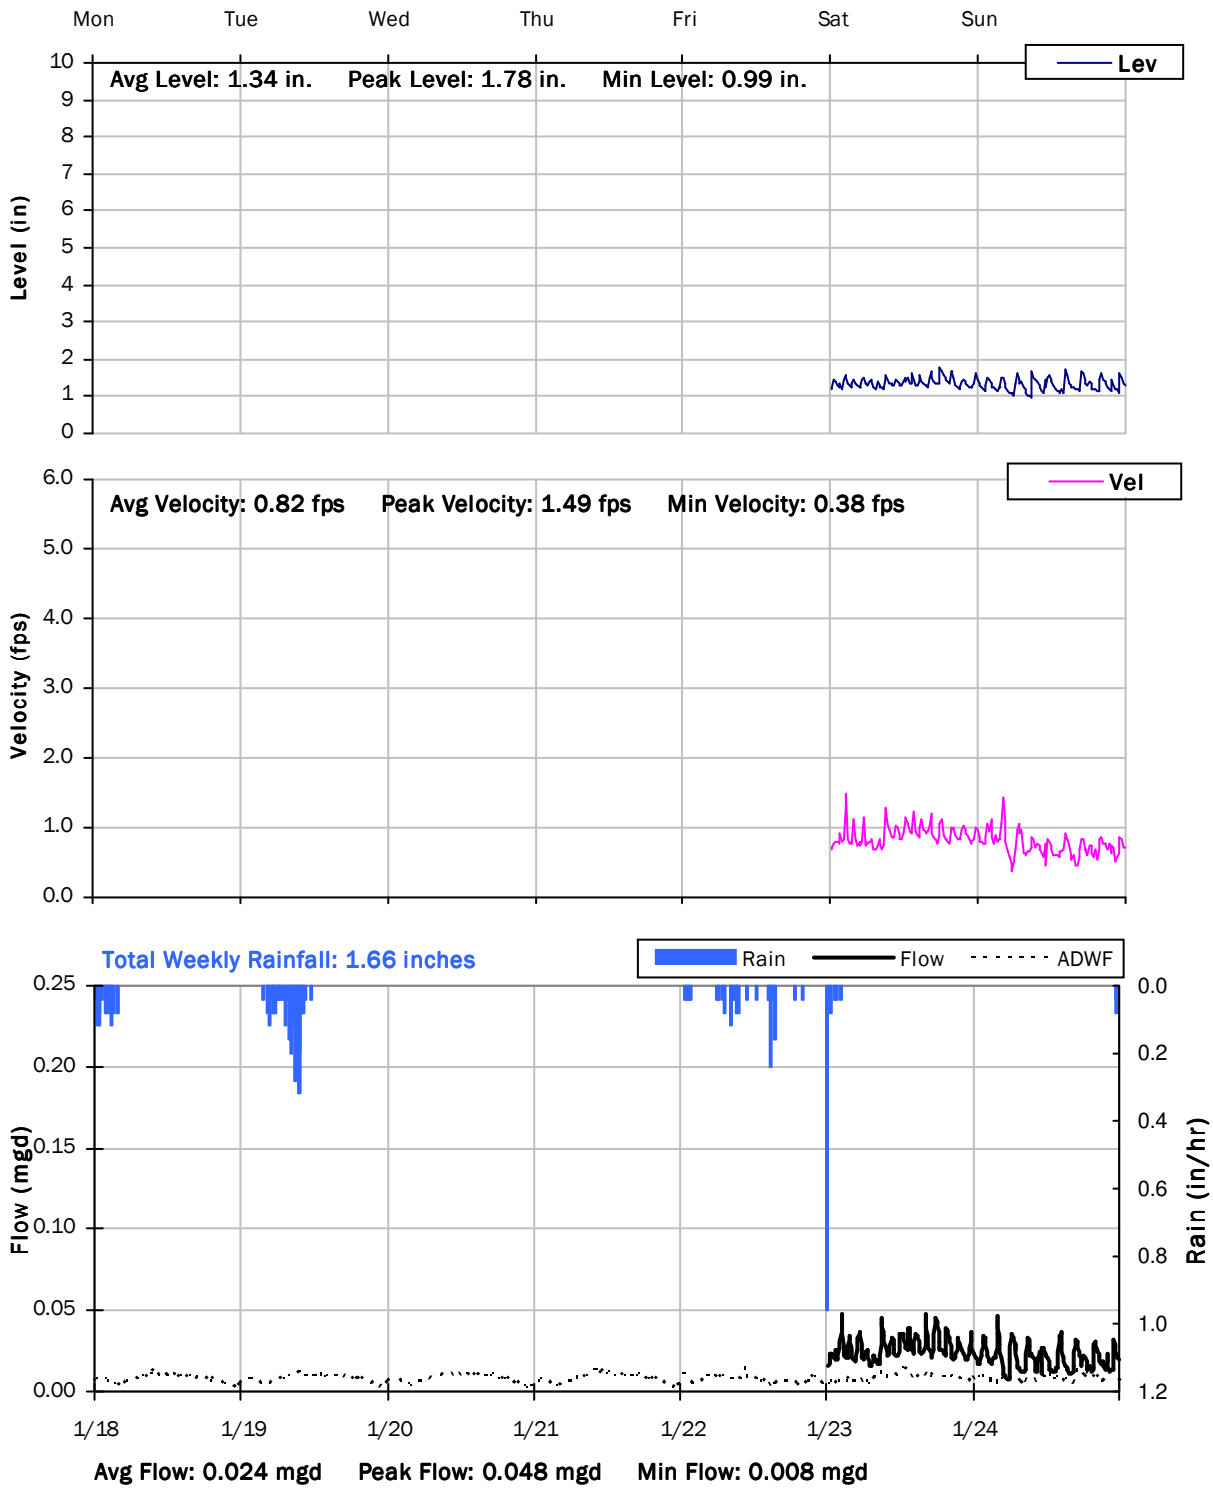
SITE 2
Weekly Level, Velocity and Flow Hydrographs
1/18/2016 to 1/25/2016

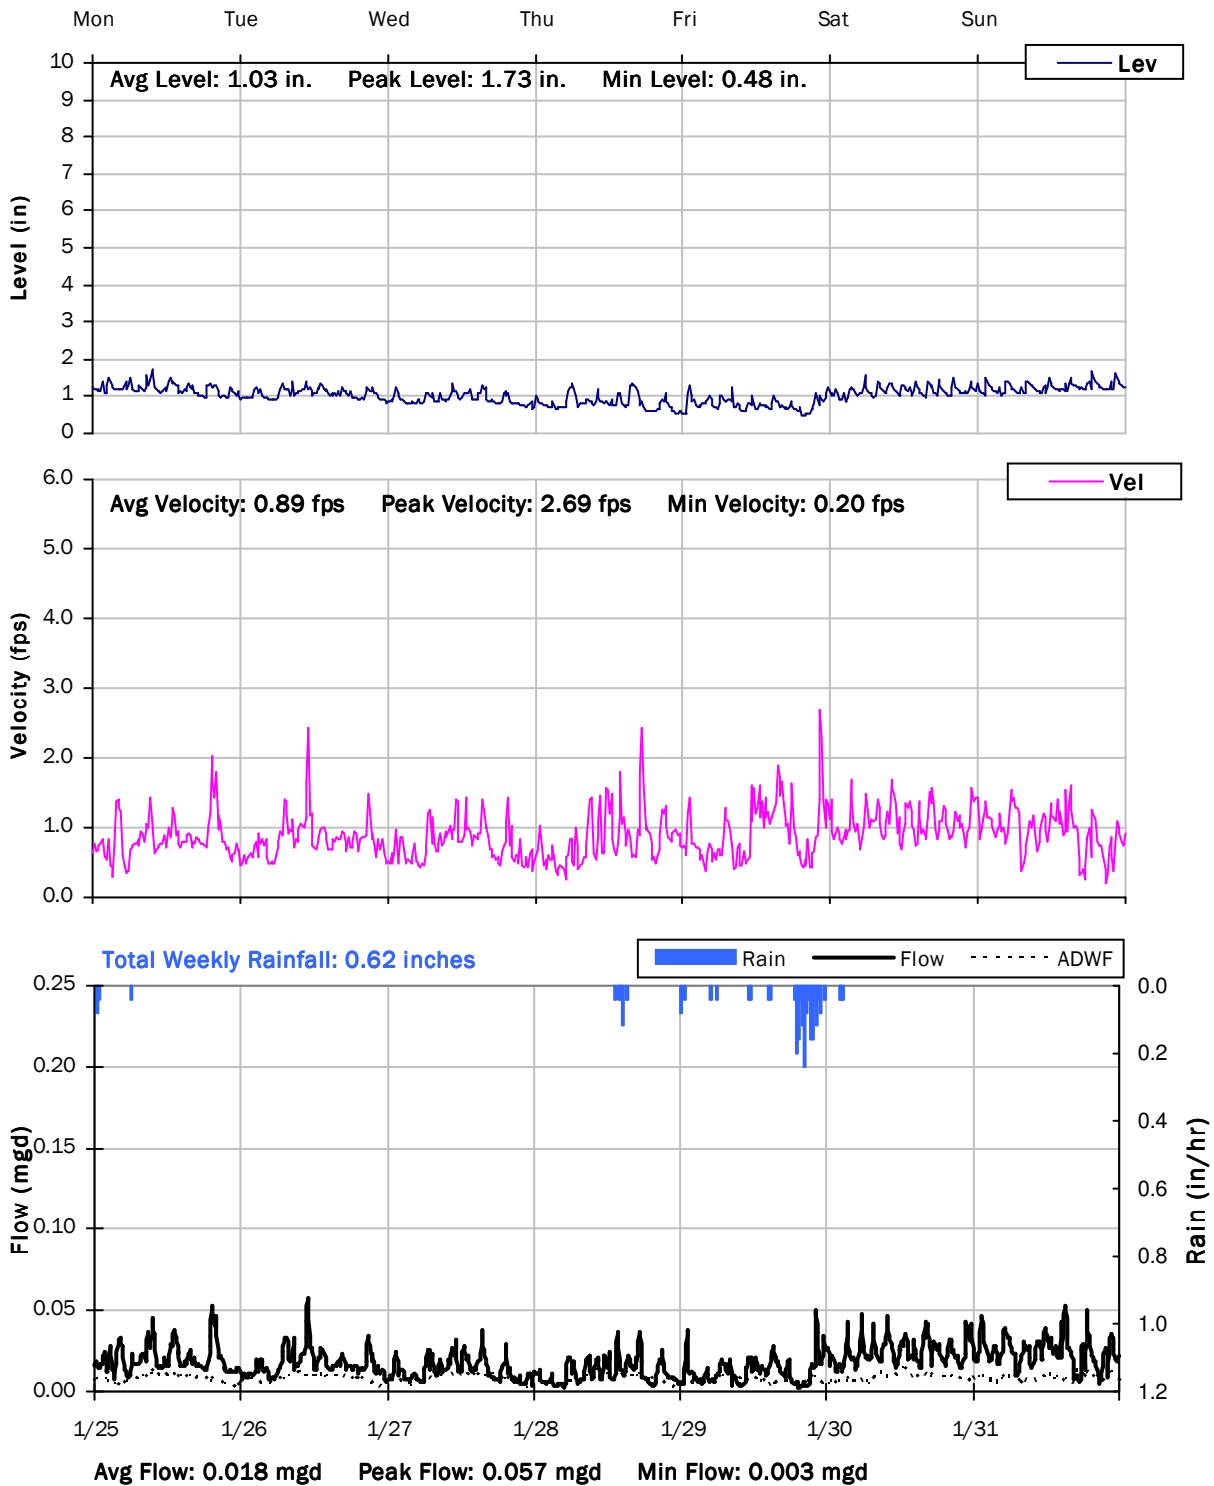
SITE 2
Weekly Level, Velocity and Flow Hydrographs
1/25/2016 to 2/1/2016

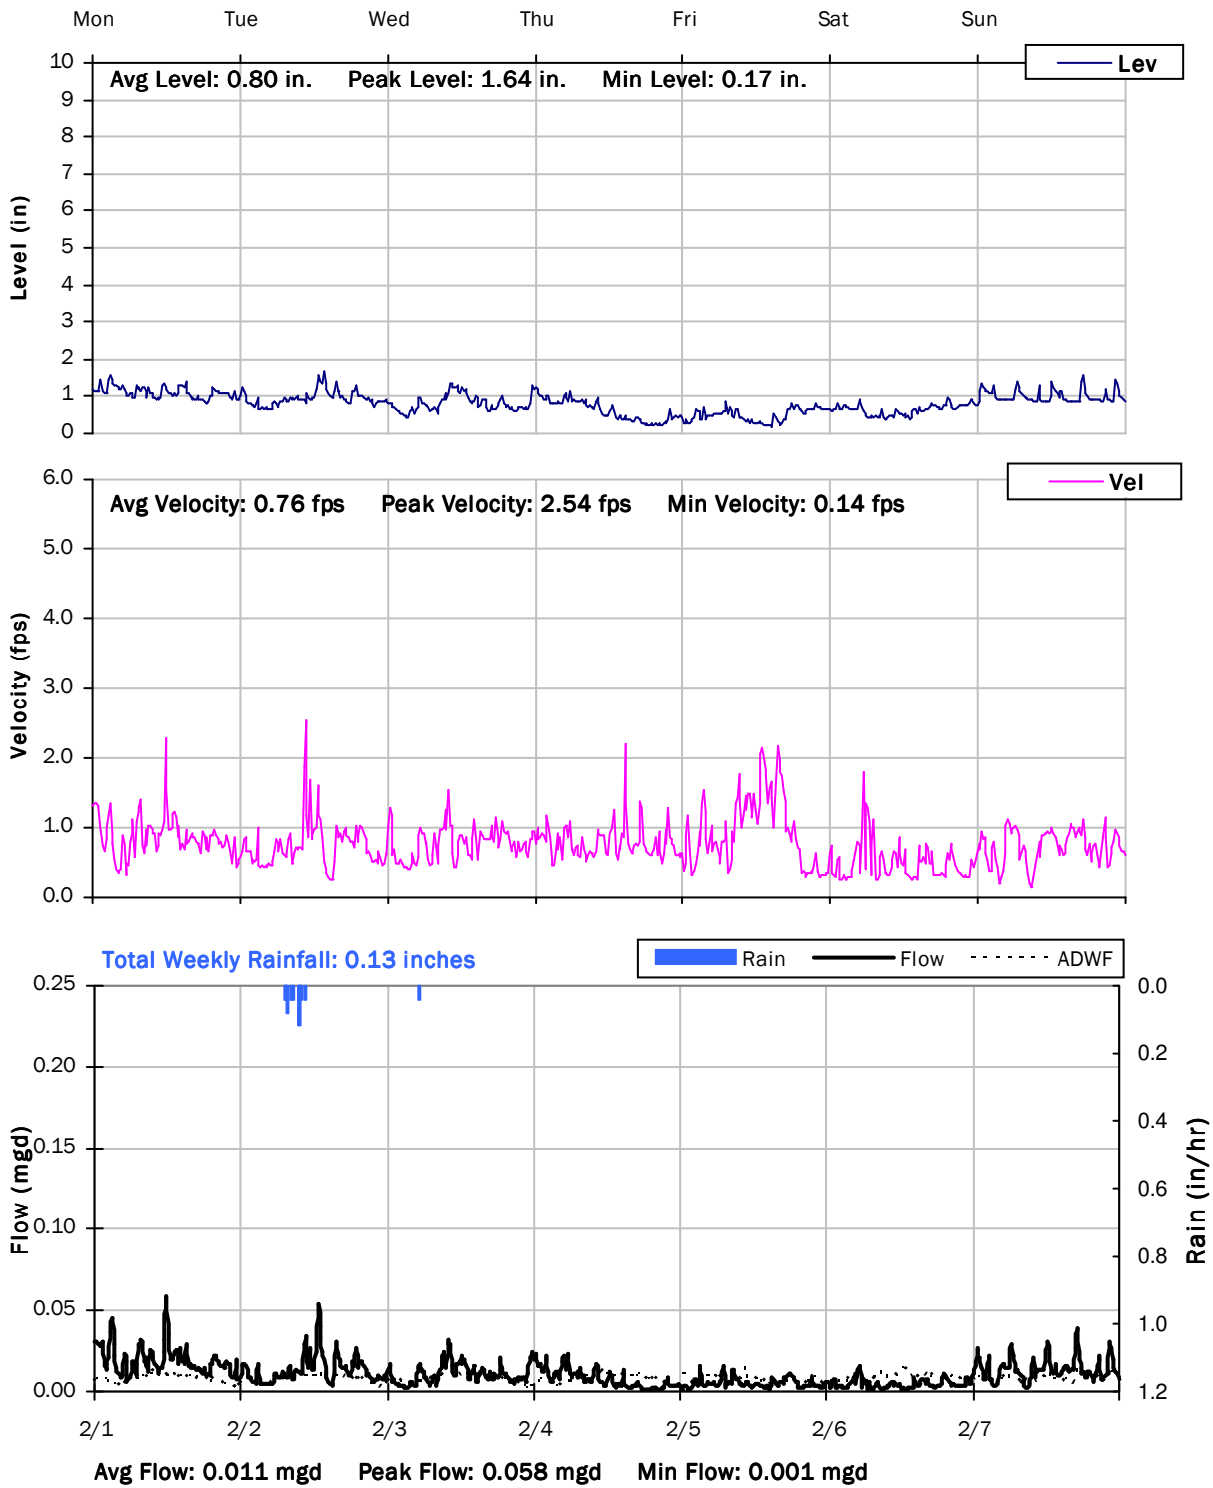
SITE 2
Weekly Level, Velocity and Flow Hydrographs
2/1/2016 to 2/8/2016

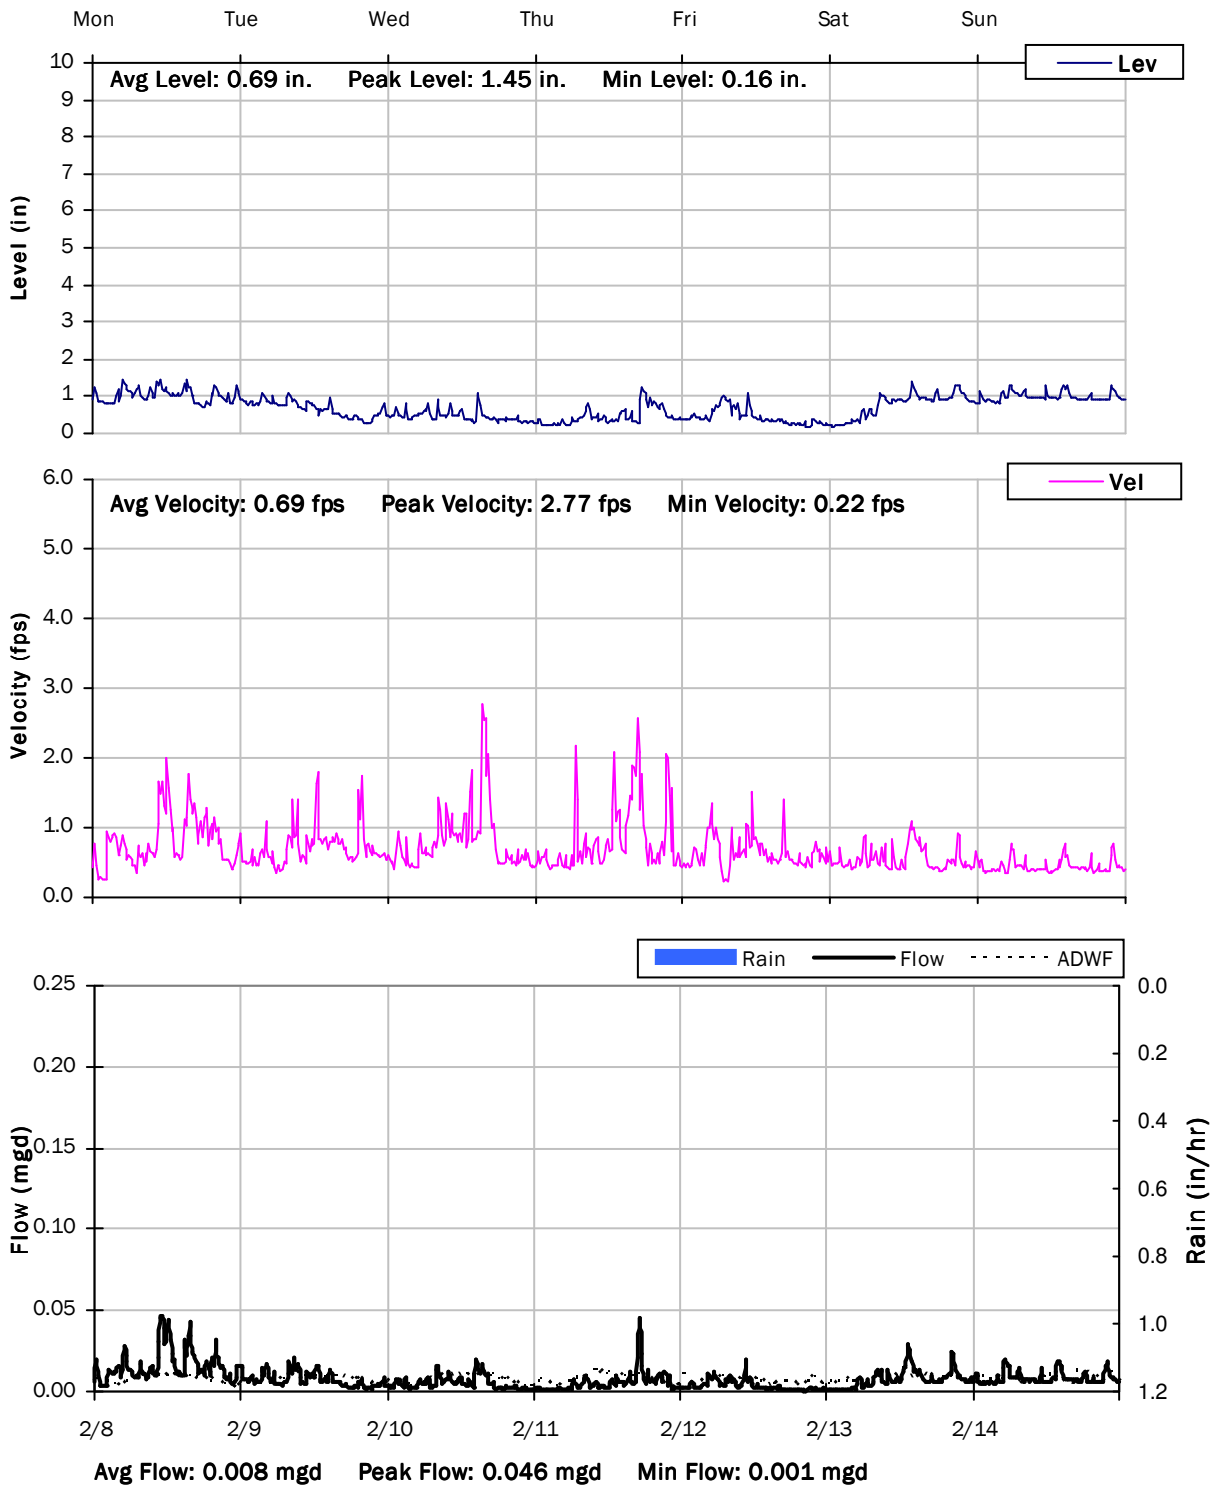
SITE 2
Weekly Level, Velocity and Flow Hydrographs
2/8/2016 to 2/15/2016

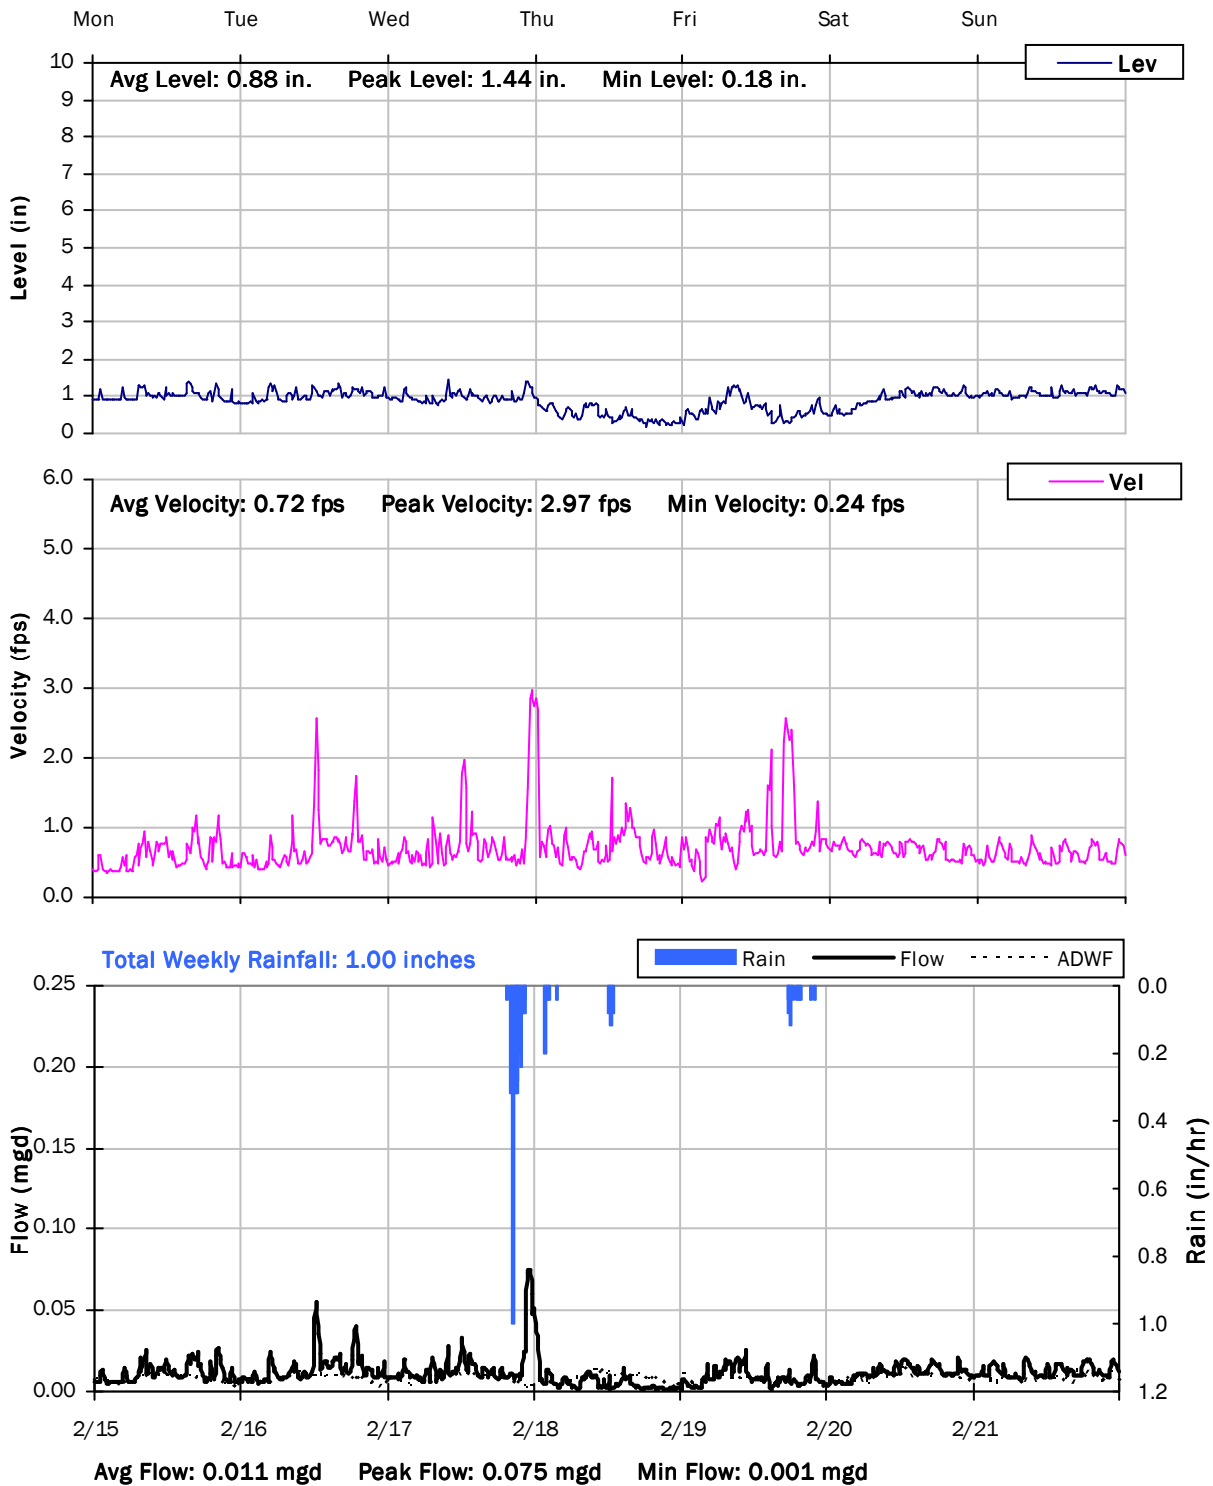
SITE 2
Weekly Level, Velocity and Flow Hydrographs
2/15/2016 to 2/22/2016

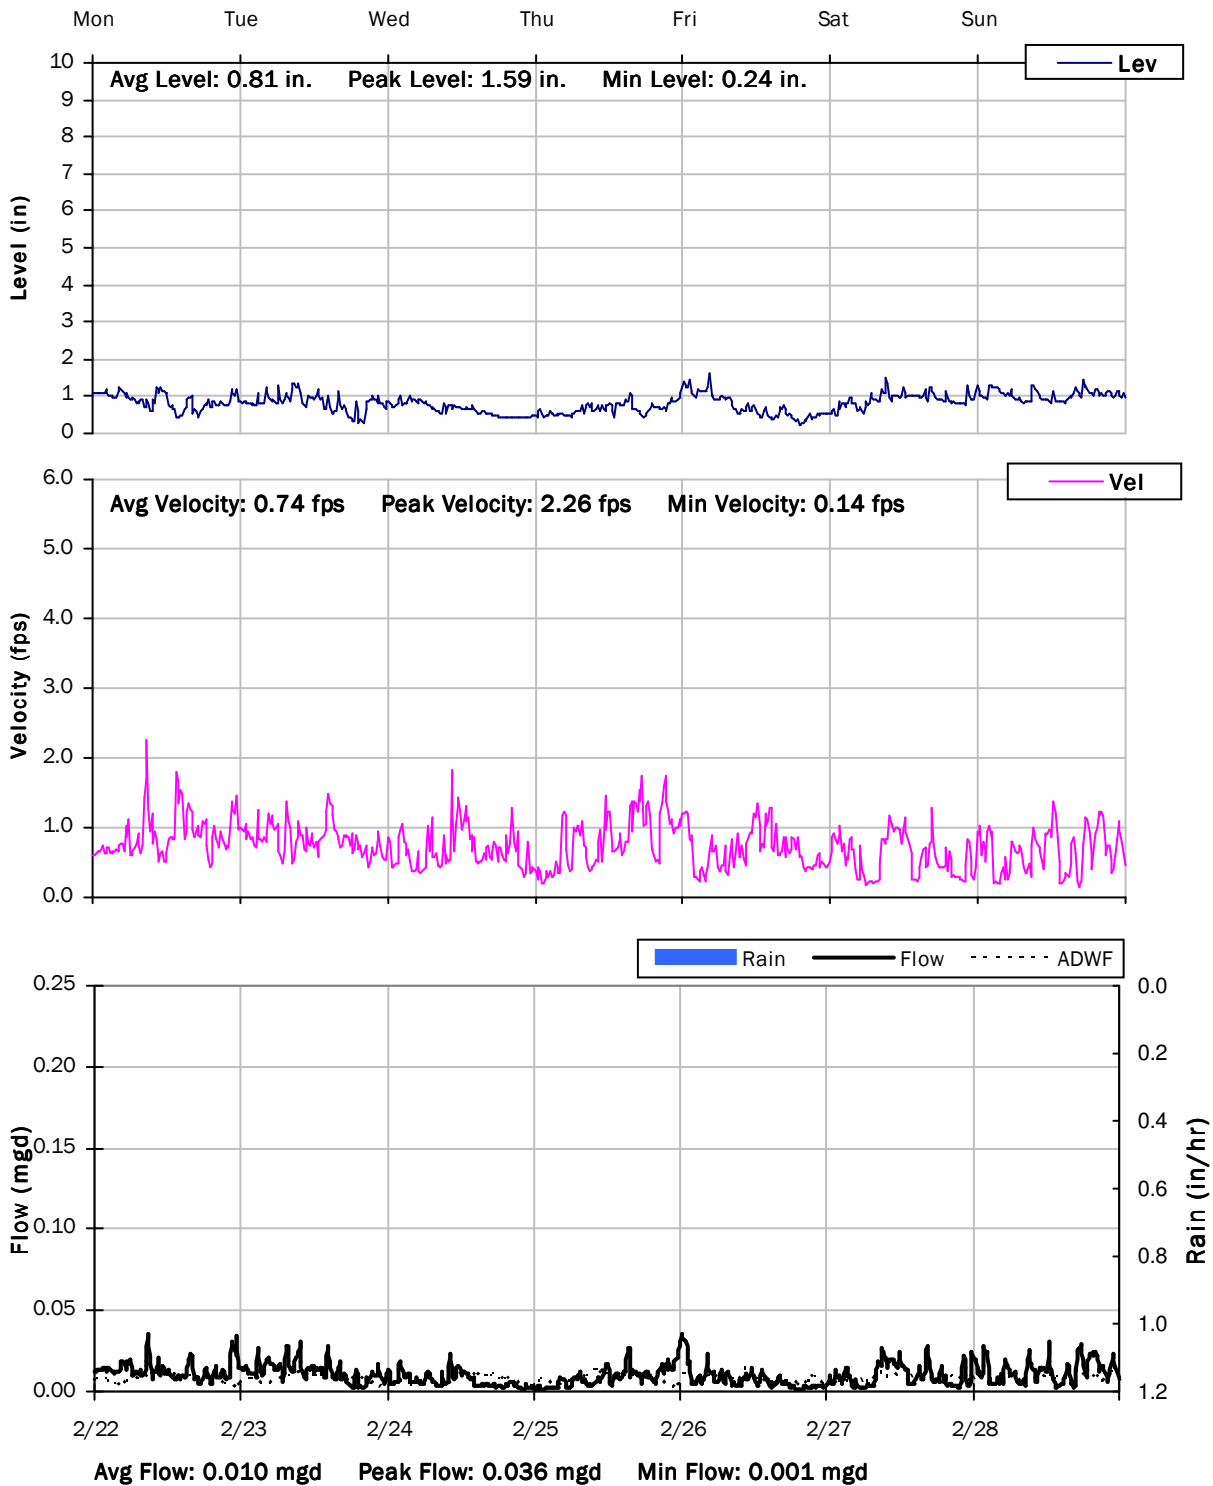
SITE 2
Weekly Level, Velocity and Flow Hydrographs
2/22/2016 to 2/29/2016

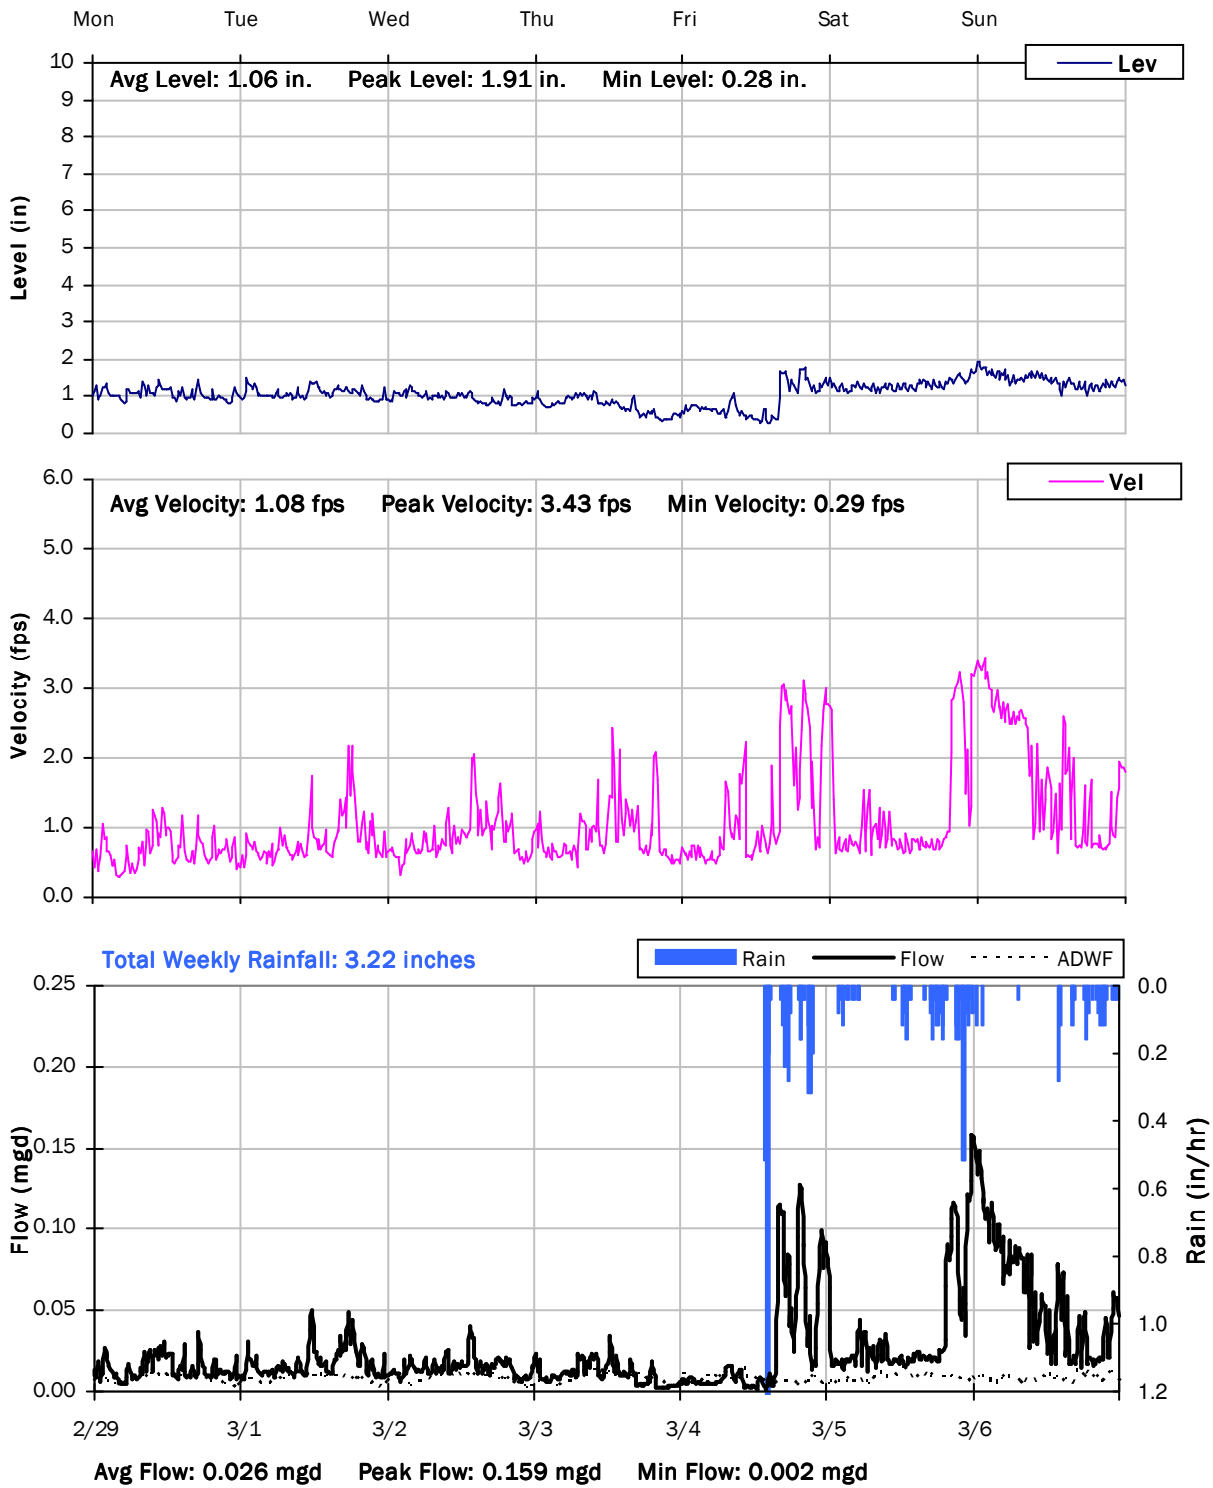
SITE 2
Weekly Level, Velocity and Flow Hydrographs
2/29/2016 to 3/7/2016

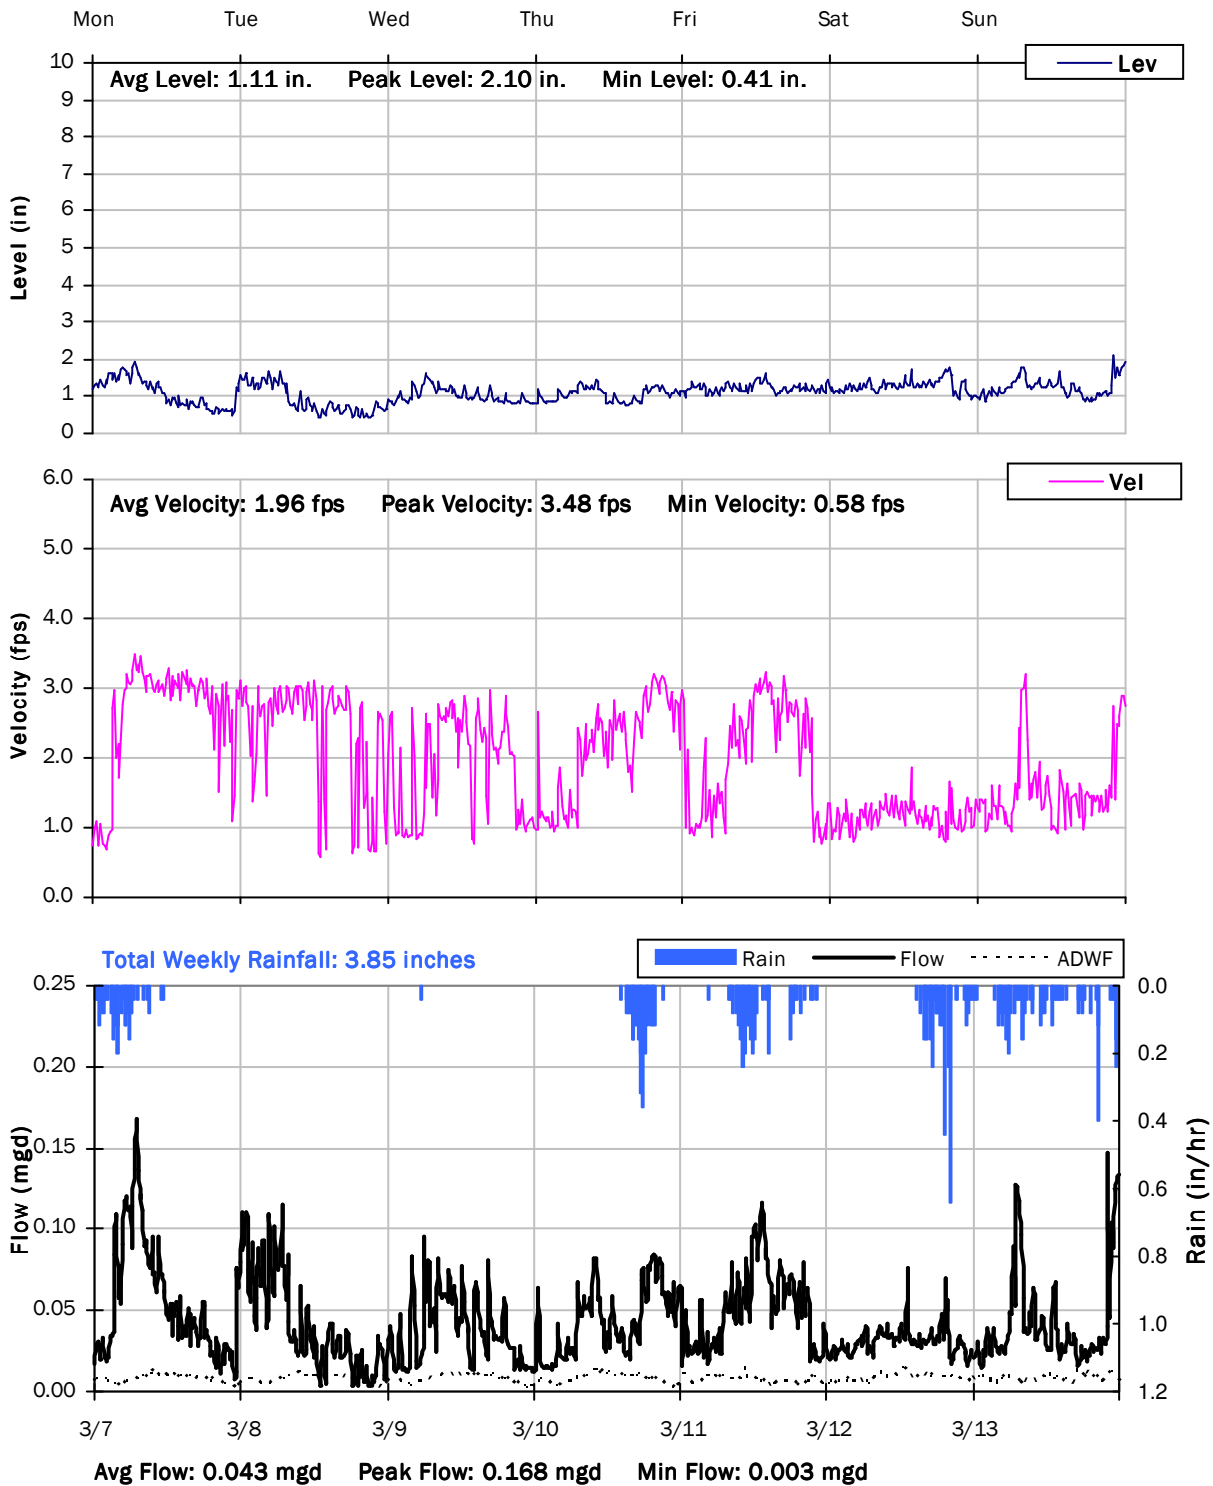
SITE 2
Weekly Level, Velocity and Flow Hydrographs
3/7/2016 to 3/14/2016

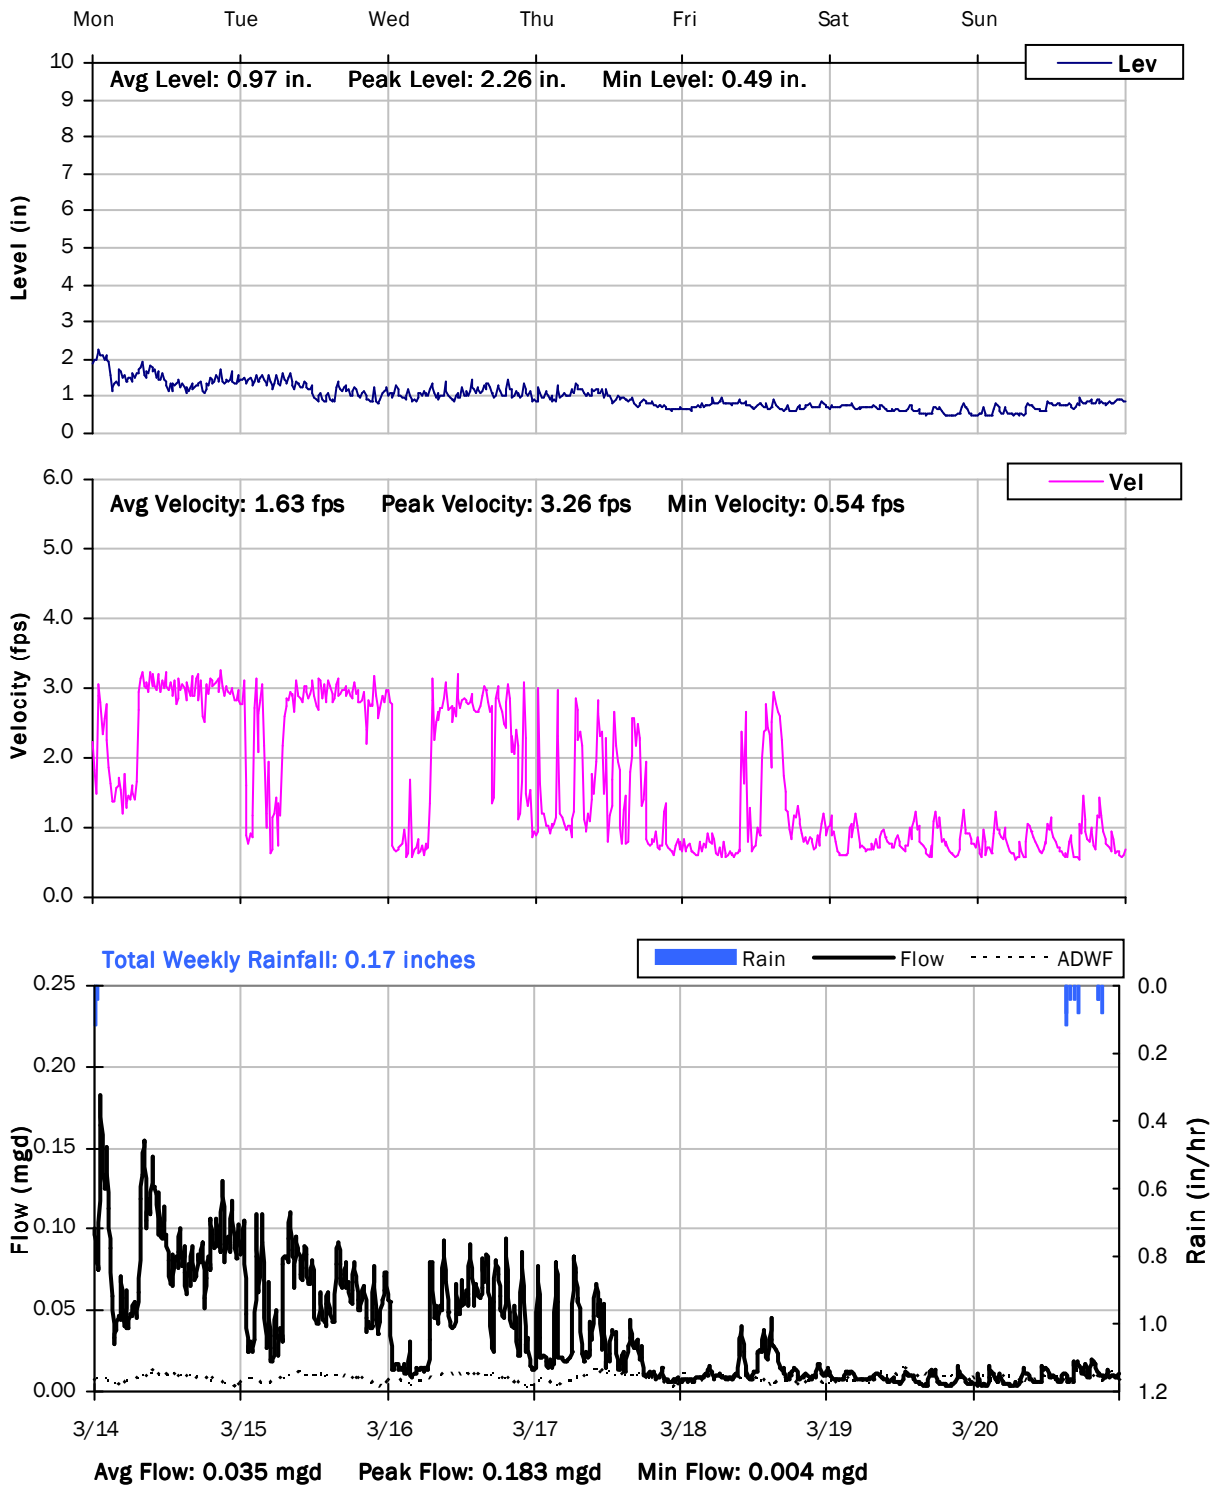
SITE 2
Weekly Level, Velocity and Flow Hydrographs
3/14/2016 to 3/21/2016

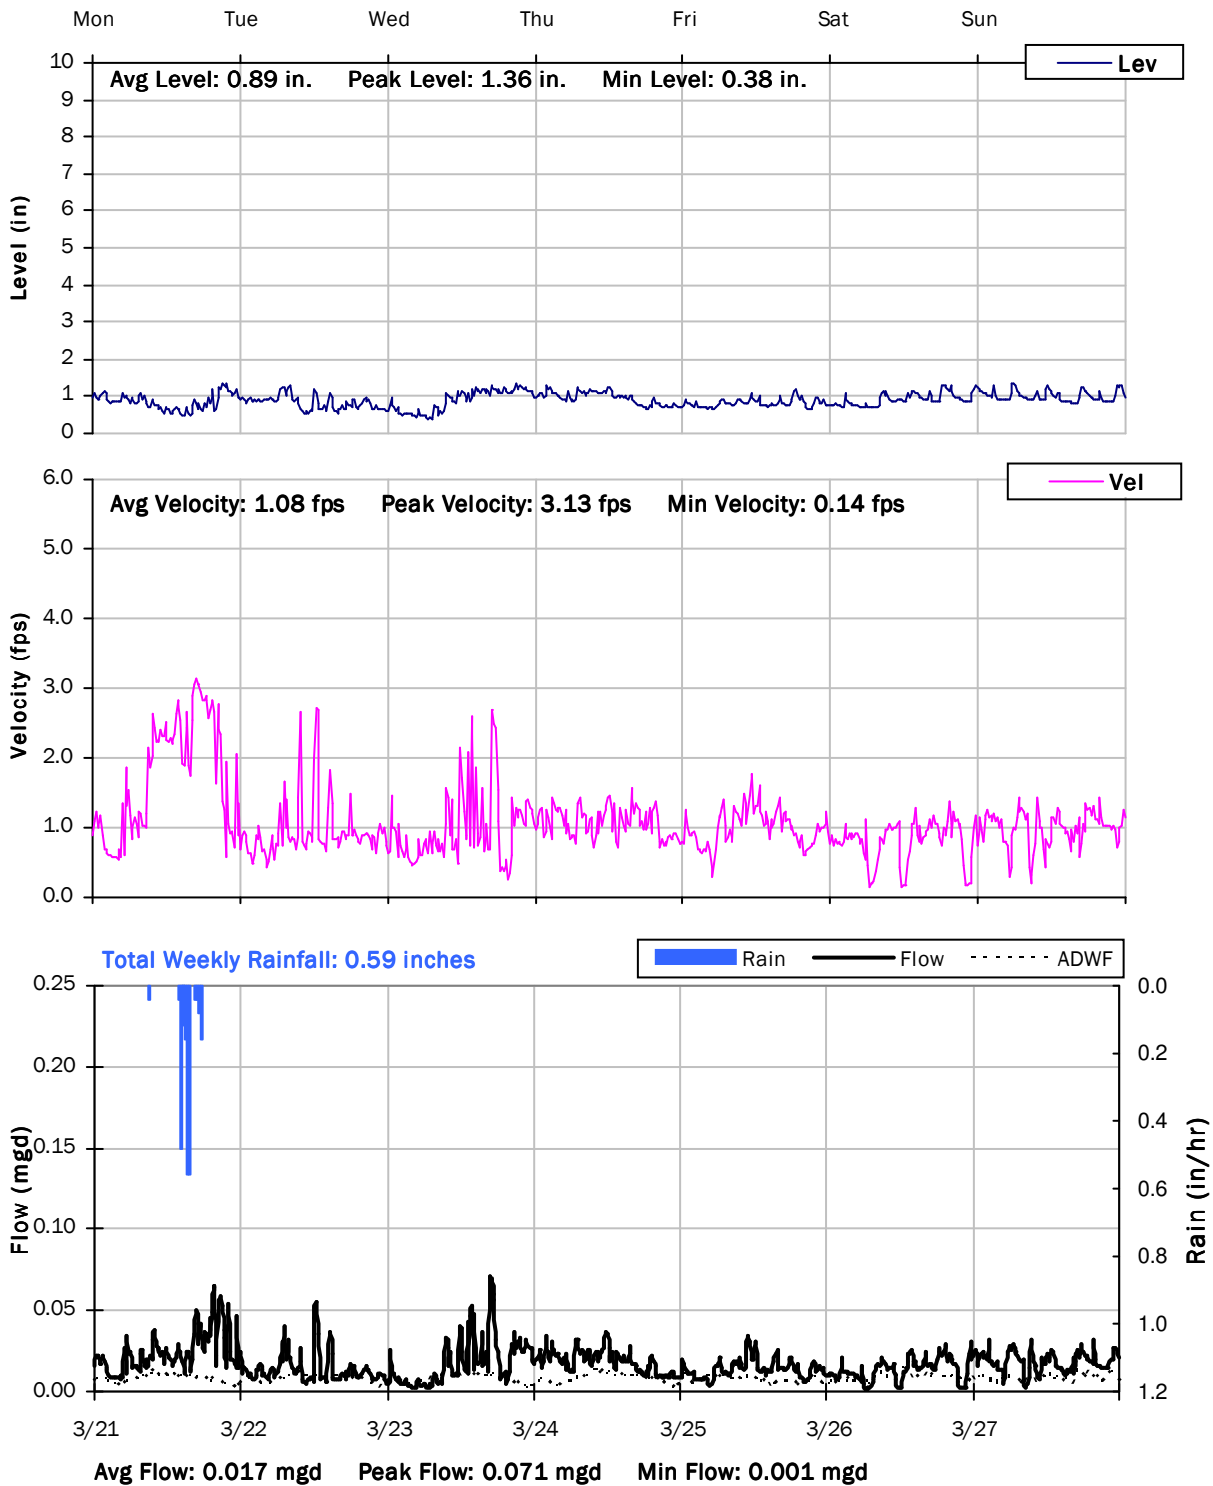
SITE 2
Weekly Level, Velocity and Flow Hydrographs
3/21/2016 to 3/28/2016

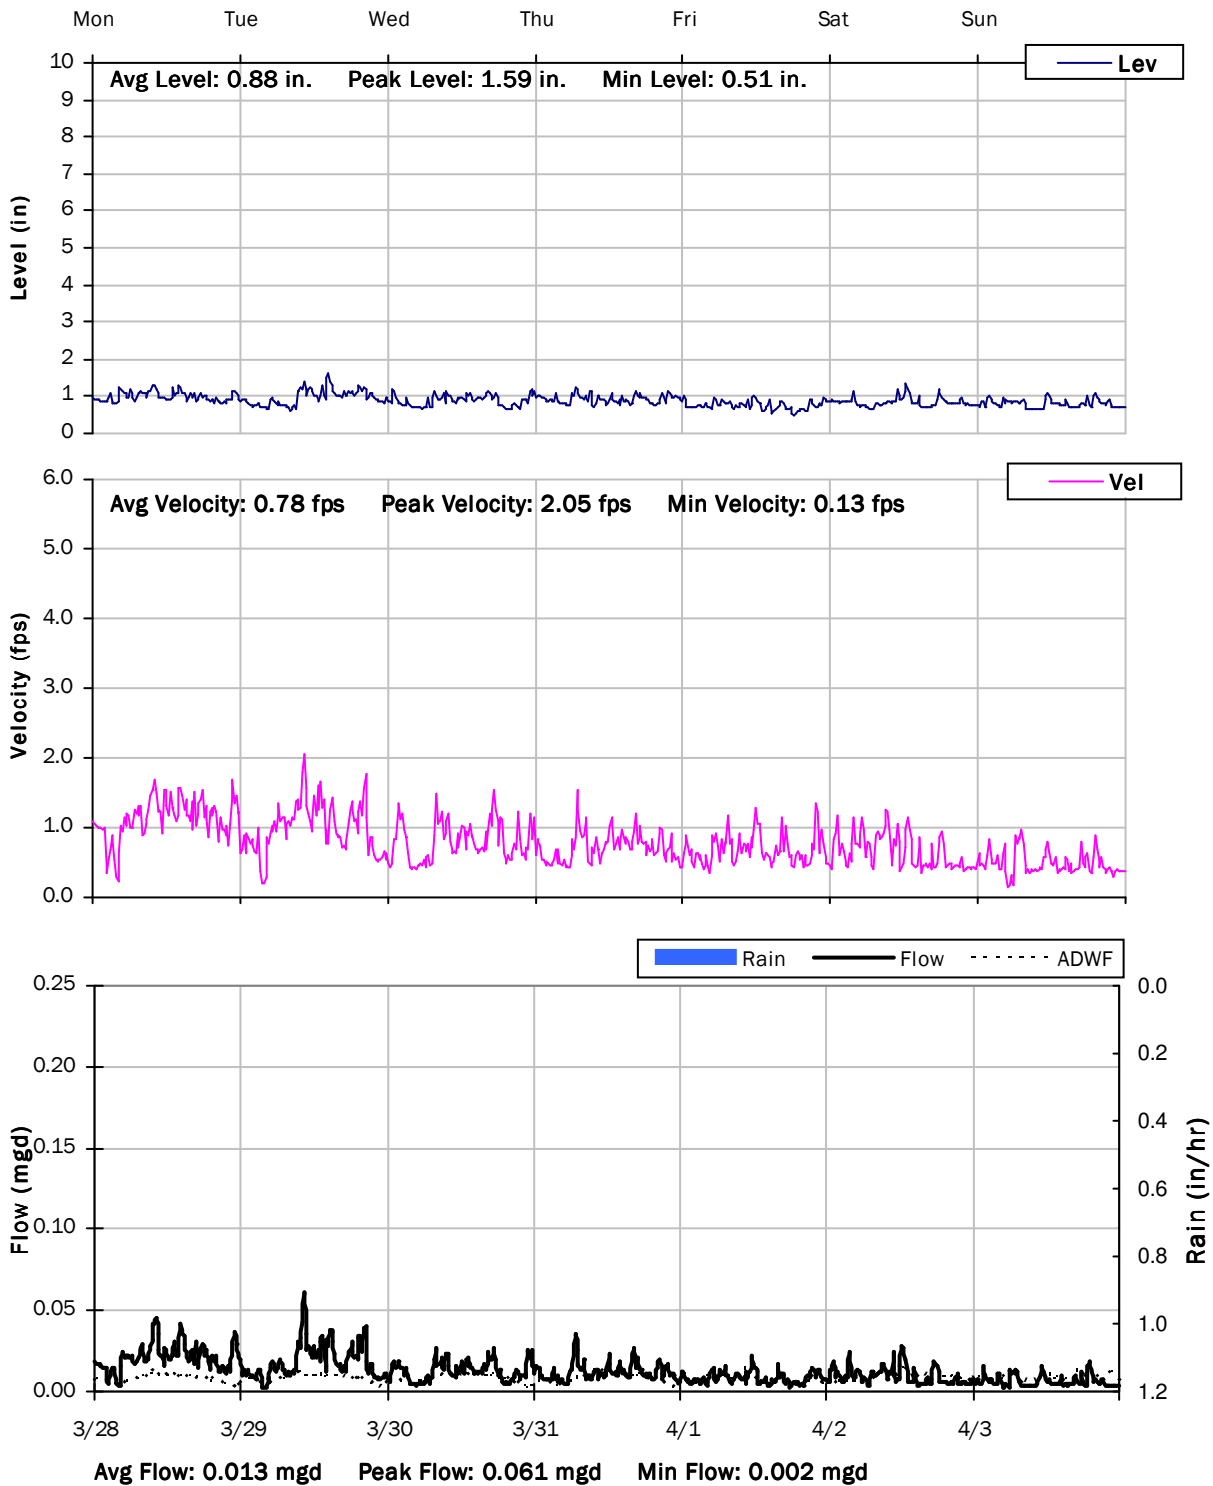
SITE 2
Weekly Level, Velocity and Flow Hydrographs
3/28/2016 to 4/4/2016

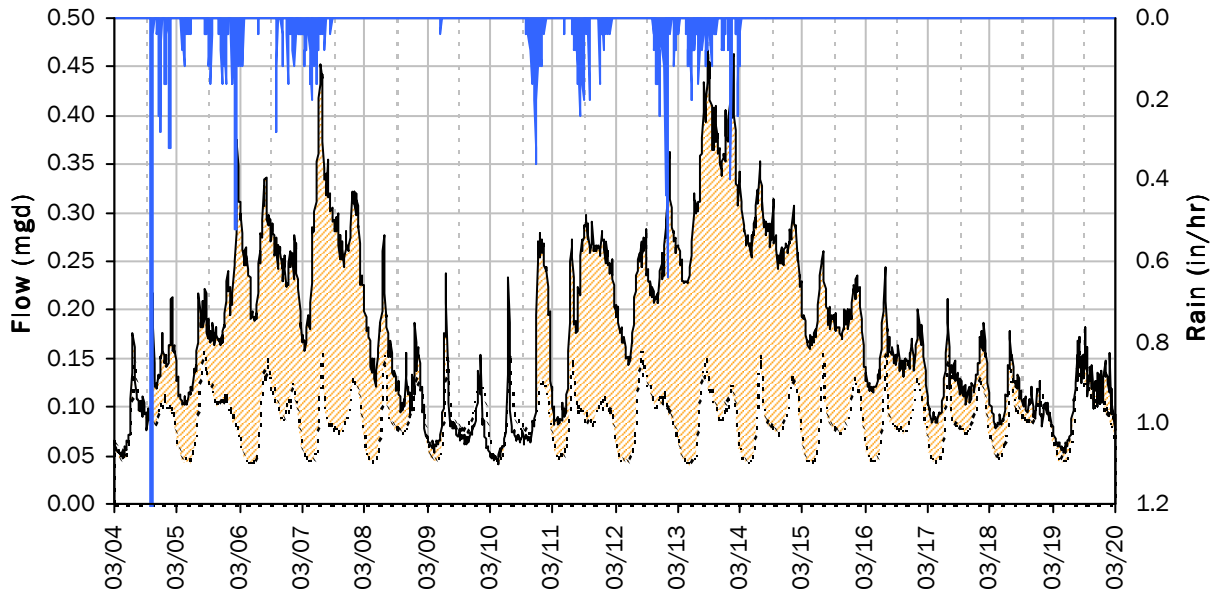
Event 1 Detail Graph

Storm Event I/I Analysis (Rain = 7.11 inches)

<u>Capacity</u>		<u>Inflow / Infiltration</u>	
Peak Flow:	0.47 mgd	Peak I/I Rate:	0.35 mgd
PF:	5.43	Total I/I:	1,524,000 gallons
Peak Level:	3.88 in		
d/D Ratio:	0.32

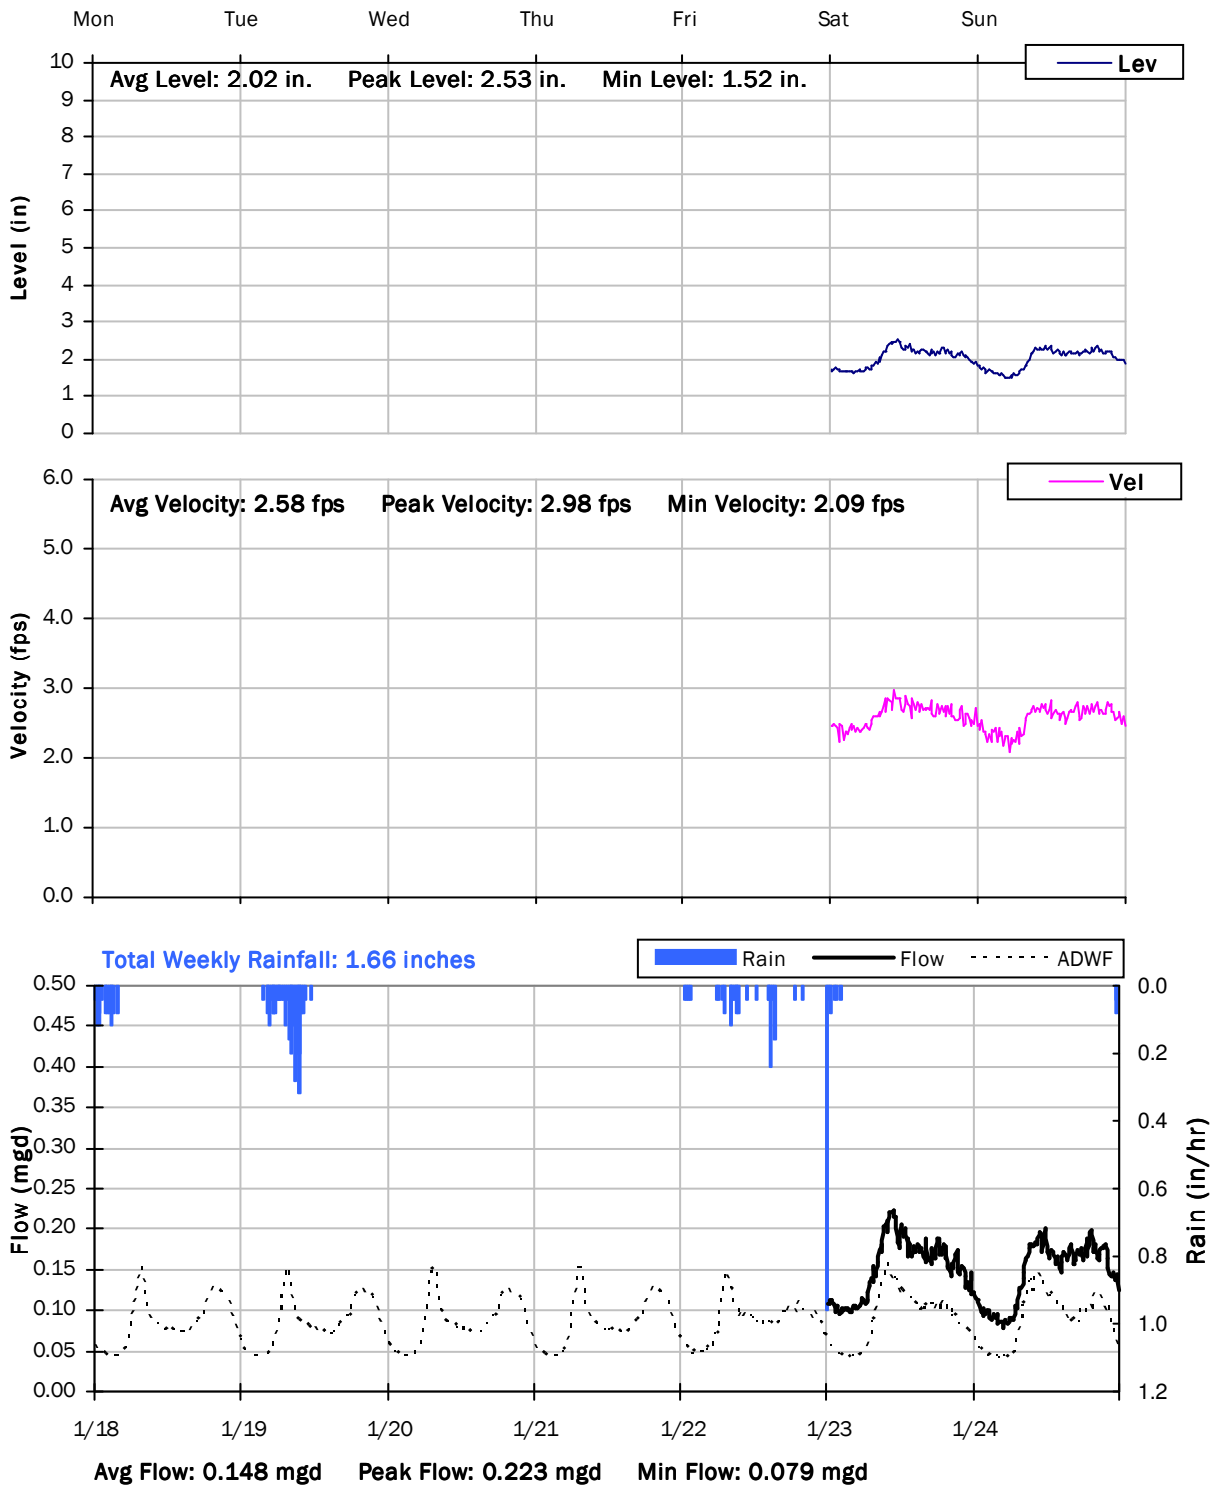
SITE 3
Weekly Level, Velocity and Flow Hydrographs
1/18/2016 to 1/25/2016
