APPENDIX A. FLOW MONITORING SITES: DATA, GRAPHS, INFORMATION

City of Lincoln

Sanitary Sewer Flow Monitoring

Temporary Monitoring: January 23 to April 3, 2016

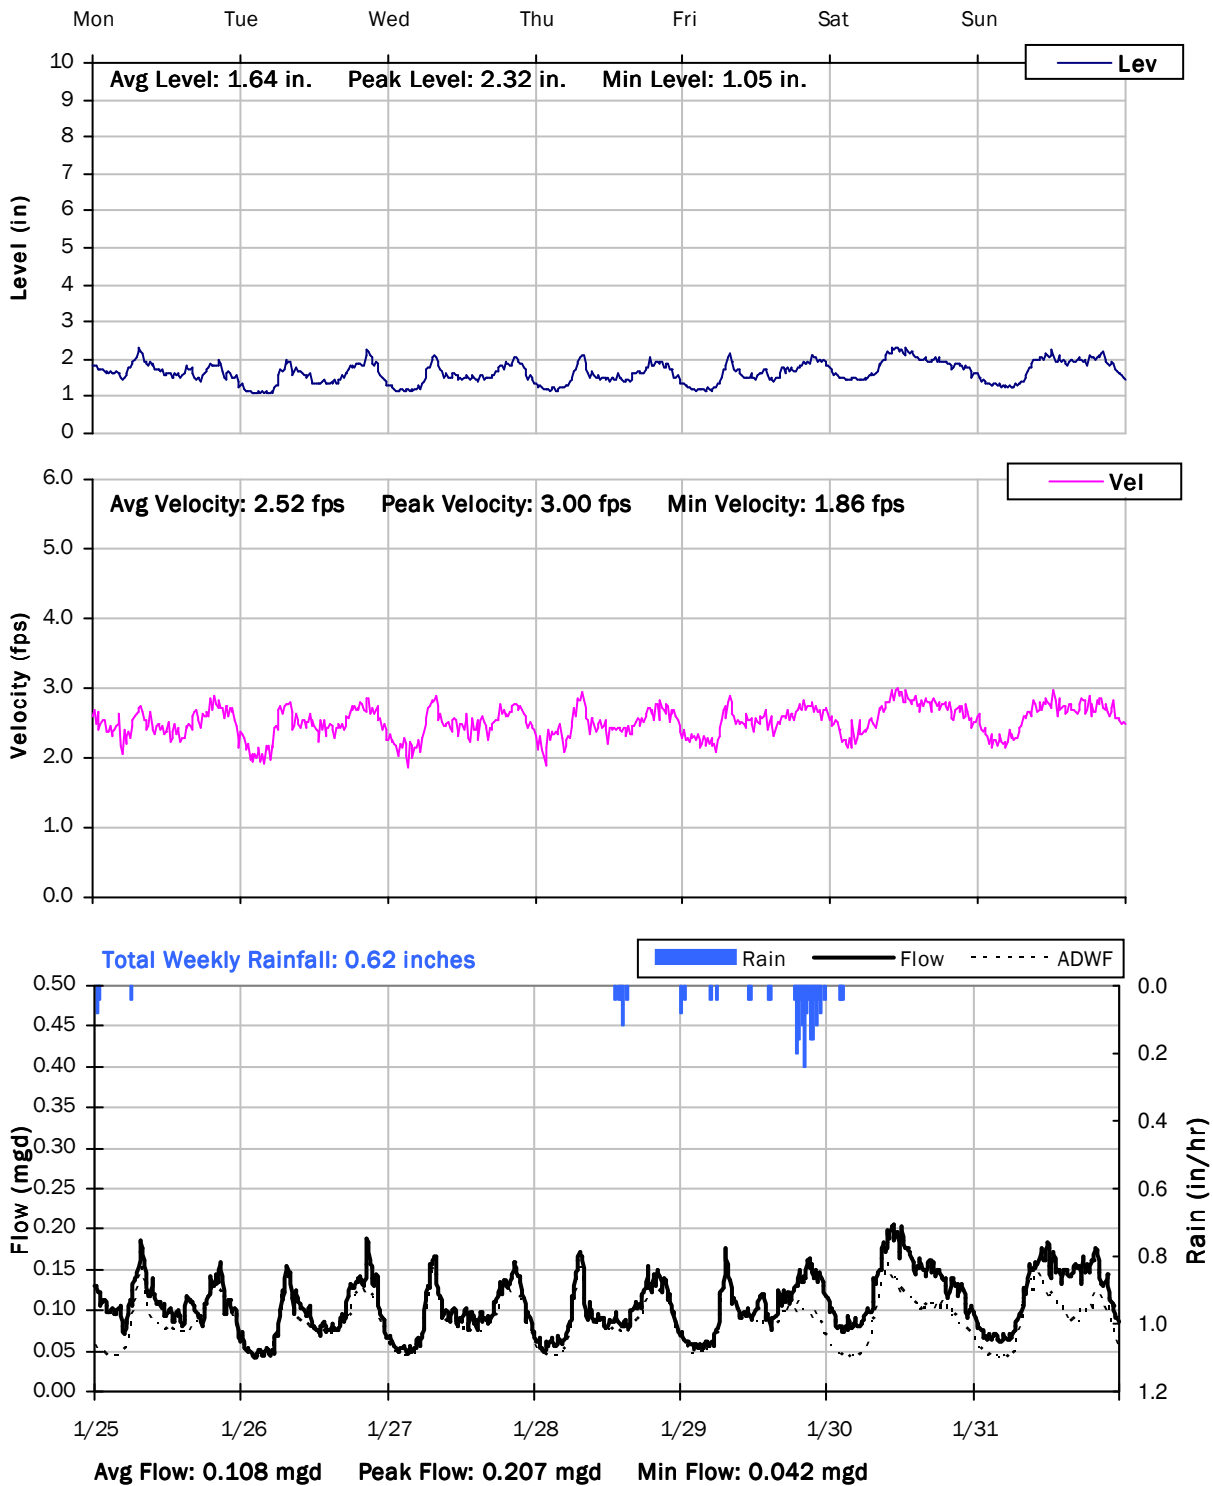
SITE 3
Weekly Level, Velocity and Flow Hydrographs
1/25/2016 to 2/1/2016

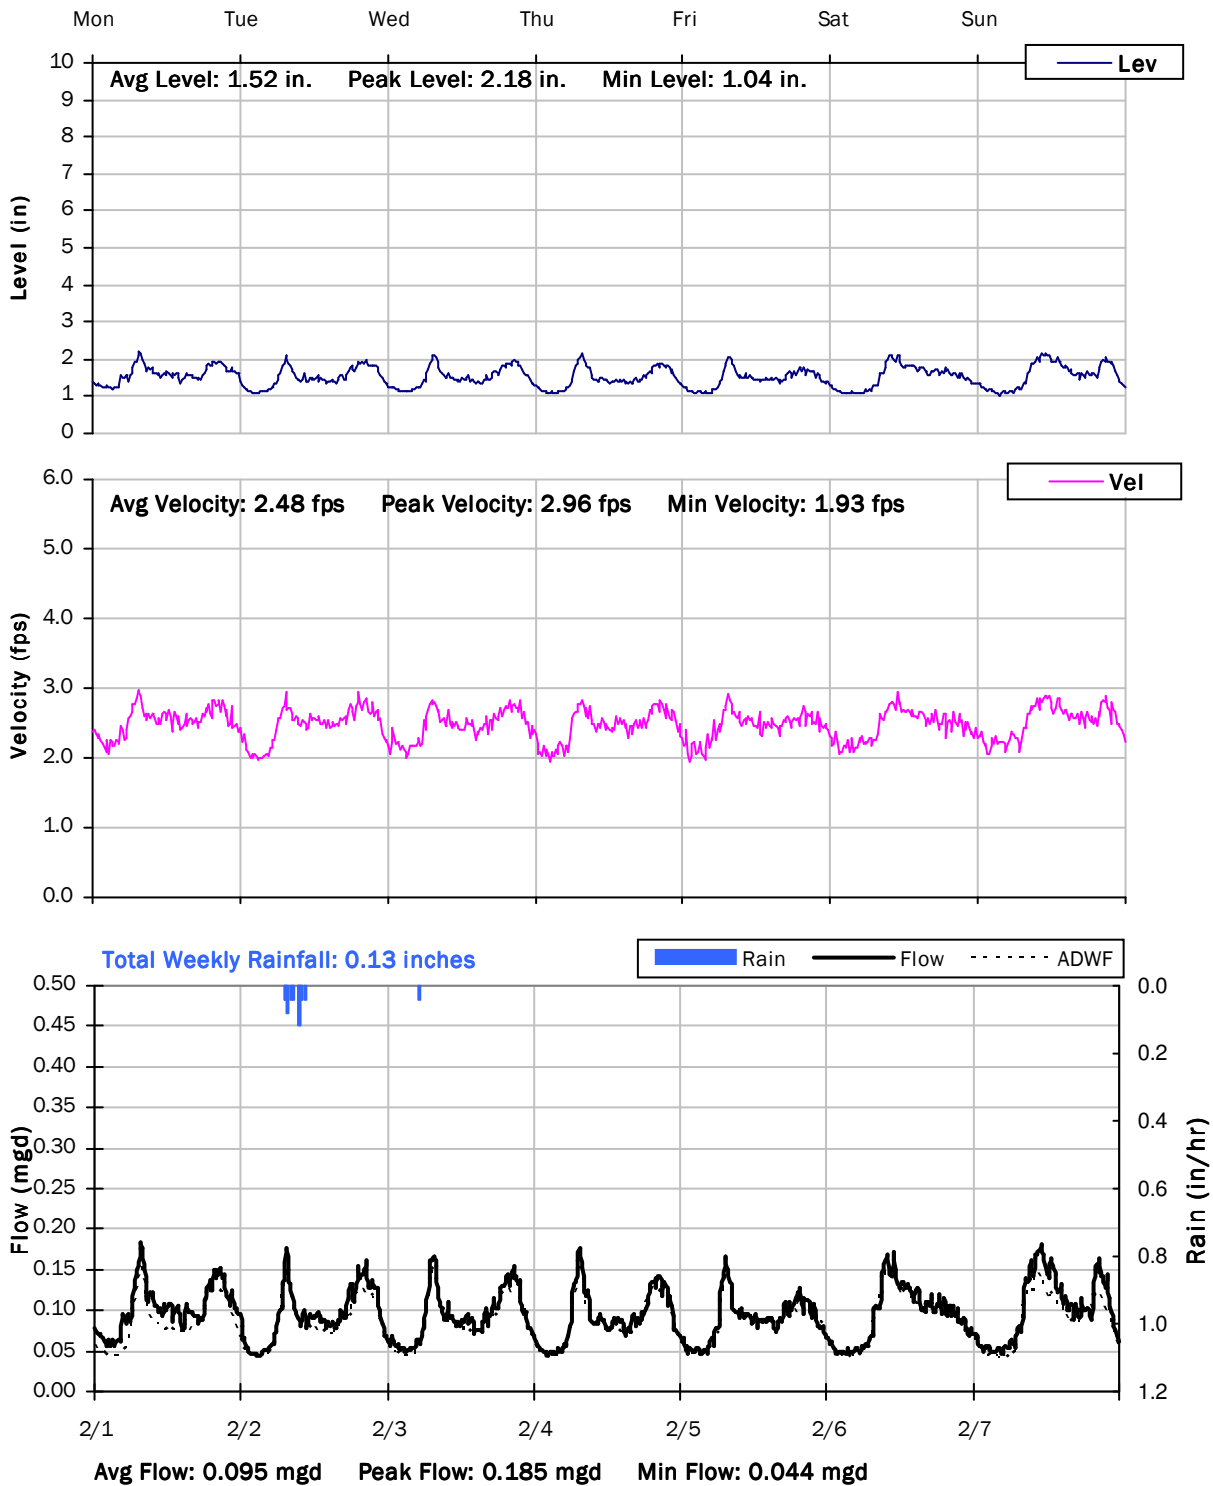
SITE 3
Weekly Level, Velocity and Flow Hydrographs
2/1/2016 to 2/8/2016

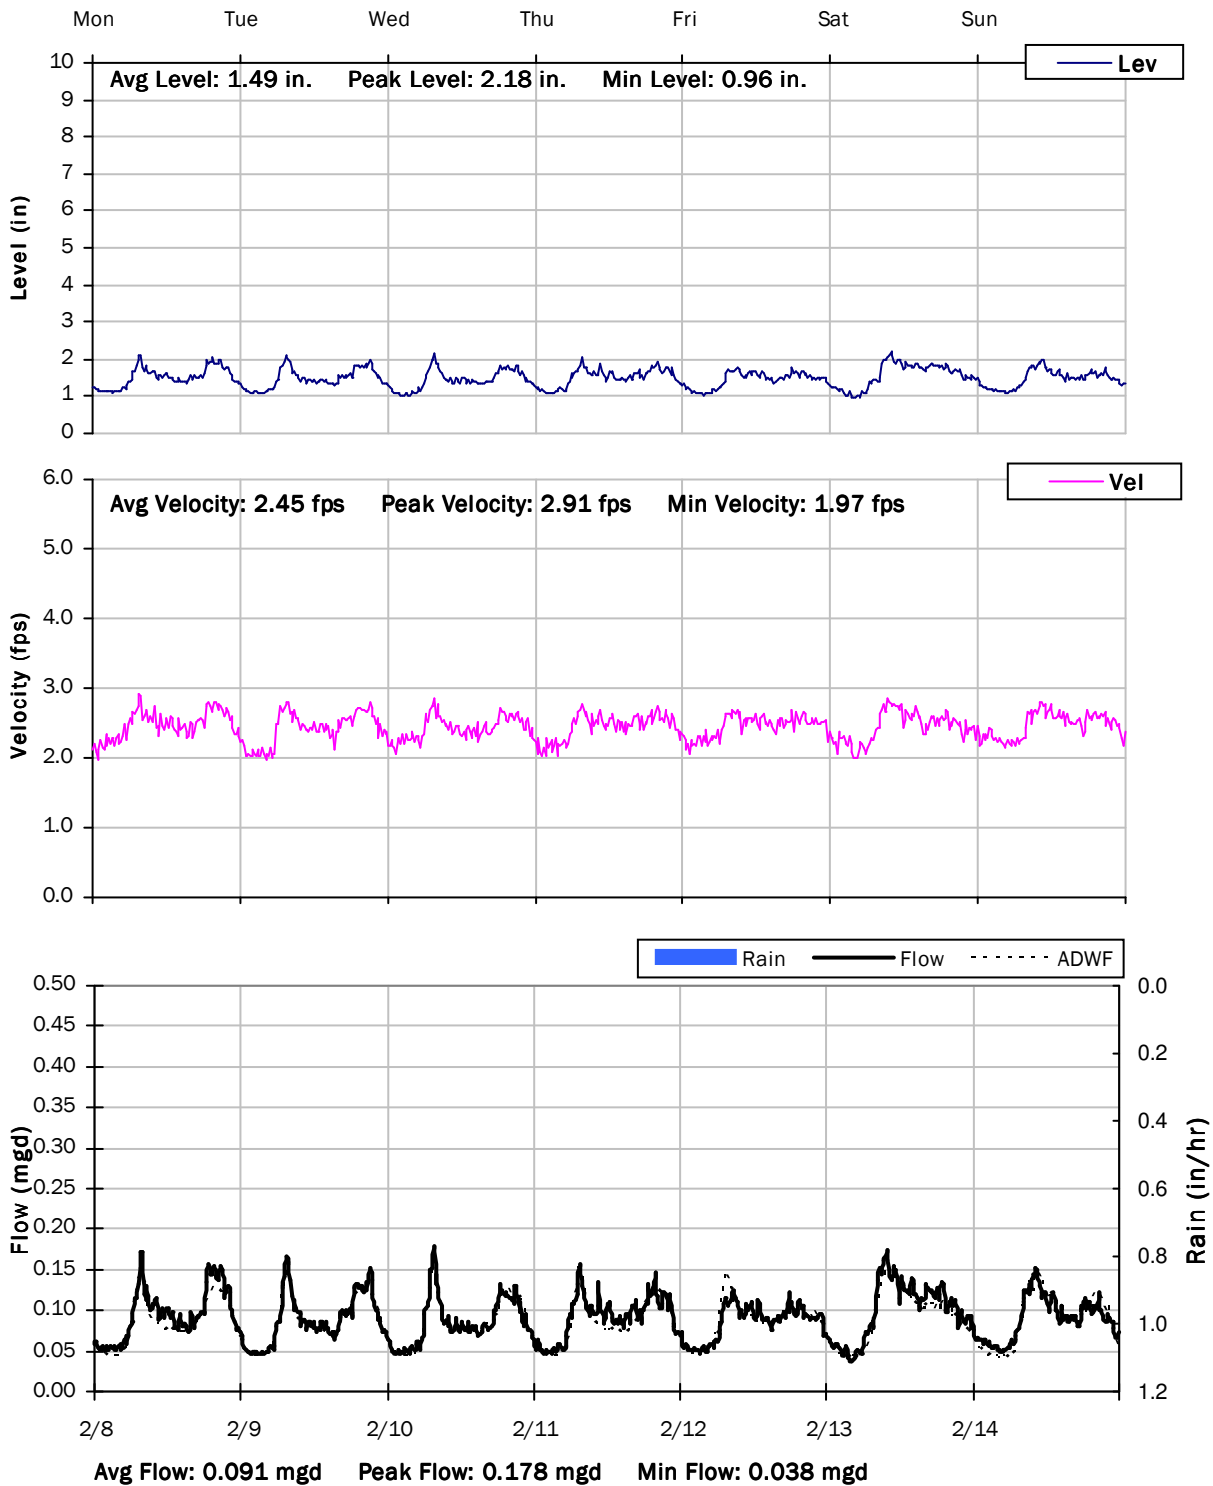
SITE 3
Weekly Level, Velocity and Flow Hydrographs
2/8/2016 to 2/15/2016

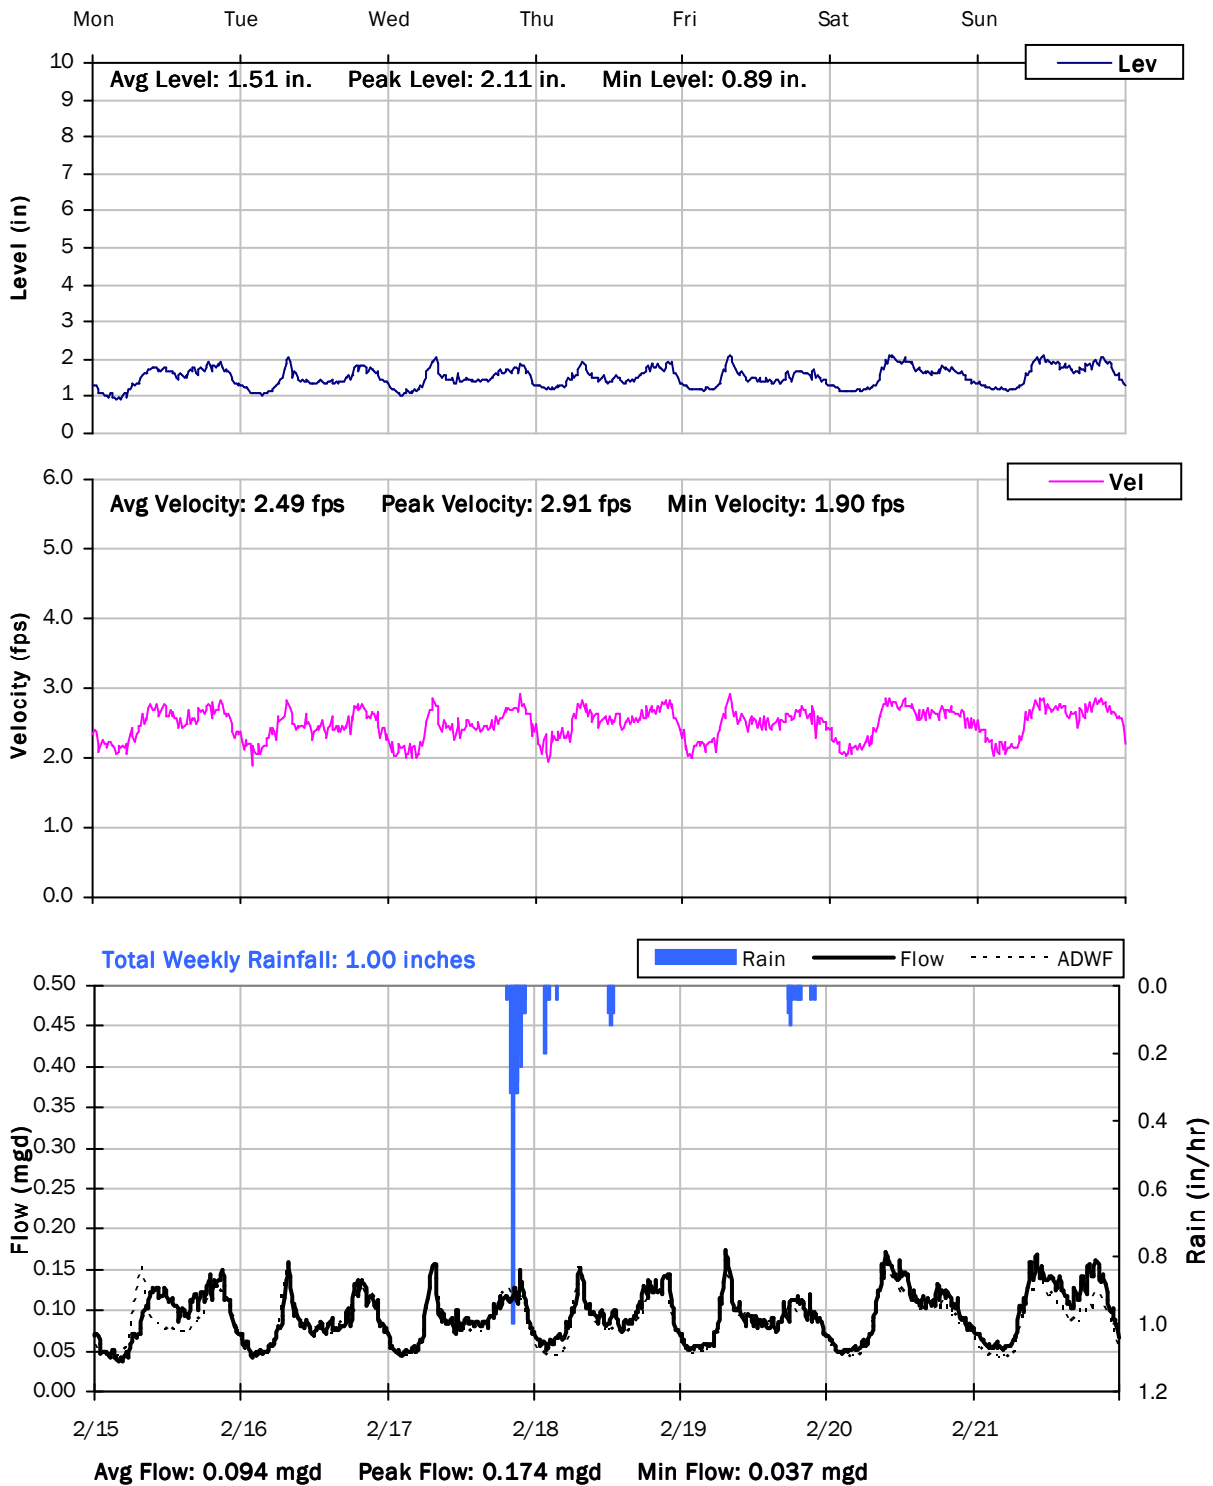
SITE 3
Weekly Level, Velocity and Flow Hydrographs
2/15/2016 to 2/22/2016

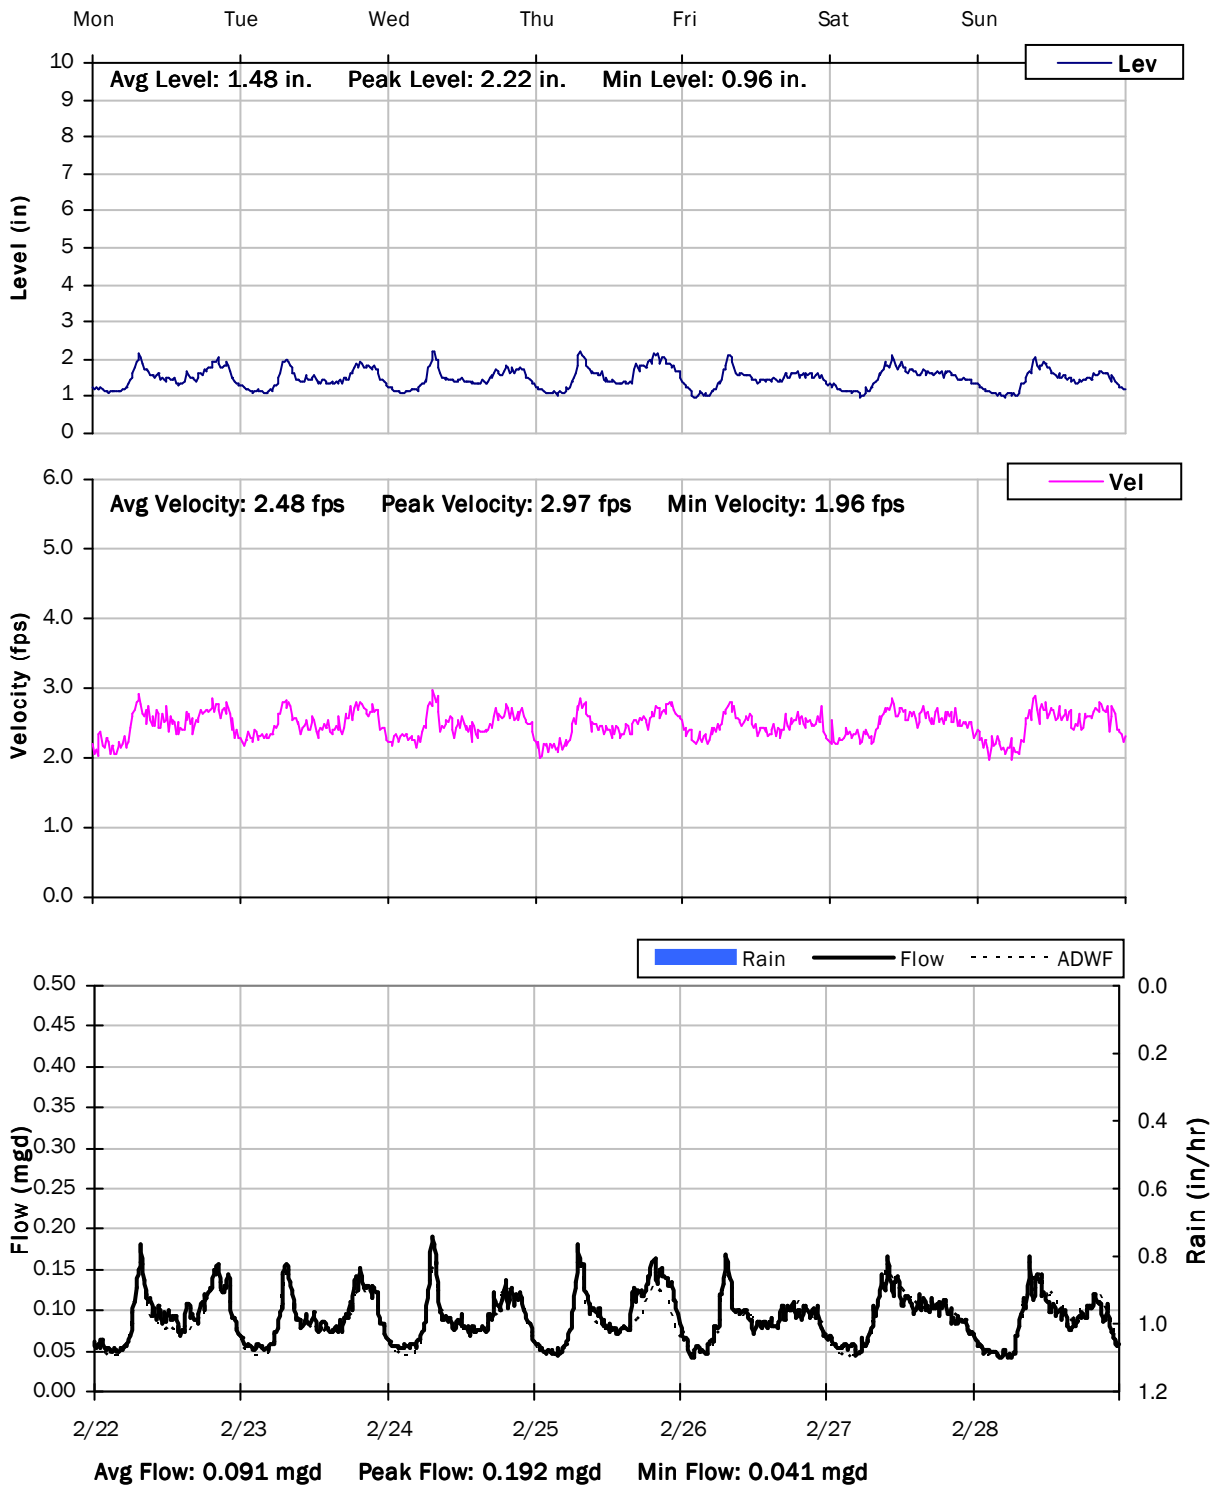
SITE 3
Weekly Level, Velocity and Flow Hydrographs
2/22/2016 to 2/29/2016

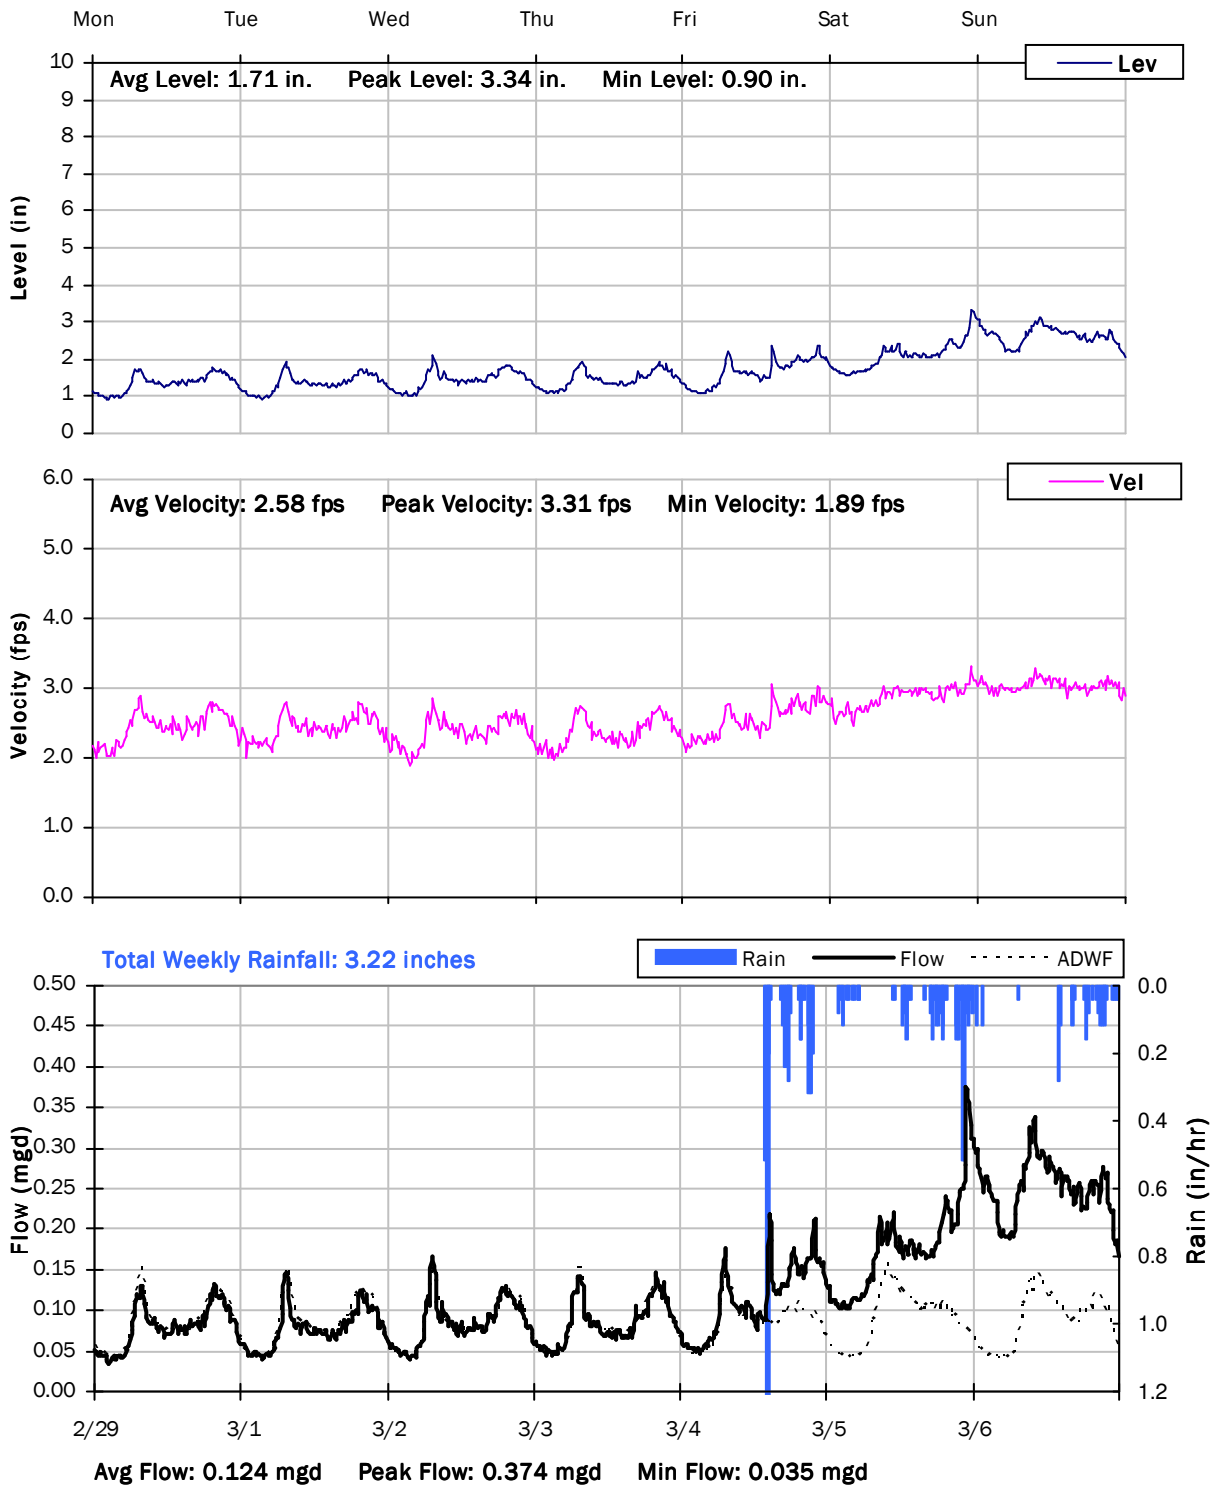
SITE 3
Weekly Level, Velocity and Flow Hydrographs
2/29/2016 to 3/7/2016

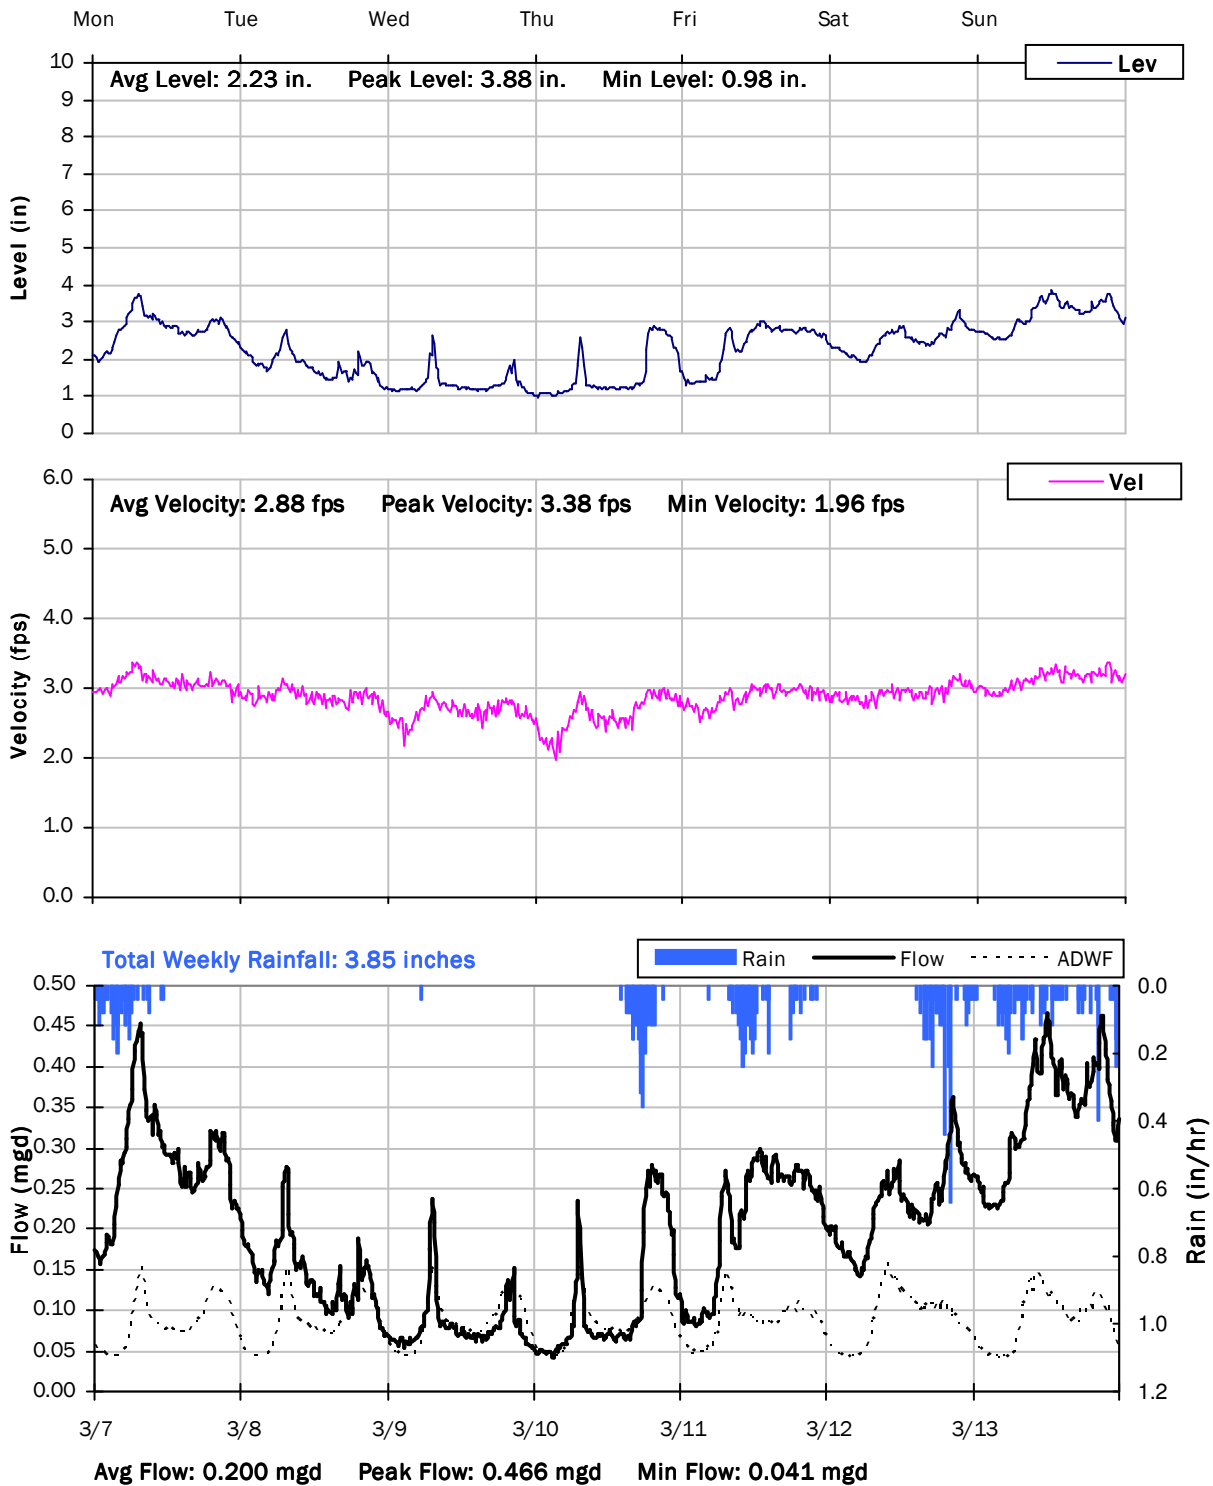
SITE 3
Weekly Level, Velocity and Flow Hydrographs
3/7/2016 to 3/14/2016

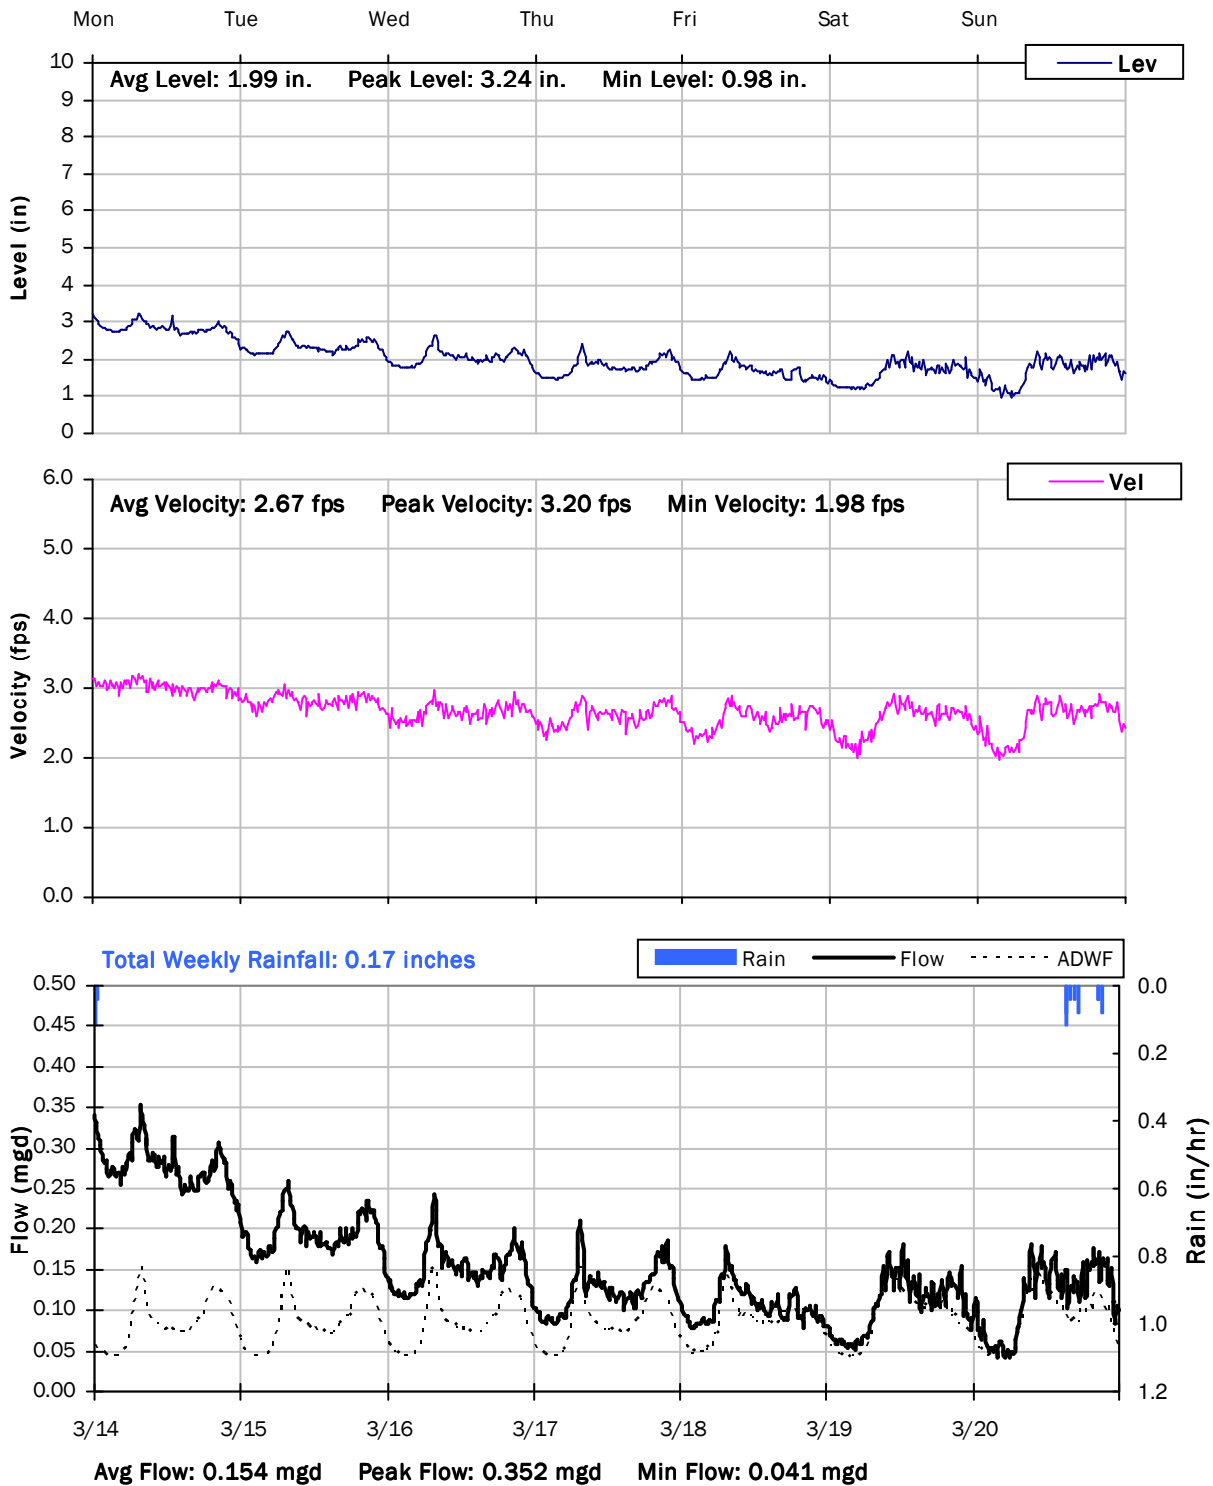
SITE 3
Weekly Level, Velocity and Flow Hydrographs
3/14/2016 to 3/21/2016

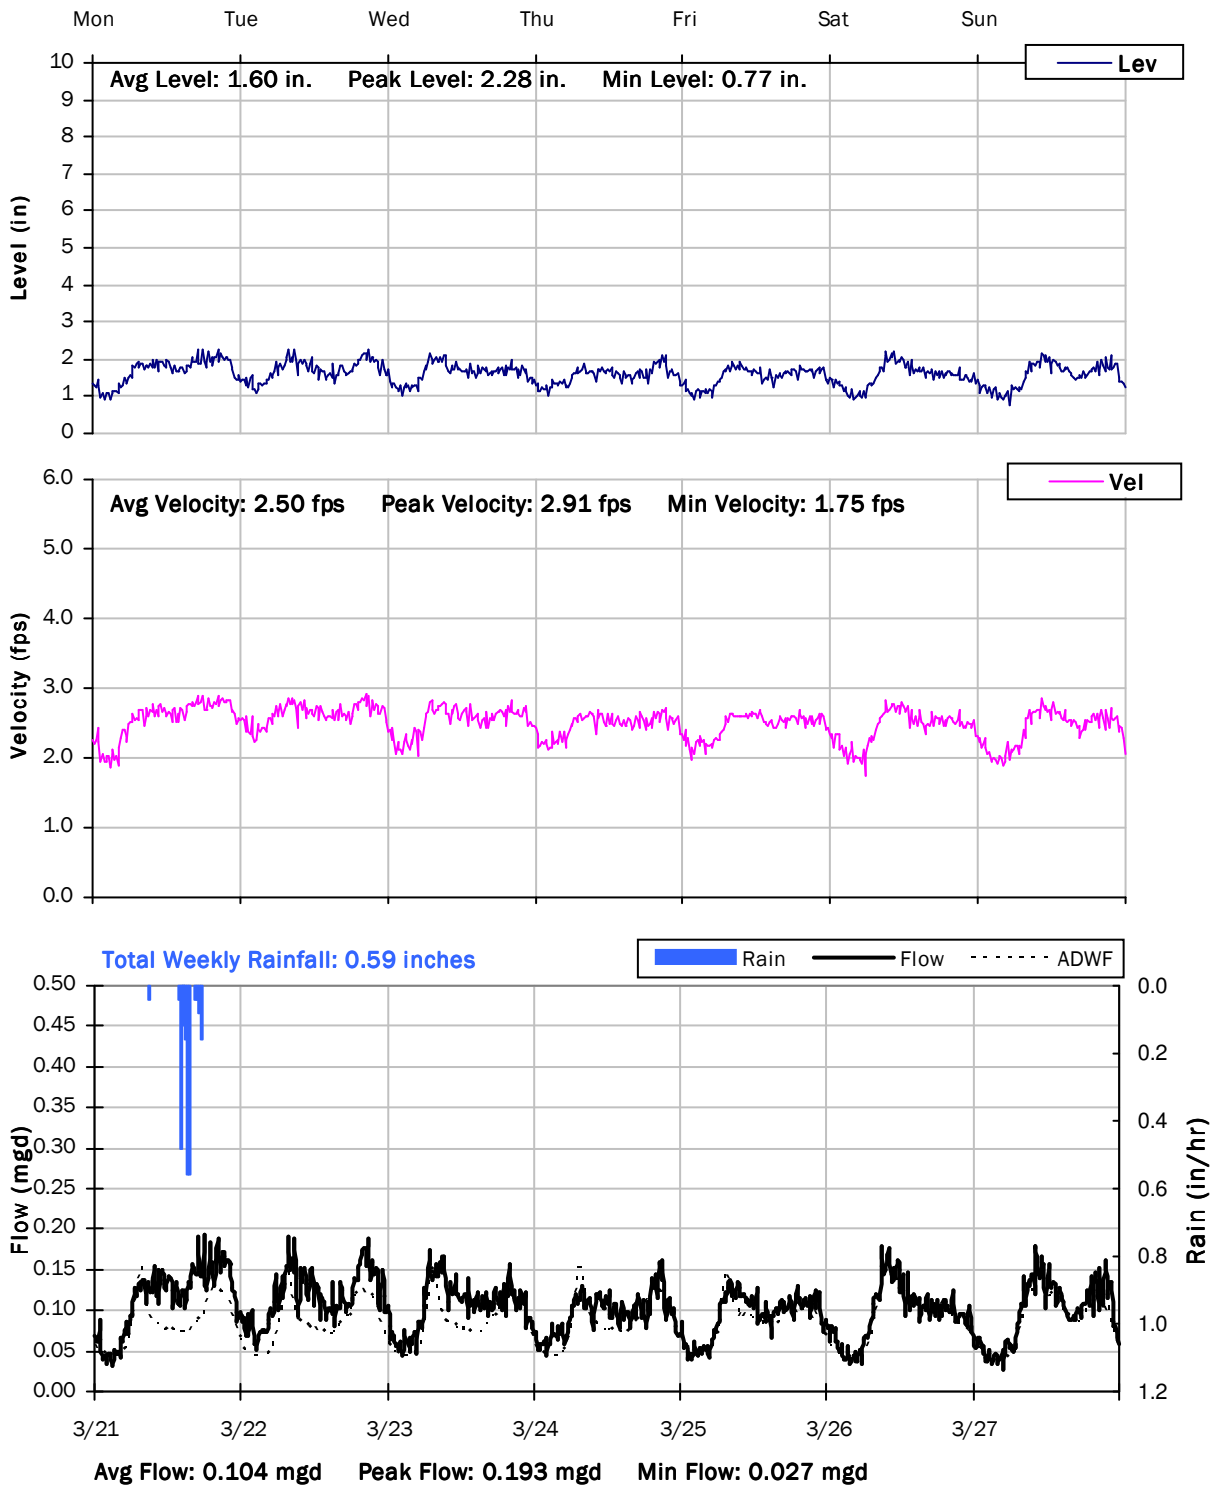
SITE 3
Weekly Level, Velocity and Flow Hydrographs
3/21/2016 to 3/28/2016

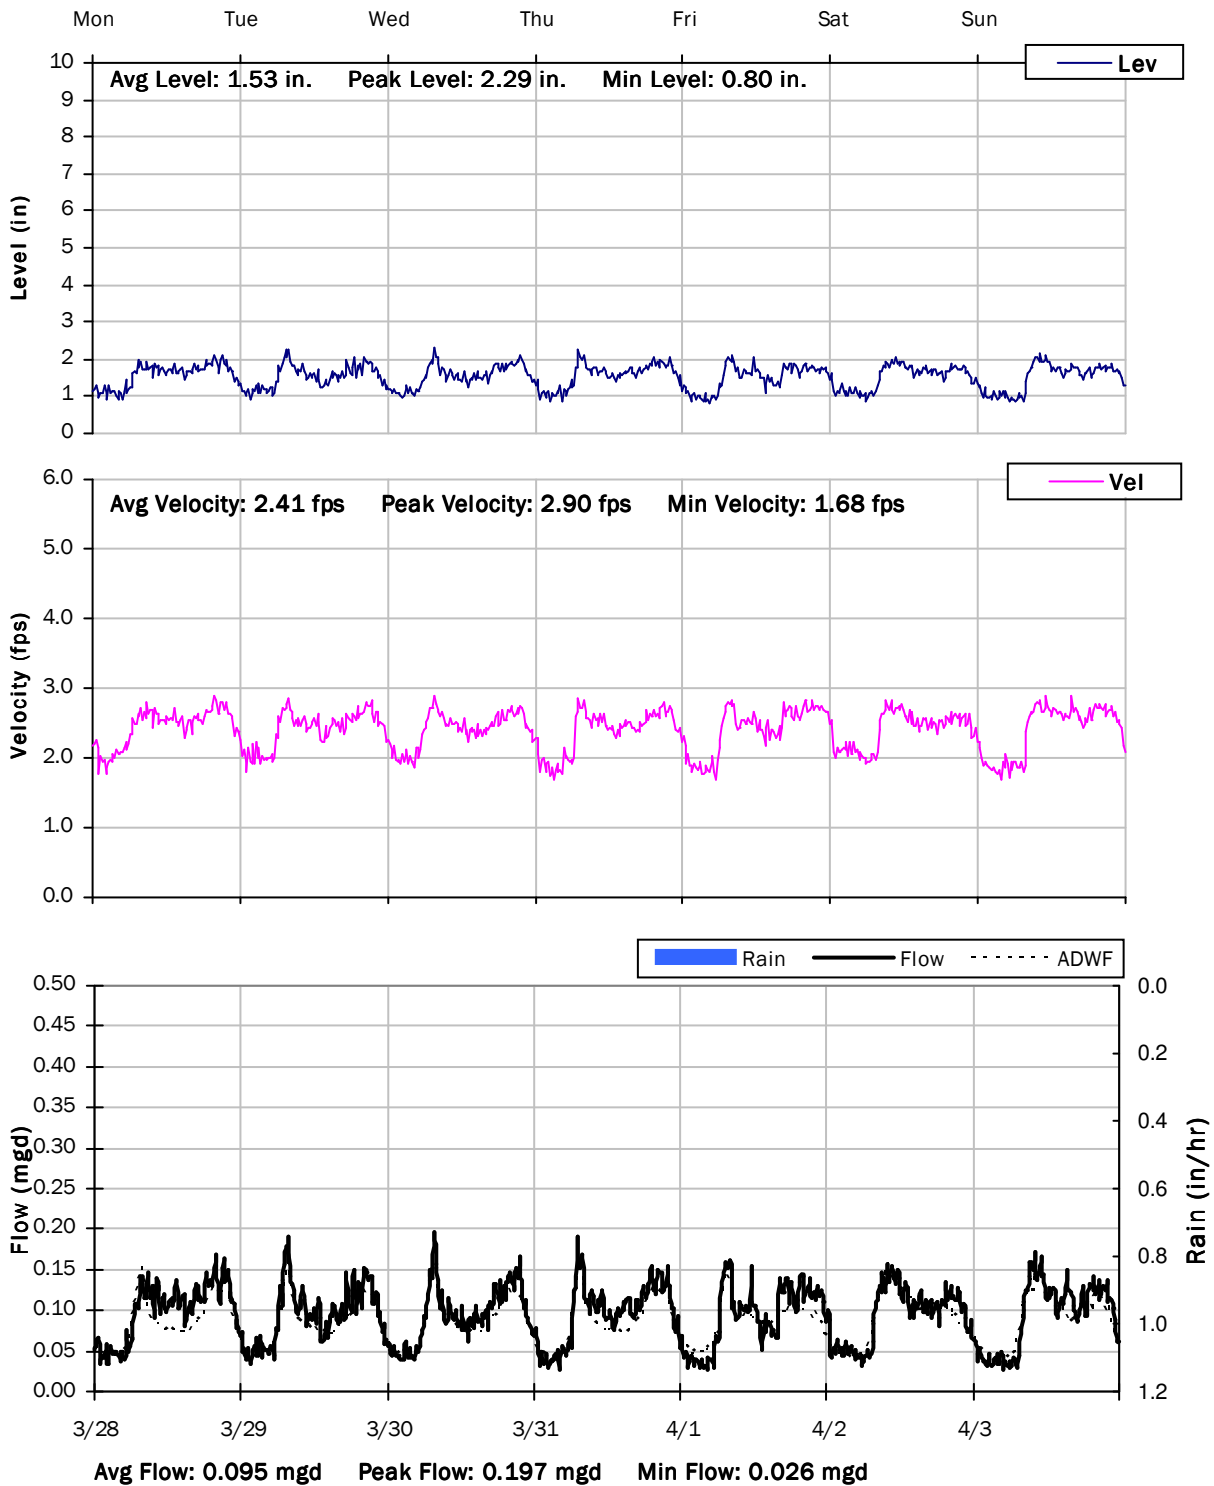
SITE 3
Weekly Level, Velocity and Flow Hydrographs
3/28/2016 to 4/4/2016

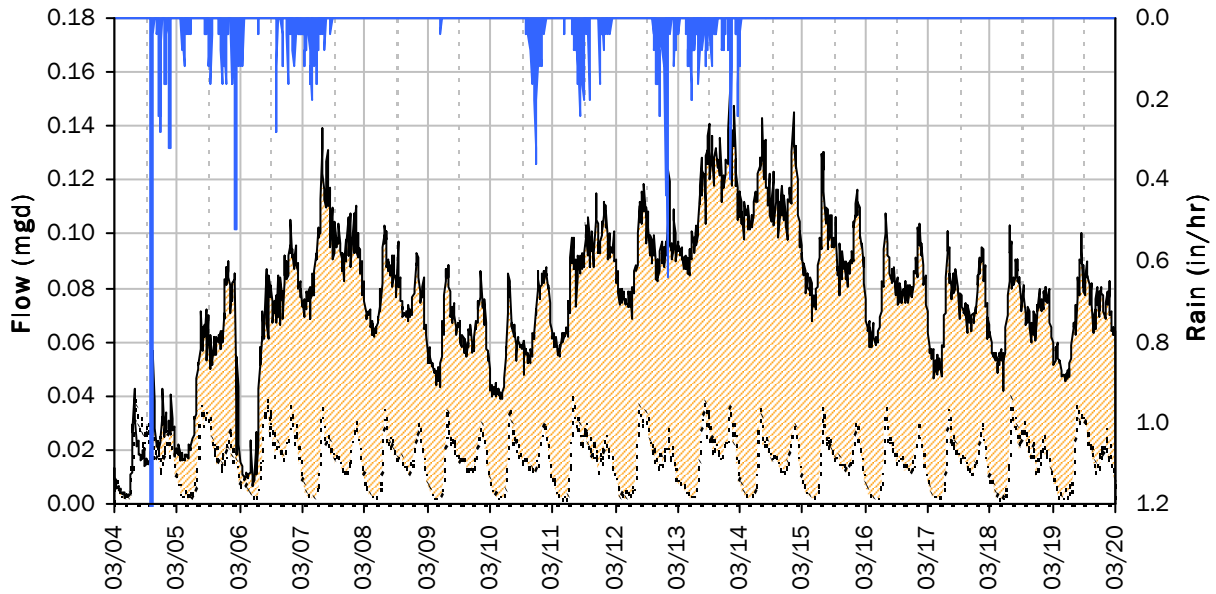
Event 1 Detail Graph

Storm Event I/I Analysis (Rain = 7.11 inches)

<u>Capacity</u>		<u>Inflow / Infiltration</u>	
Peak Flow:	0.15 mgd	Peak I/I Rate:	0.12 mgd
PF:	9.72	Total I/I:	963,000 gallons
Peak Level:	4.82 in		
d/D Ratio:	0.48

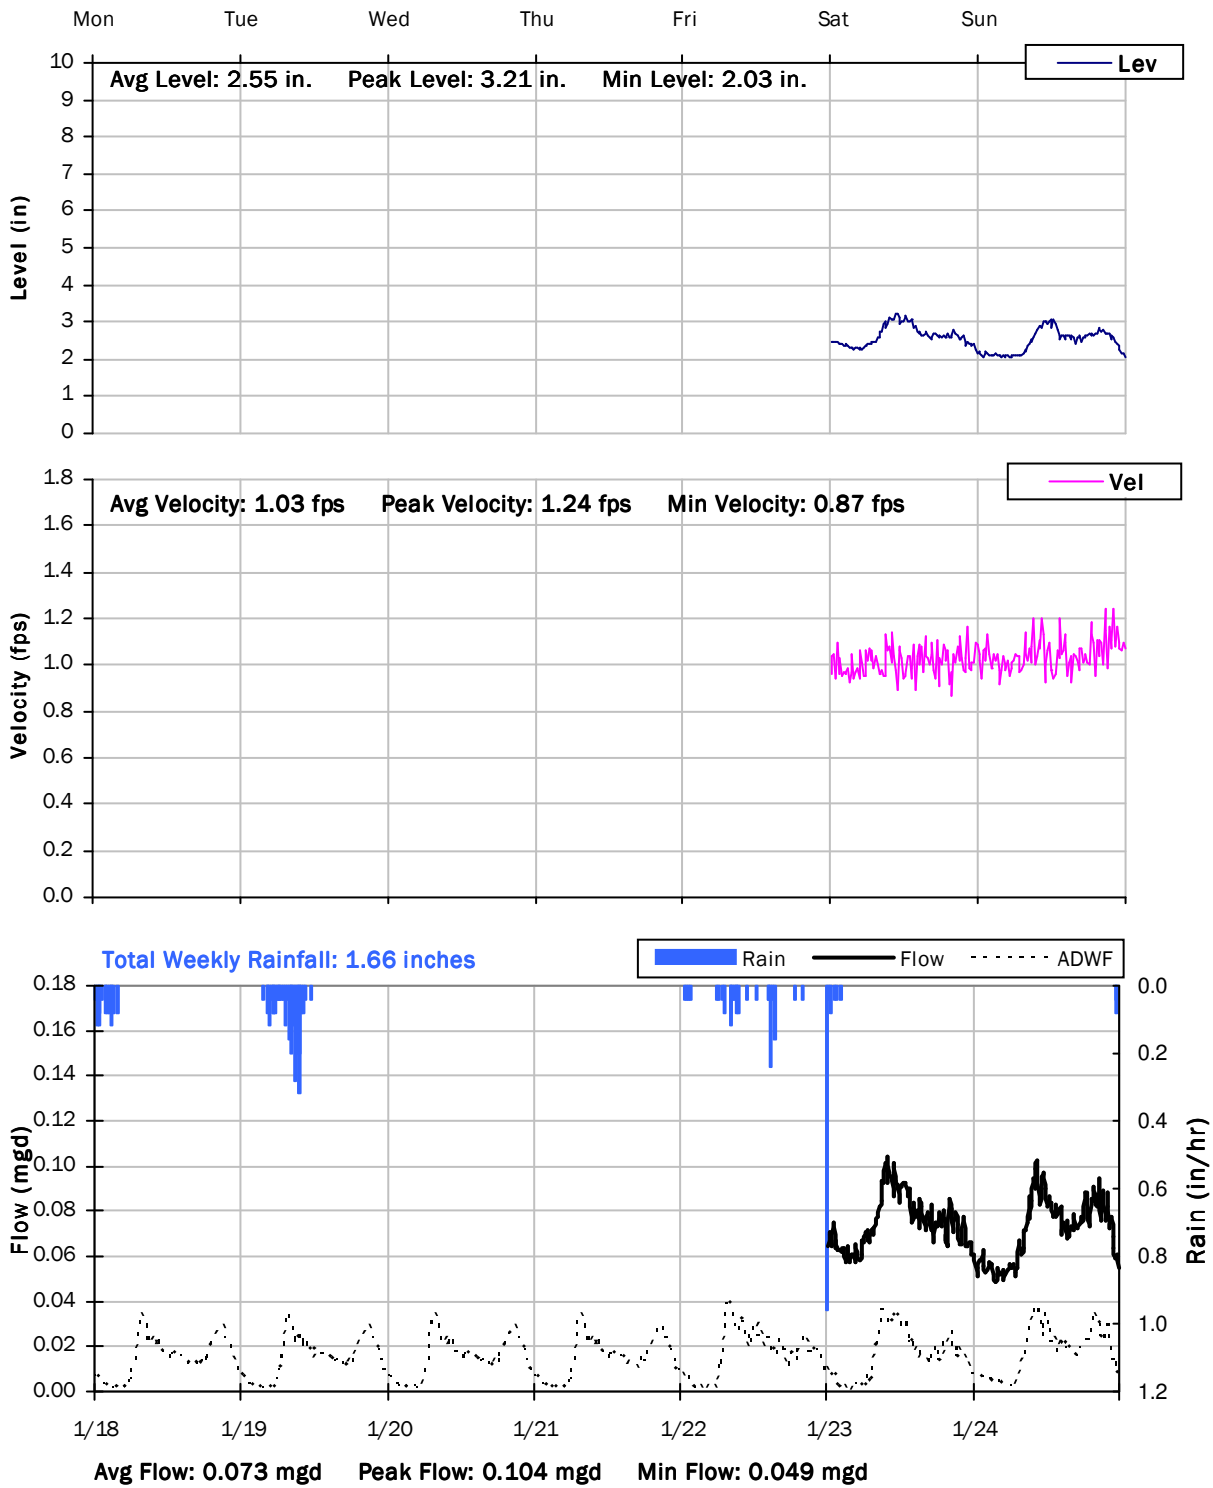
SITE 4
Weekly Level, Velocity and Flow Hydrographs
1/18/2016 to 1/25/2016

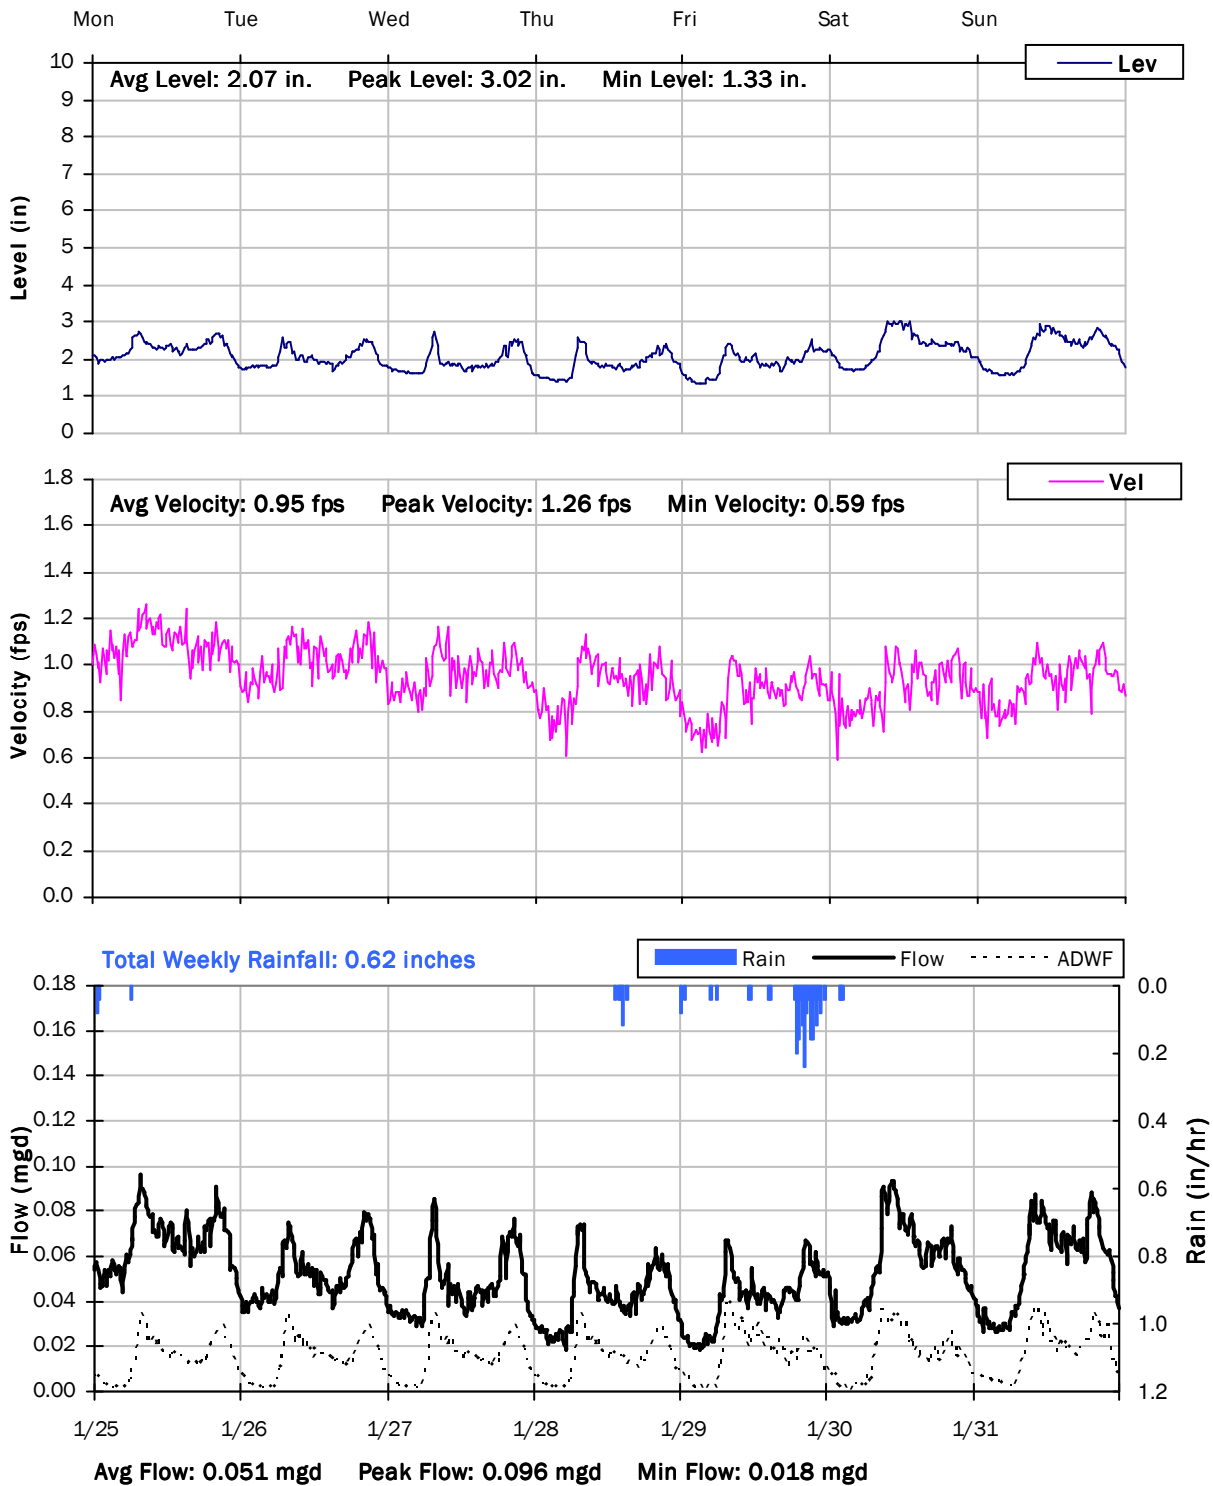
SITE 4
Weekly Level, Velocity and Flow Hydrographs
1/25/2016 to 2/1/2016
