APPENDIX A. FLOW MONITORING SITES: DATA, GRAPHS, INFORMATION

City of Lincoln

Sanitary Sewer Flow Monitoring

Temporary Monitoring: January 23 to April 3, 2016

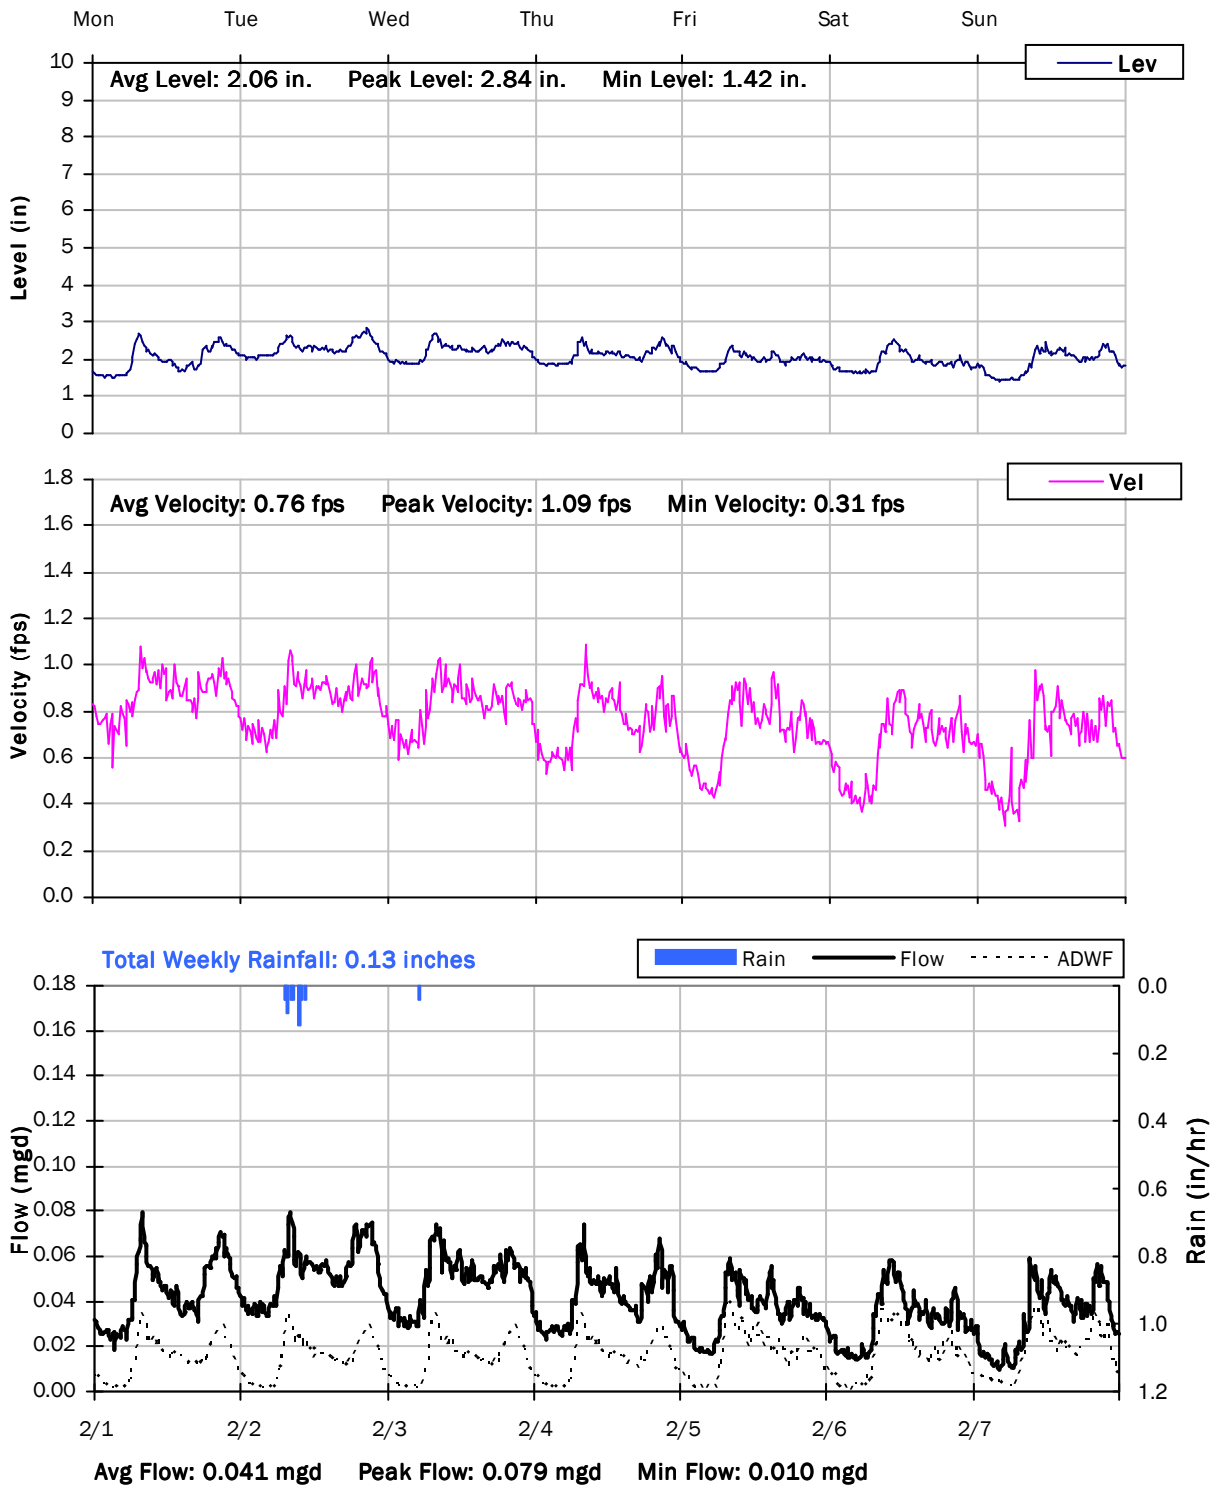
SITE 4
Weekly Level, Velocity and Flow Hydrographs
2/1/2016 to 2/8/2016

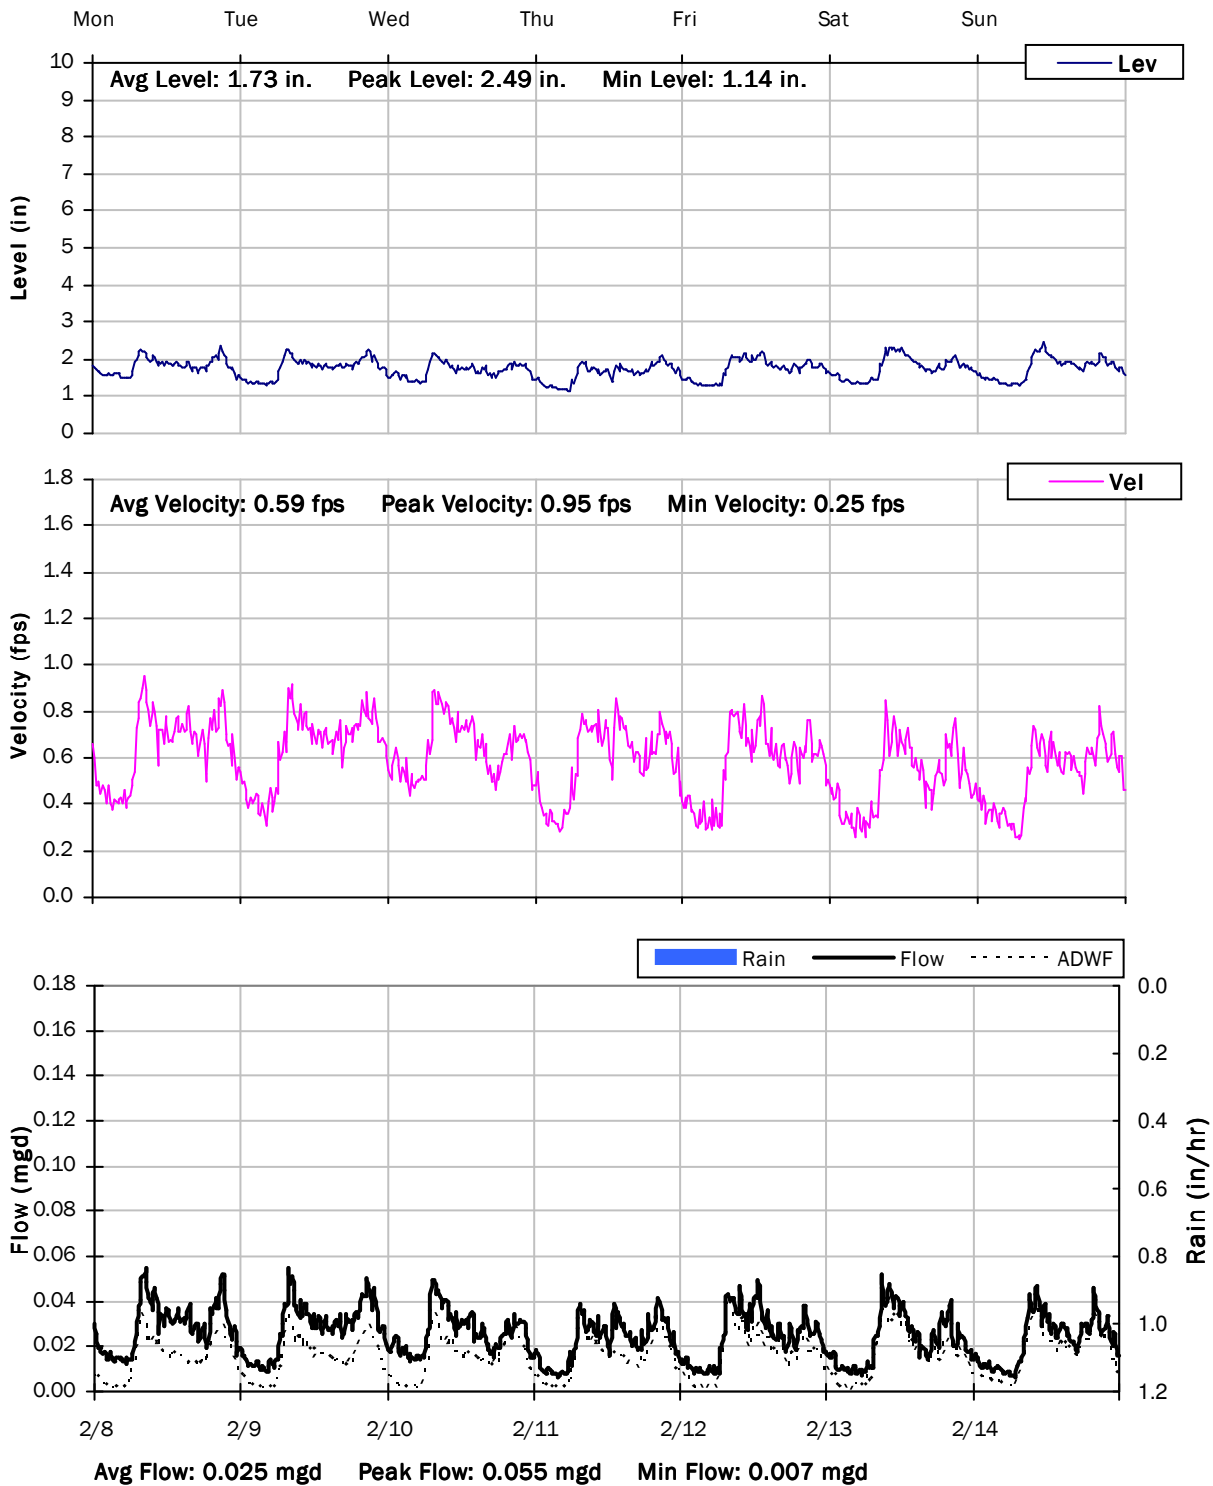
SITE 4
Weekly Level, Velocity and Flow Hydrographs
2/8/2016 to 2/15/2016

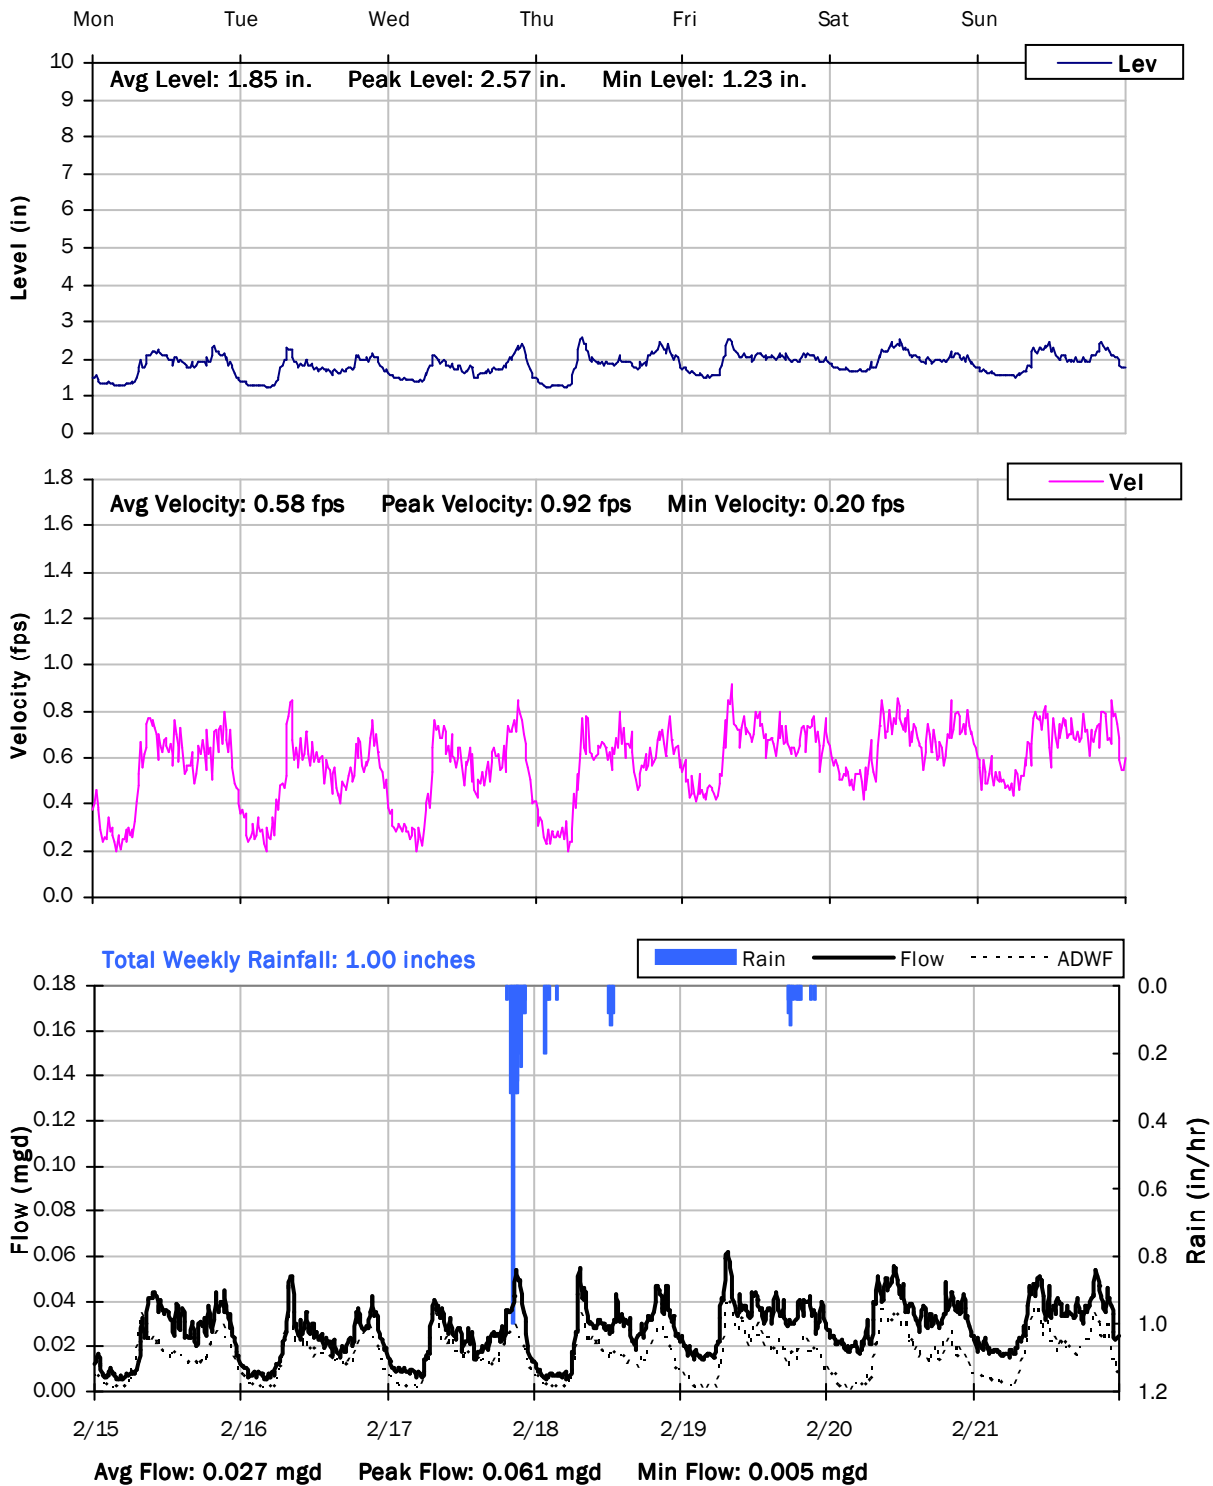
SITE 4
Weekly Level, Velocity and Flow Hydrographs
2/15/2016 to 2/22/2016

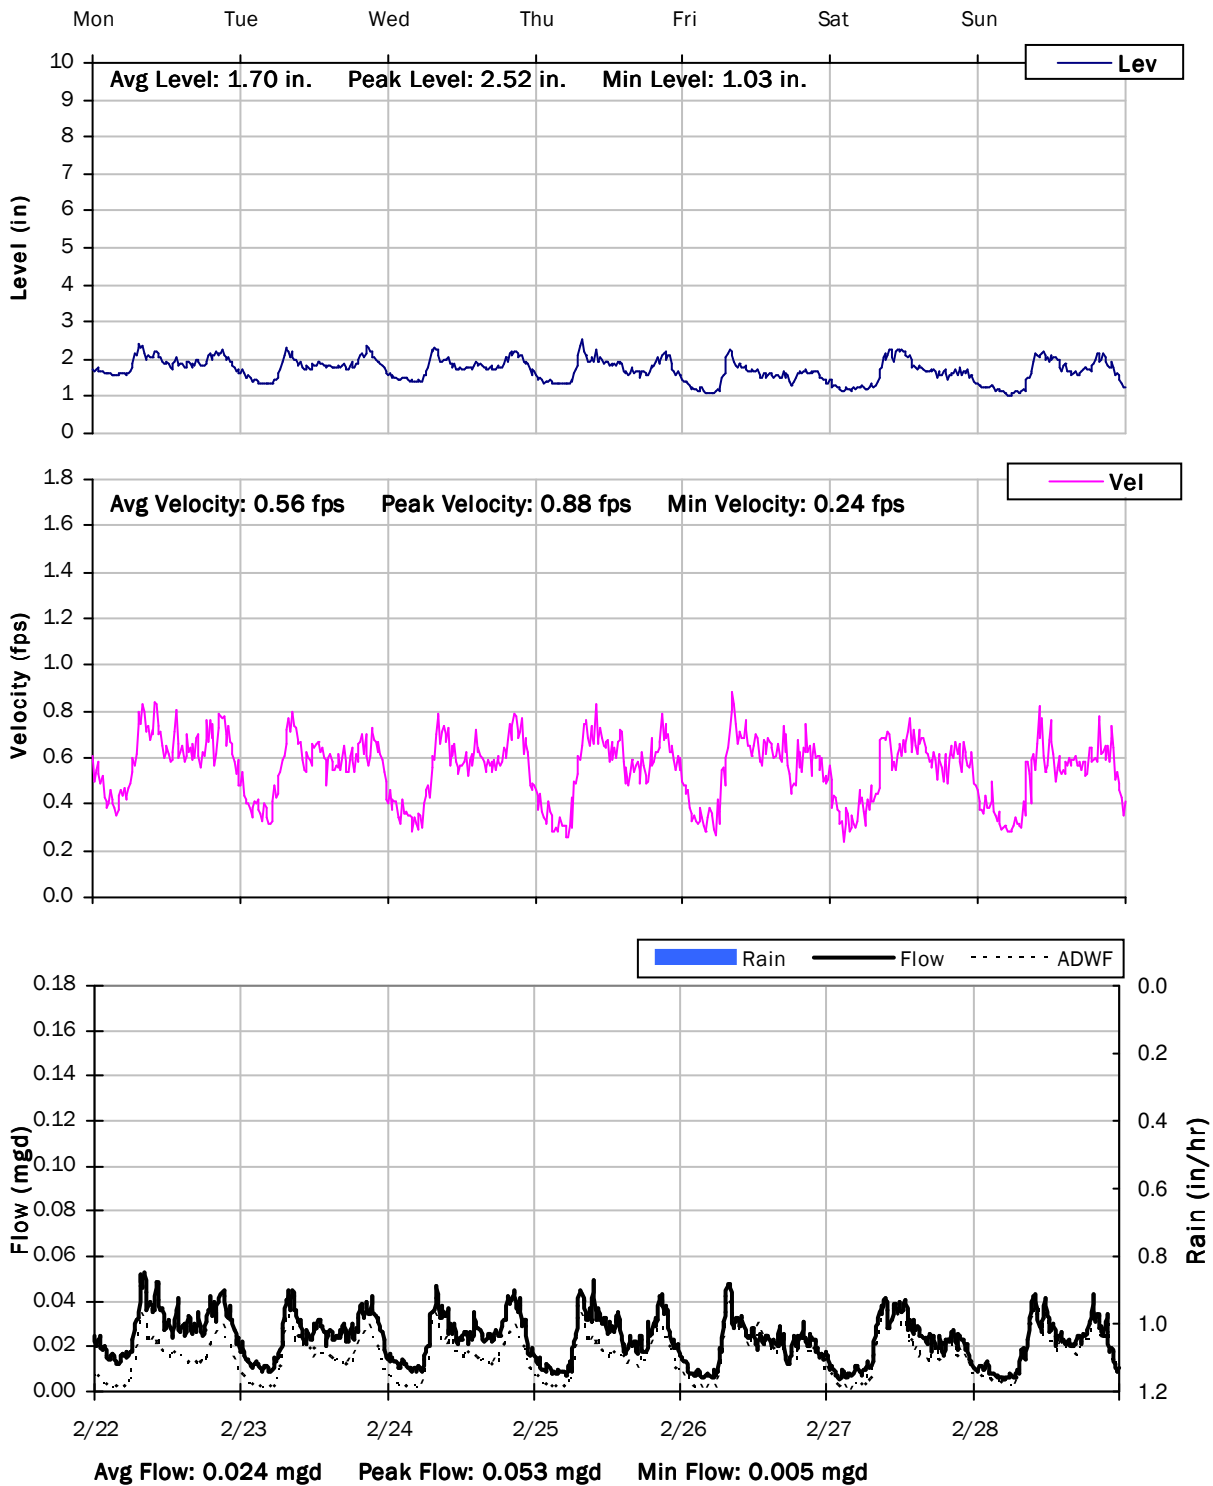
SITE 4
Weekly Level, Velocity and Flow Hydrographs
2/22/2016 to 2/29/2016

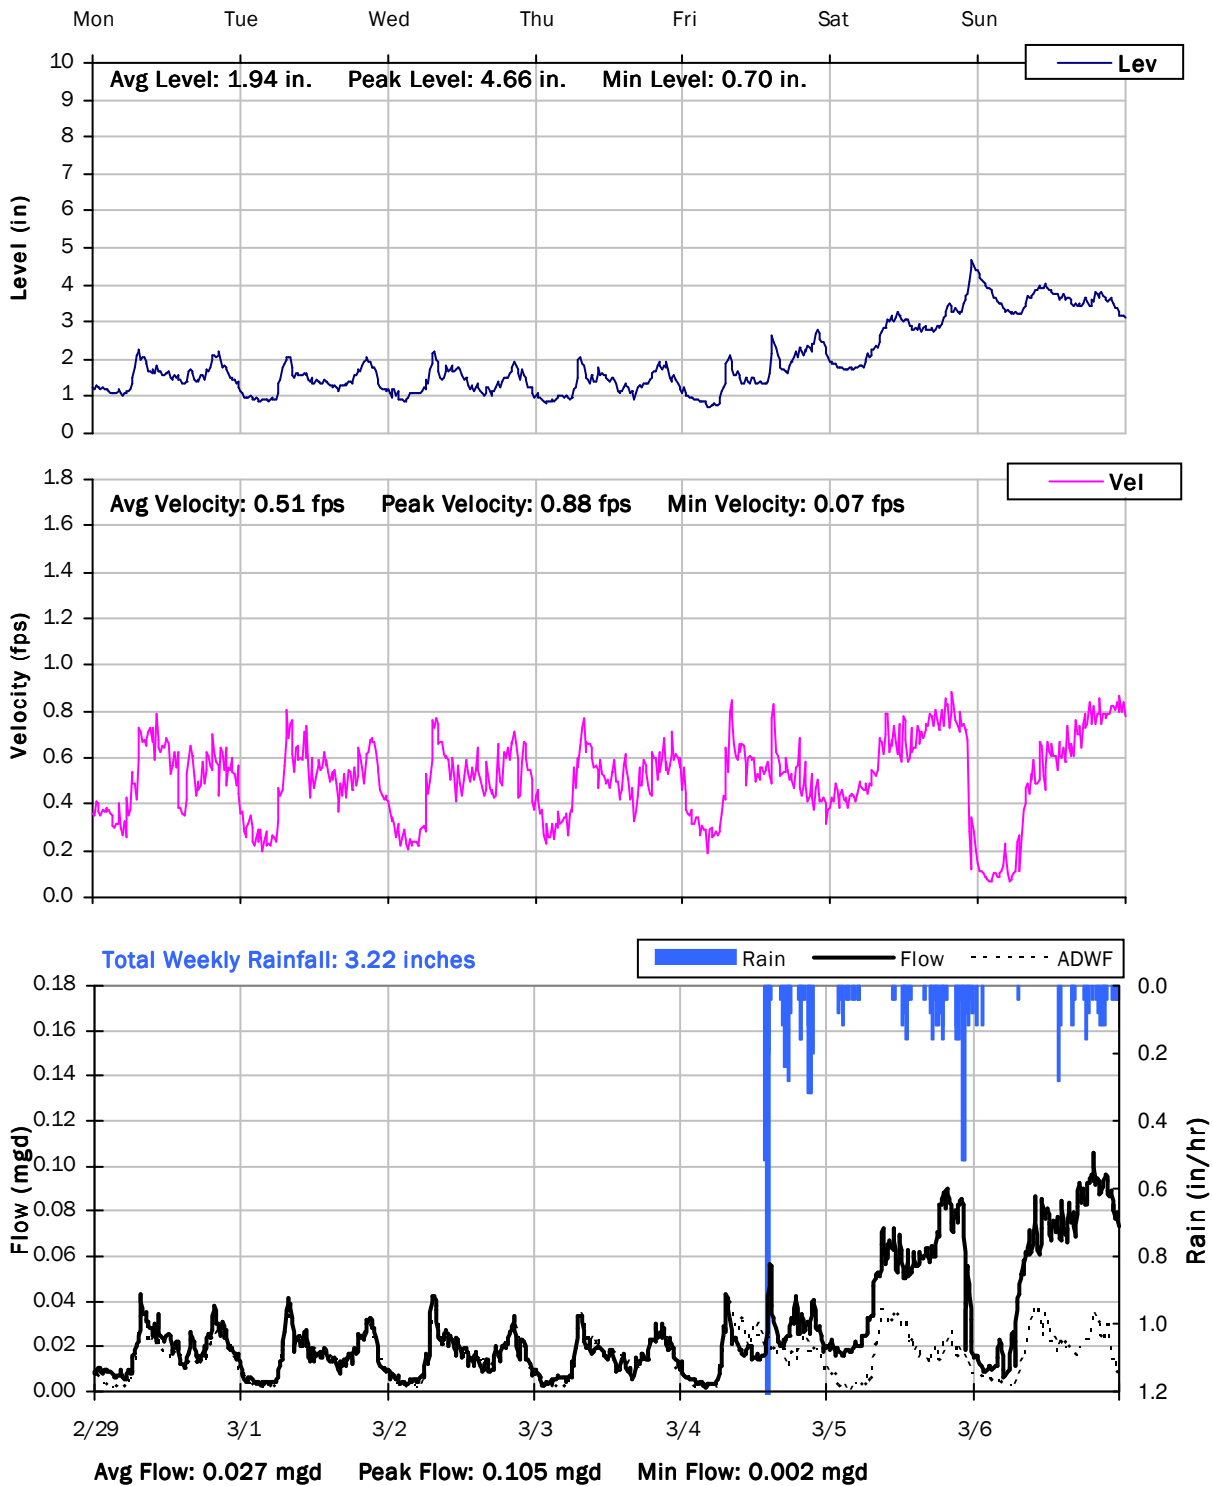
SITE 4
Weekly Level, Velocity and Flow Hydrographs
2/29/2016 to 3/7/2016

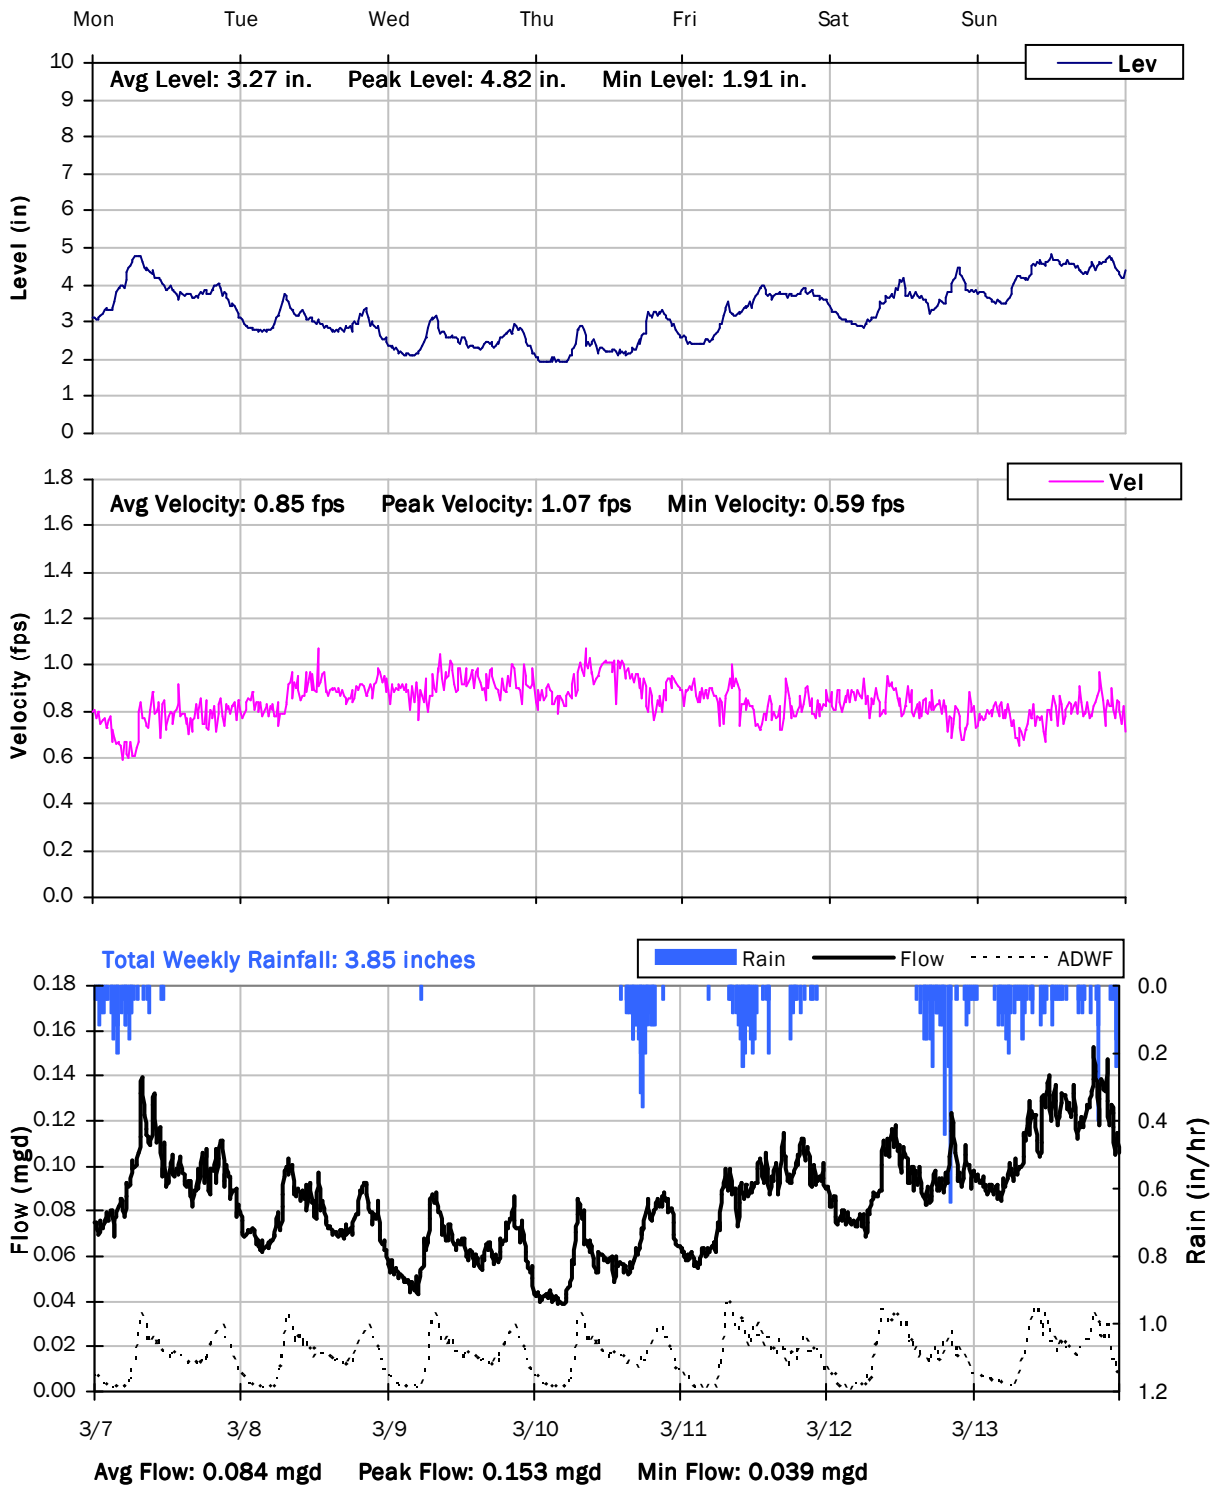
SITE 4
Weekly Level, Velocity and Flow Hydrographs
3/7/2016 to 3/14/2016

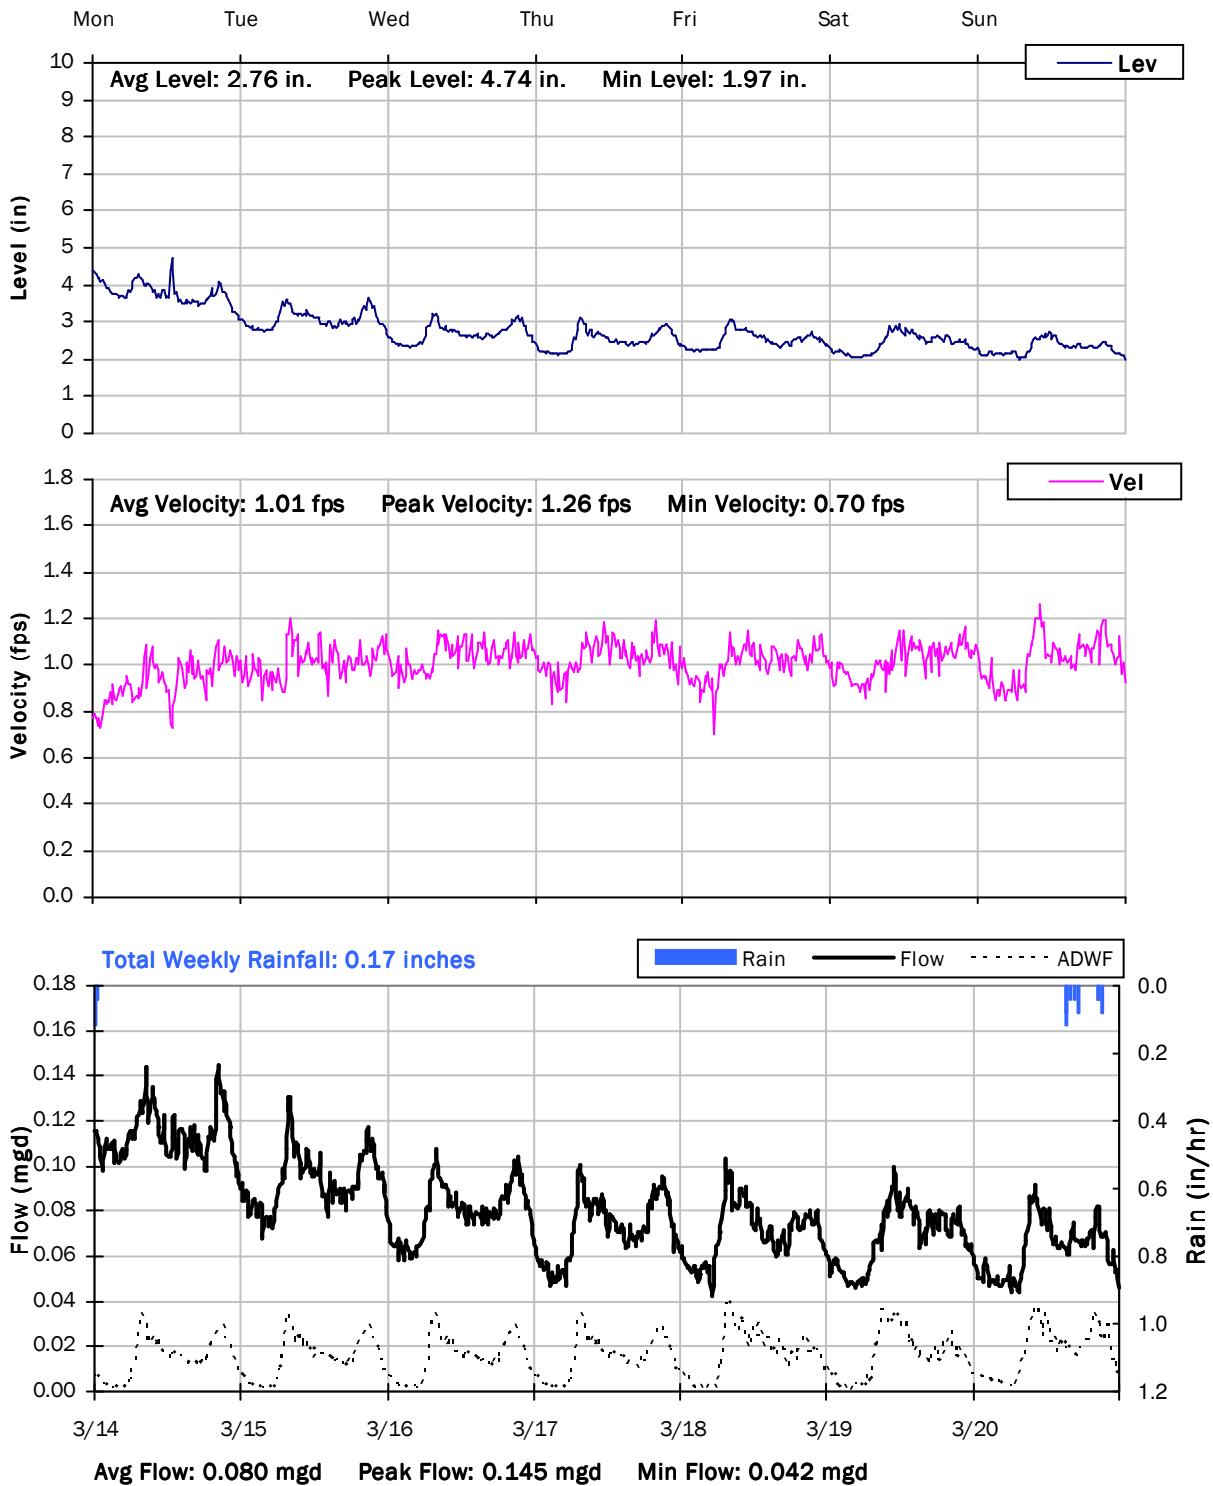
SITE 4
Weekly Level, Velocity and Flow Hydrographs
3/14/2016 to 3/21/2016

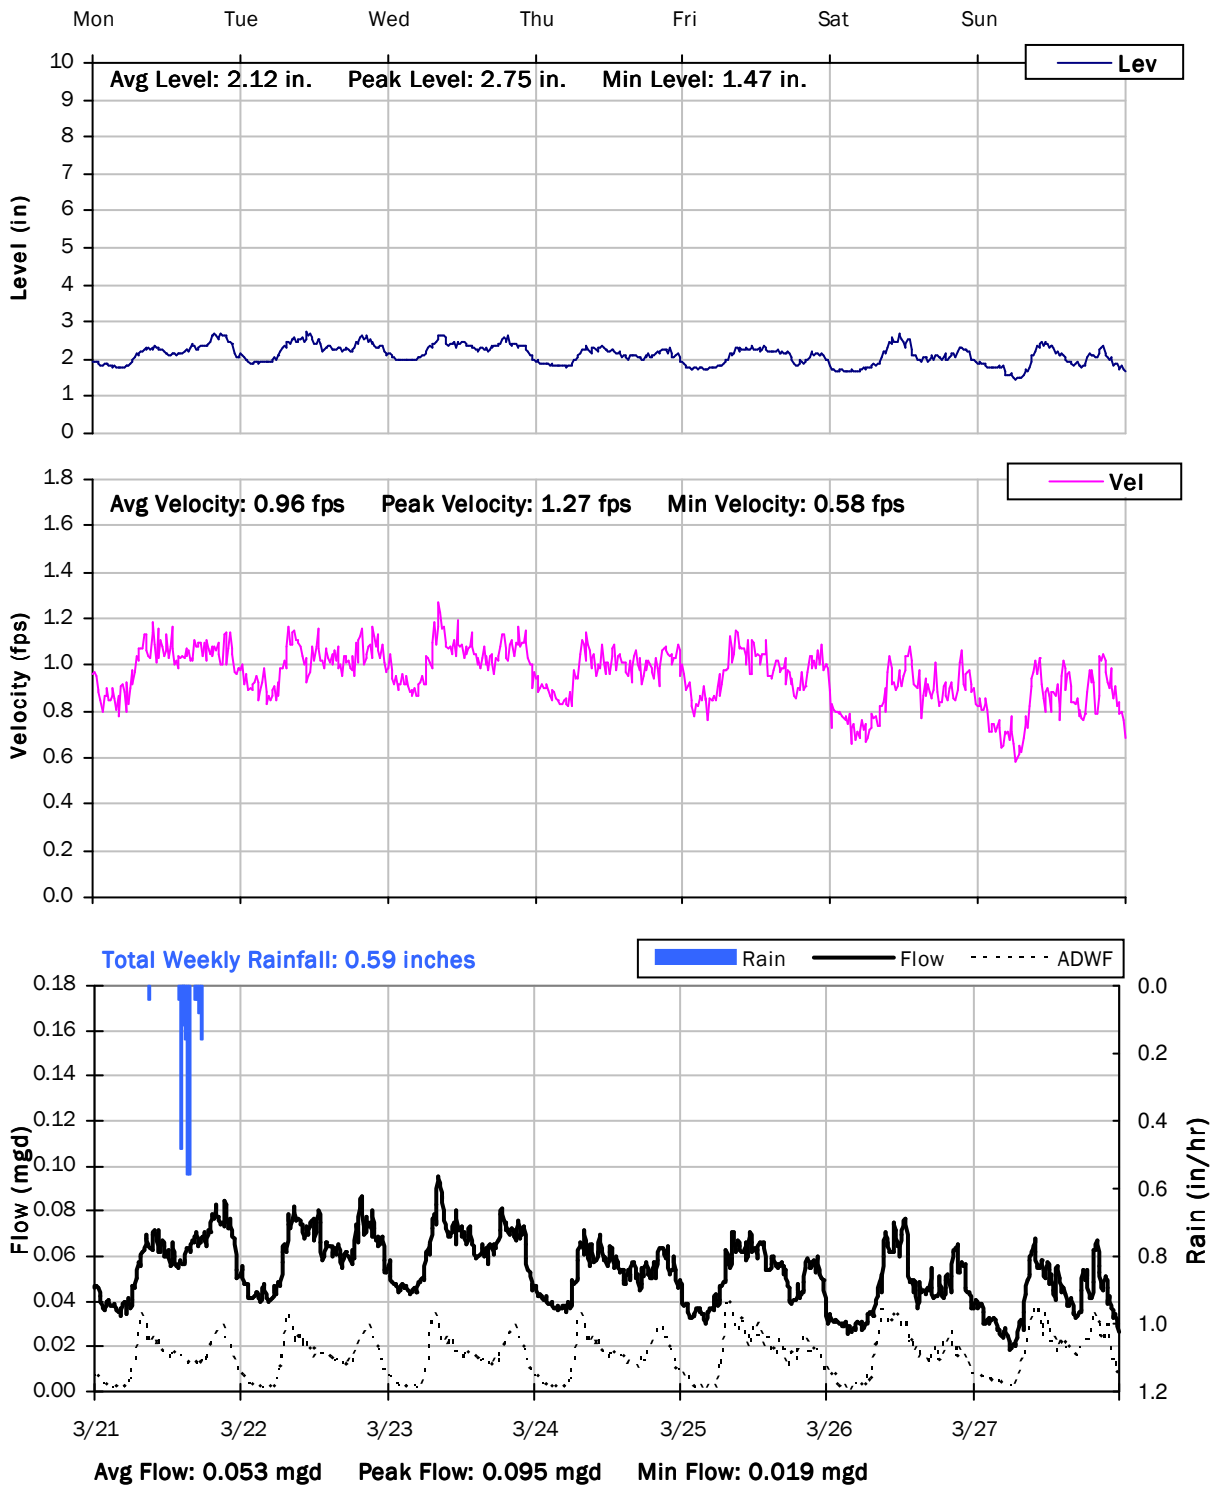
SITE 4
Weekly Level, Velocity and Flow Hydrographs
3/21/2016 to 3/28/2016

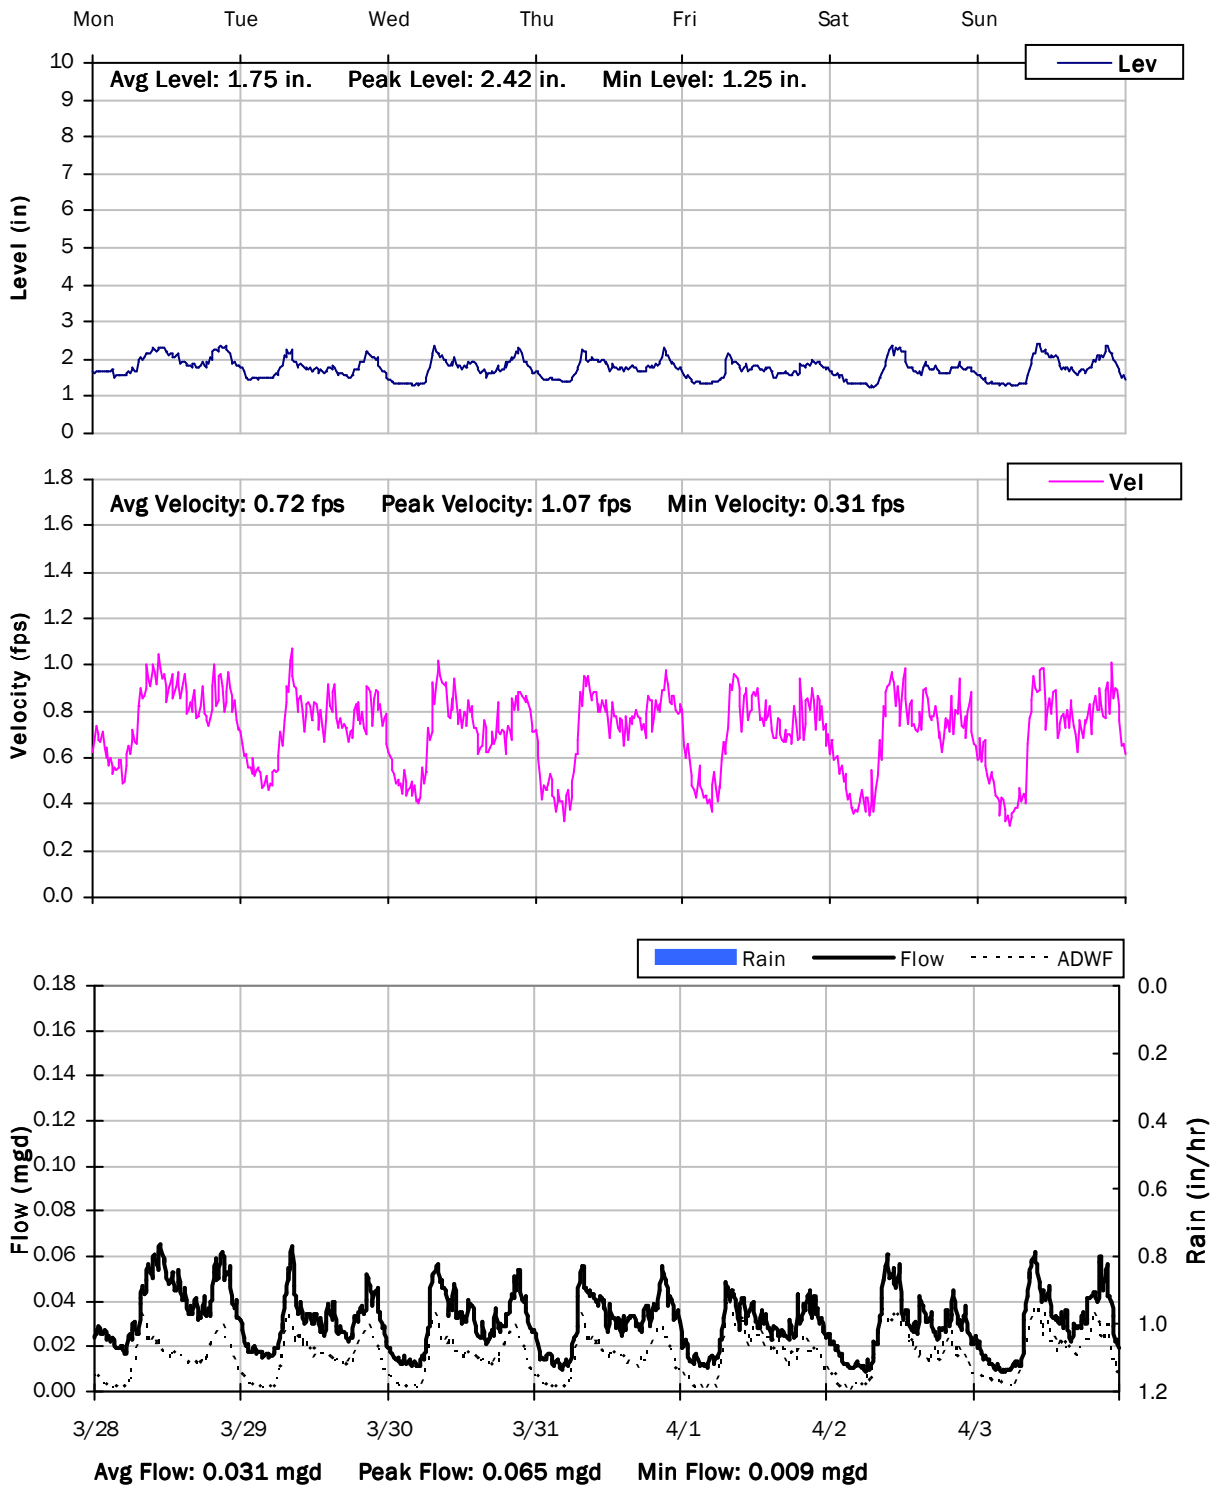
SITE 4
Weekly Level, Velocity and Flow Hydrographs
3/28/2016 to 4/4/2016

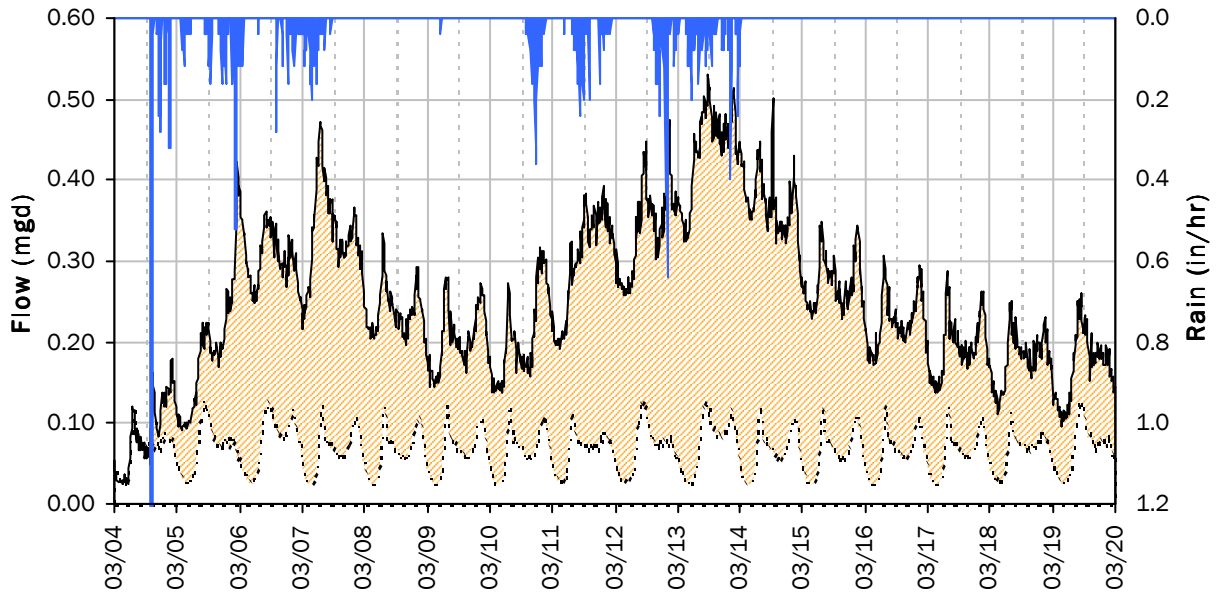
Event 1 Detail Graph

Storm Event I/I Analysis (Rain = 7.11 inches)

<u>Capacity</u>		<u>Inflow / Infiltration</u>	
Peak Flow:	0.53 <i>mgd</i>	Peak I/I Rate:	0.44 <i>mgd</i>
PF:	7.92	Total I/I:	2,990,000 <i>gallons</i>
Peak Level:	6.06 <i>in</i>		
d/D Ratio:	0.51

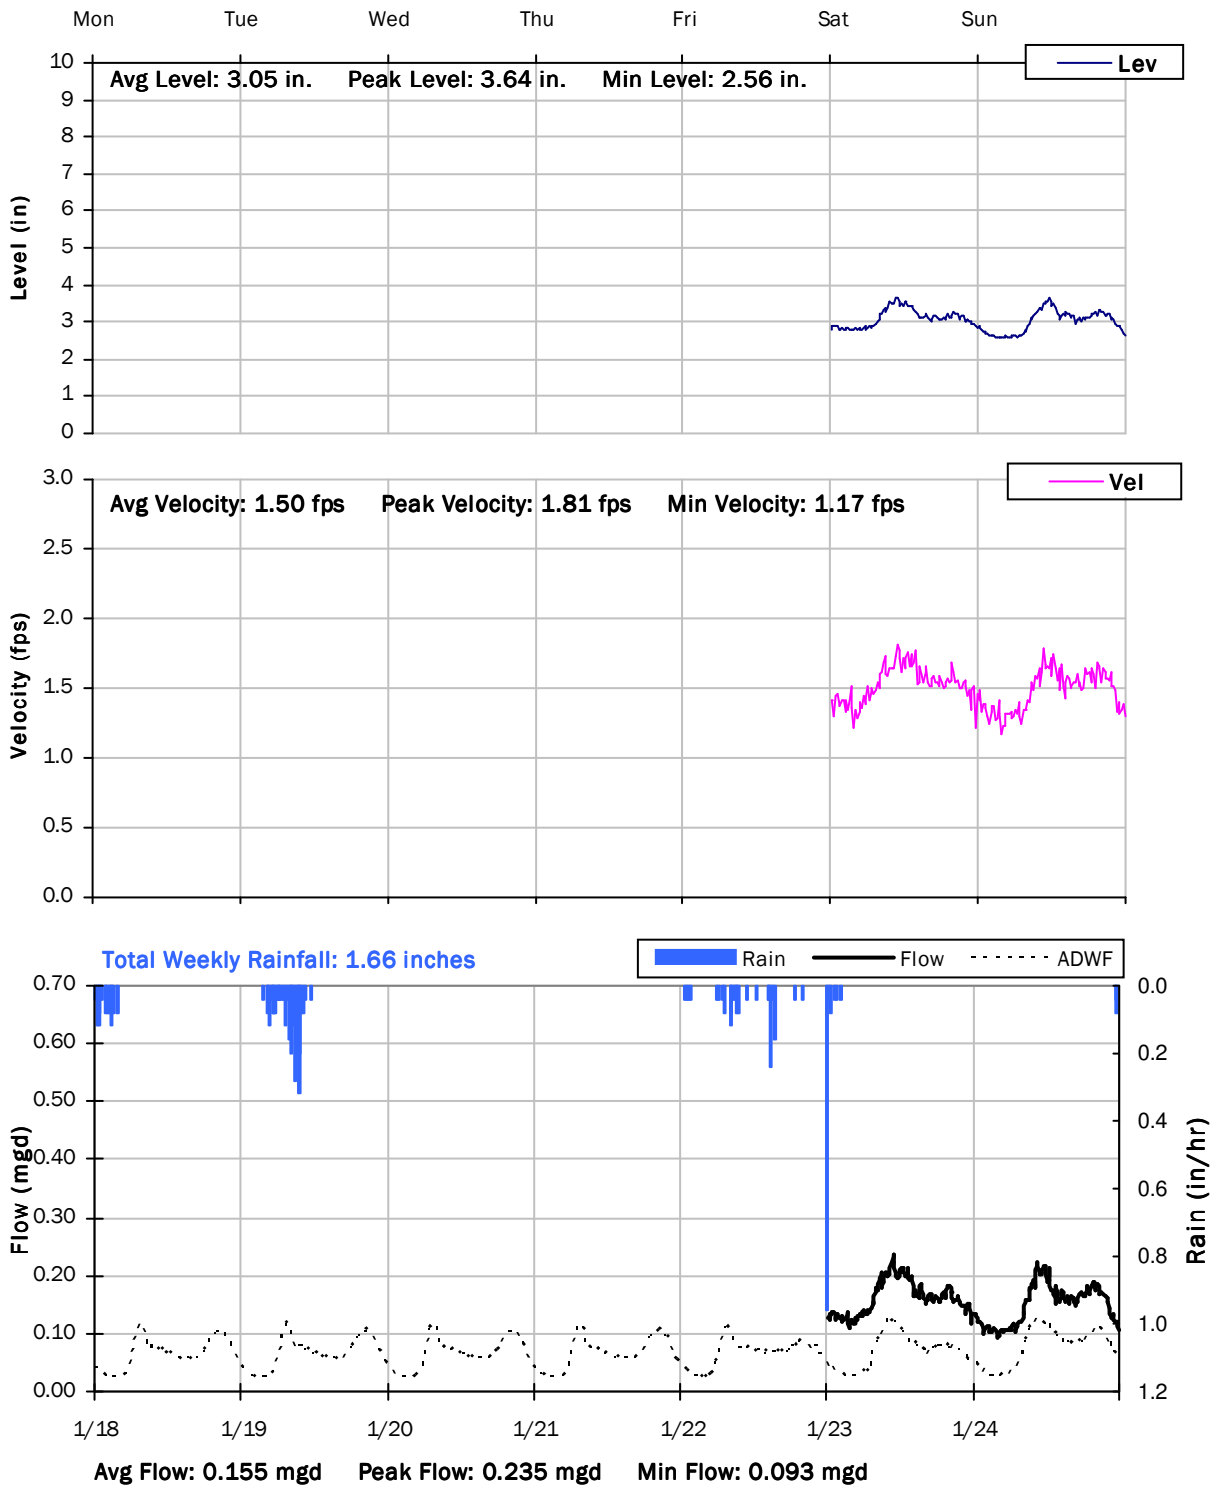
SITE 5
Weekly Level, Velocity and Flow Hydrographs
1/18/2016 to 1/25/2016

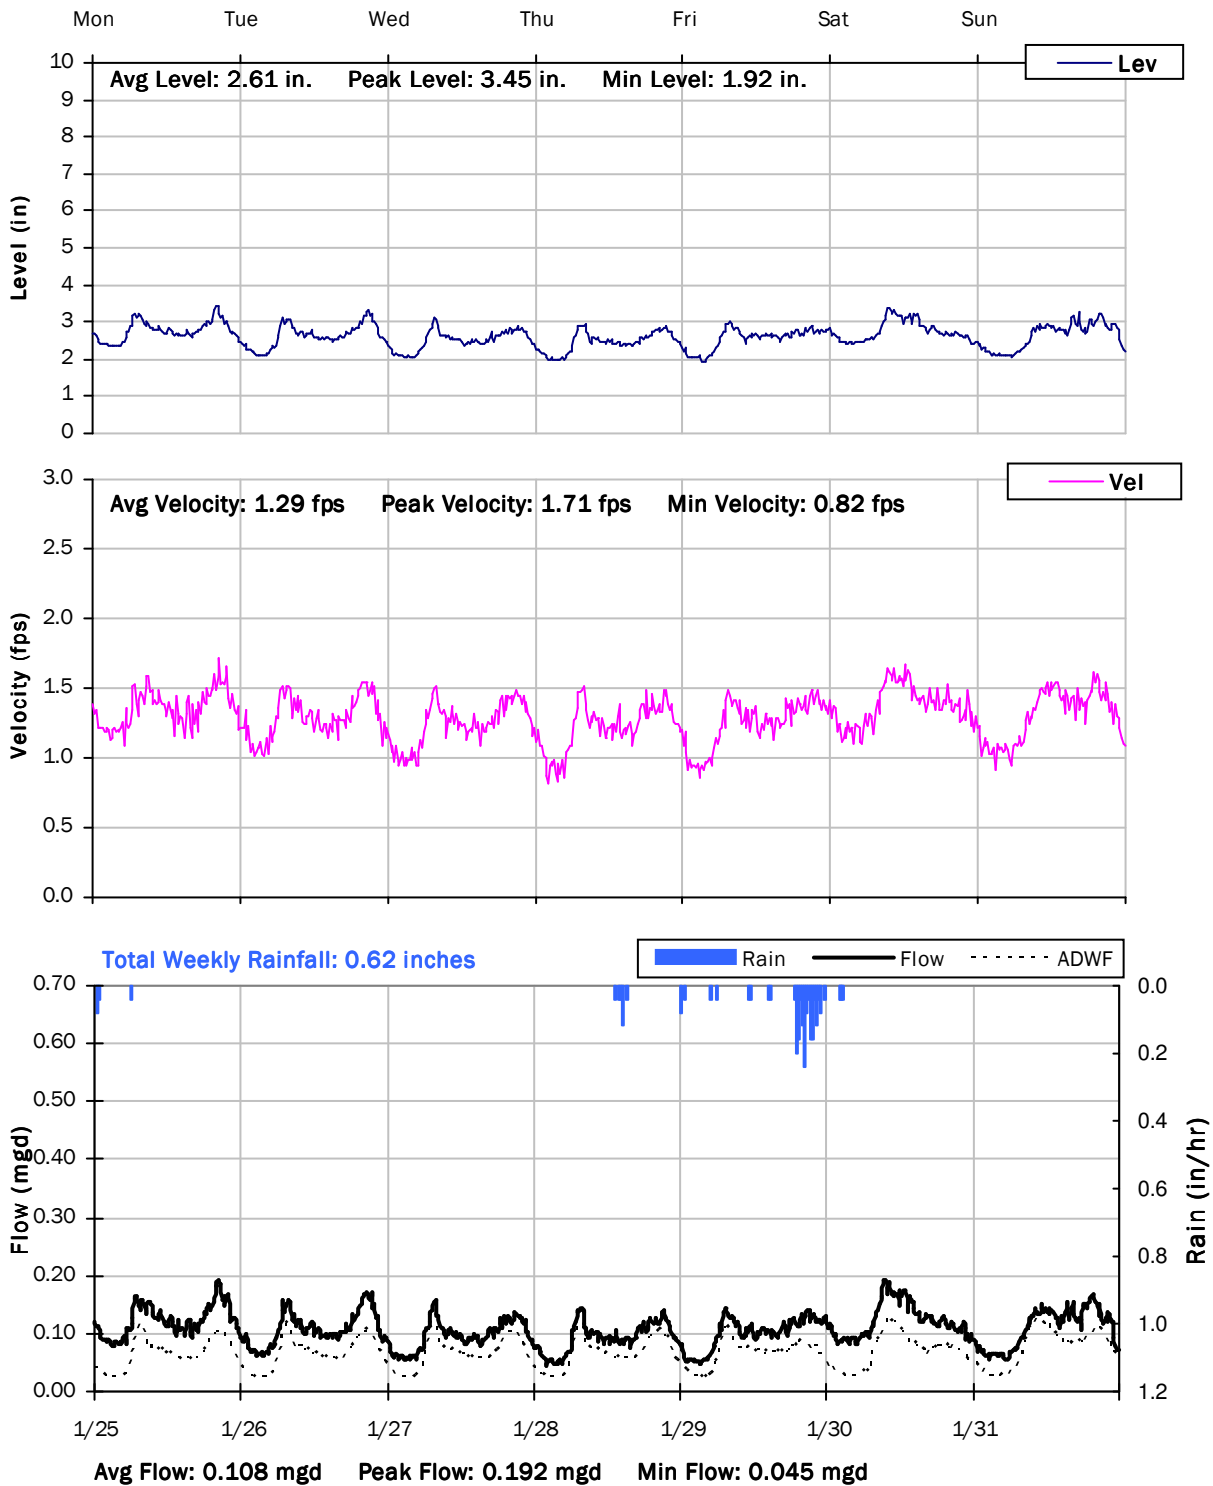
SITE 5
Weekly Level, Velocity and Flow Hydrographs
1/25/2016 to 2/1/2016

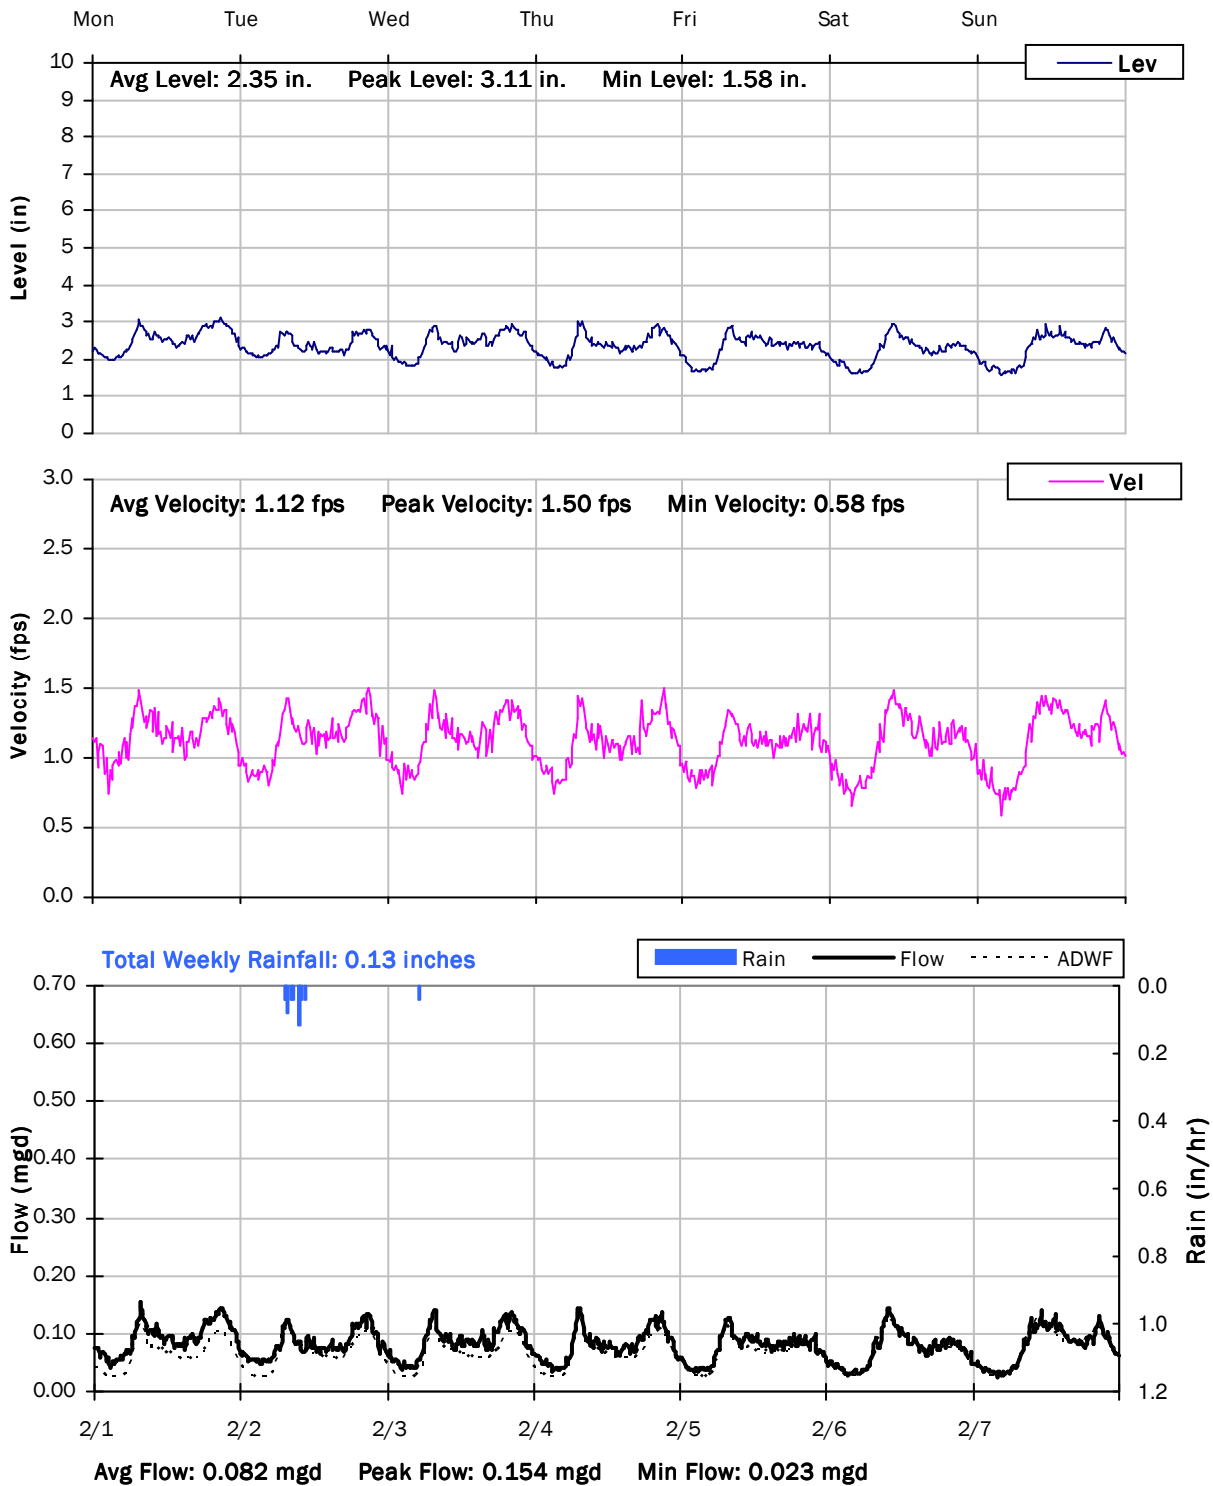
SITE 5
Weekly Level, Velocity and Flow Hydrographs
2/1/2016 to 2/8/2016
