APPENDIX A. FLOW MONITORING SITES: DATA, GRAPHS, INFORMATION

City of Lincoln

Sanitary Sewer Flow Monitoring

Temporary Monitoring: January 23 to April 3, 2016

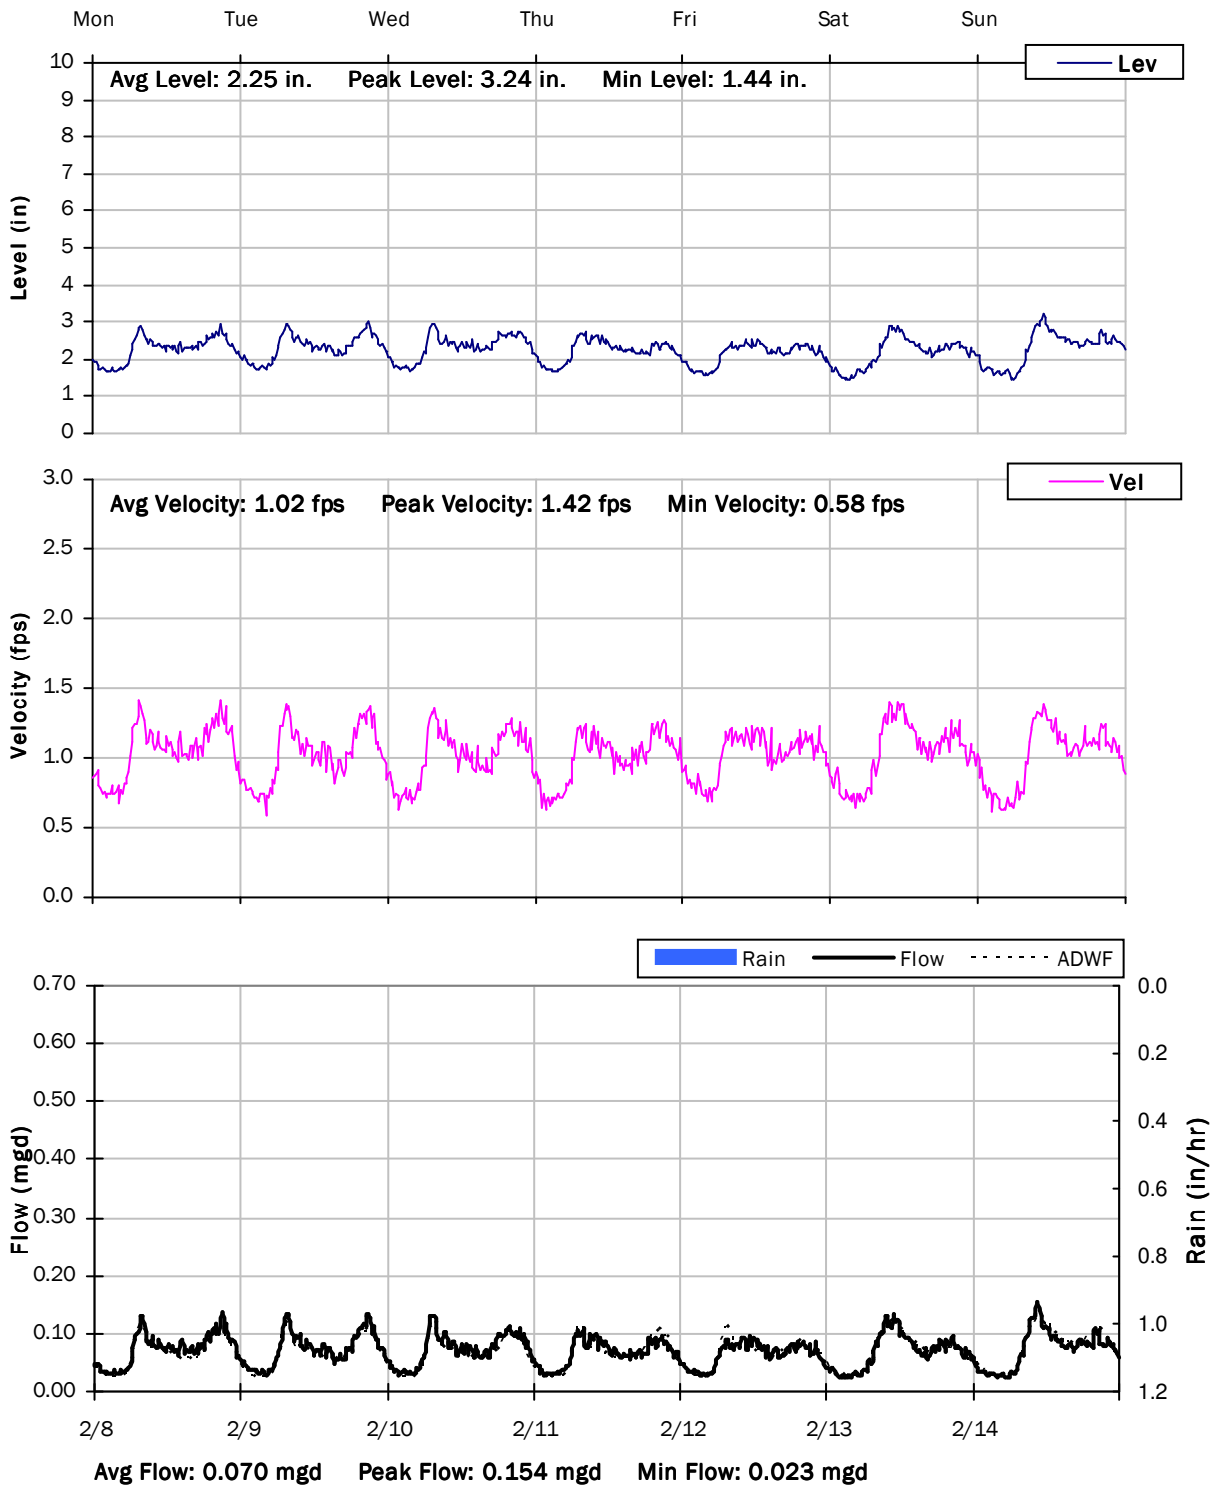
SITE 5
Weekly Level, Velocity and Flow Hydrographs
2/8/2016 to 2/15/2016

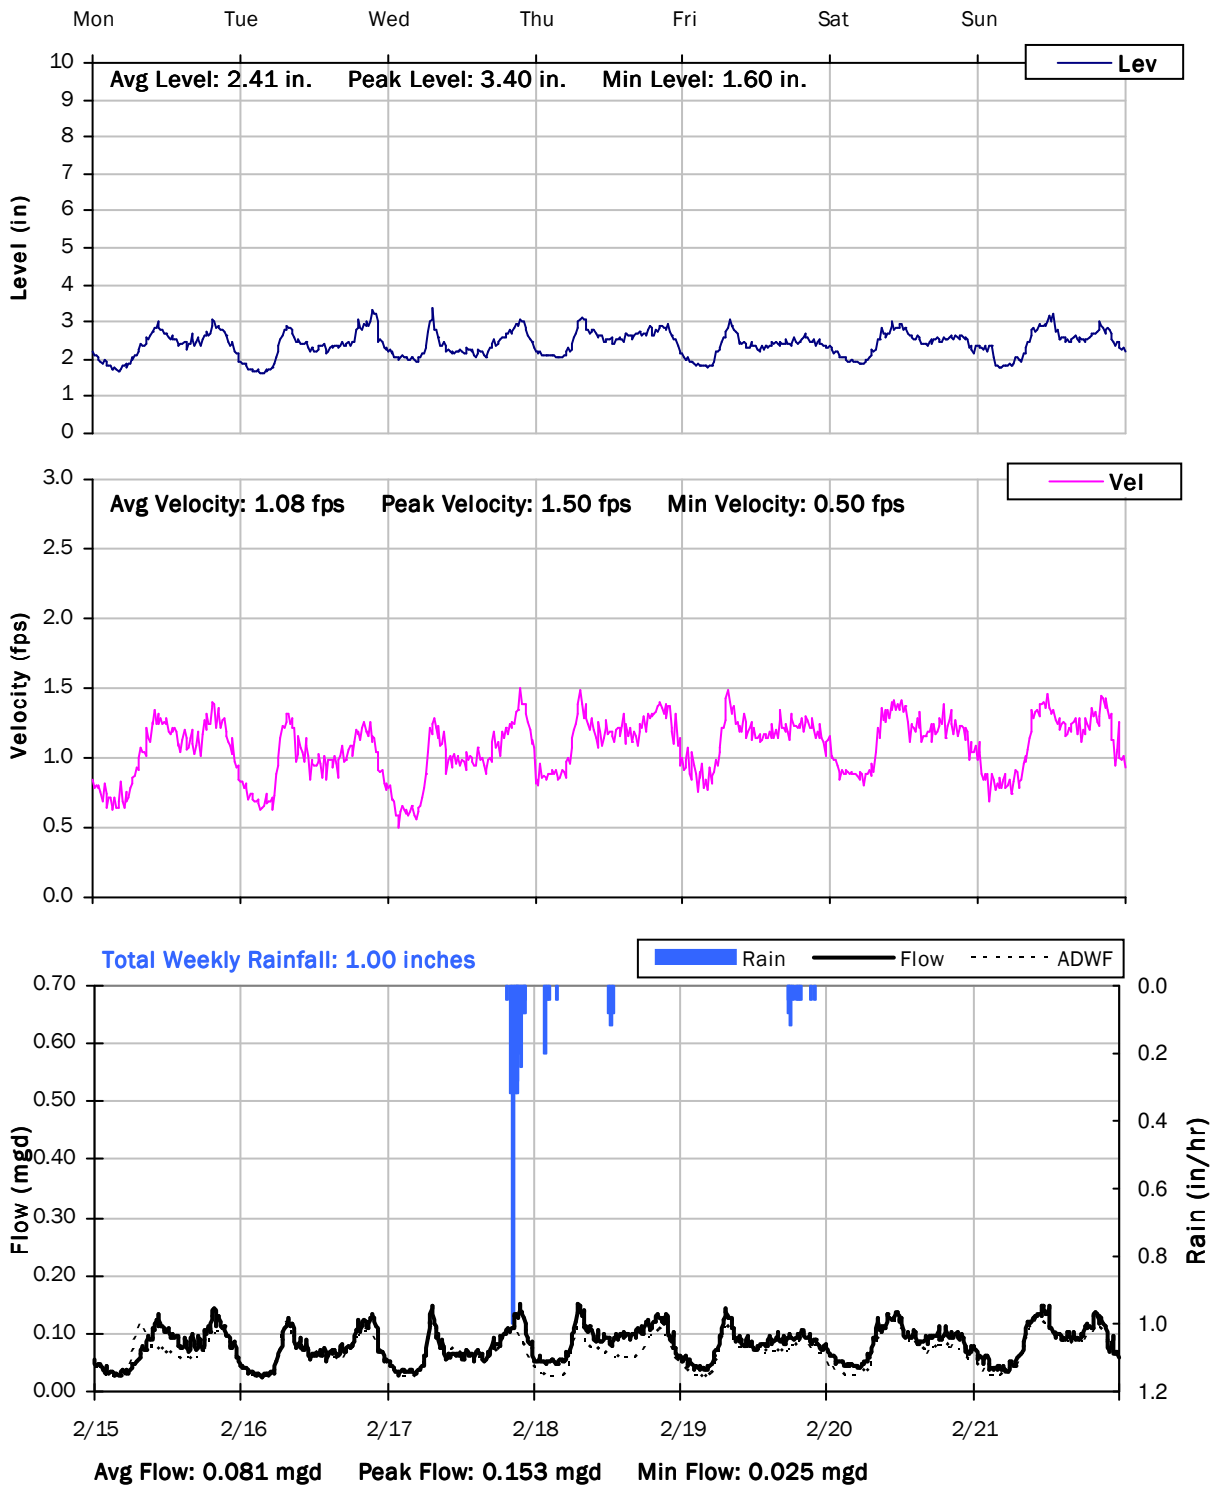
SITE 5
Weekly Level, Velocity and Flow Hydrographs
2/15/2016 to 2/22/2016

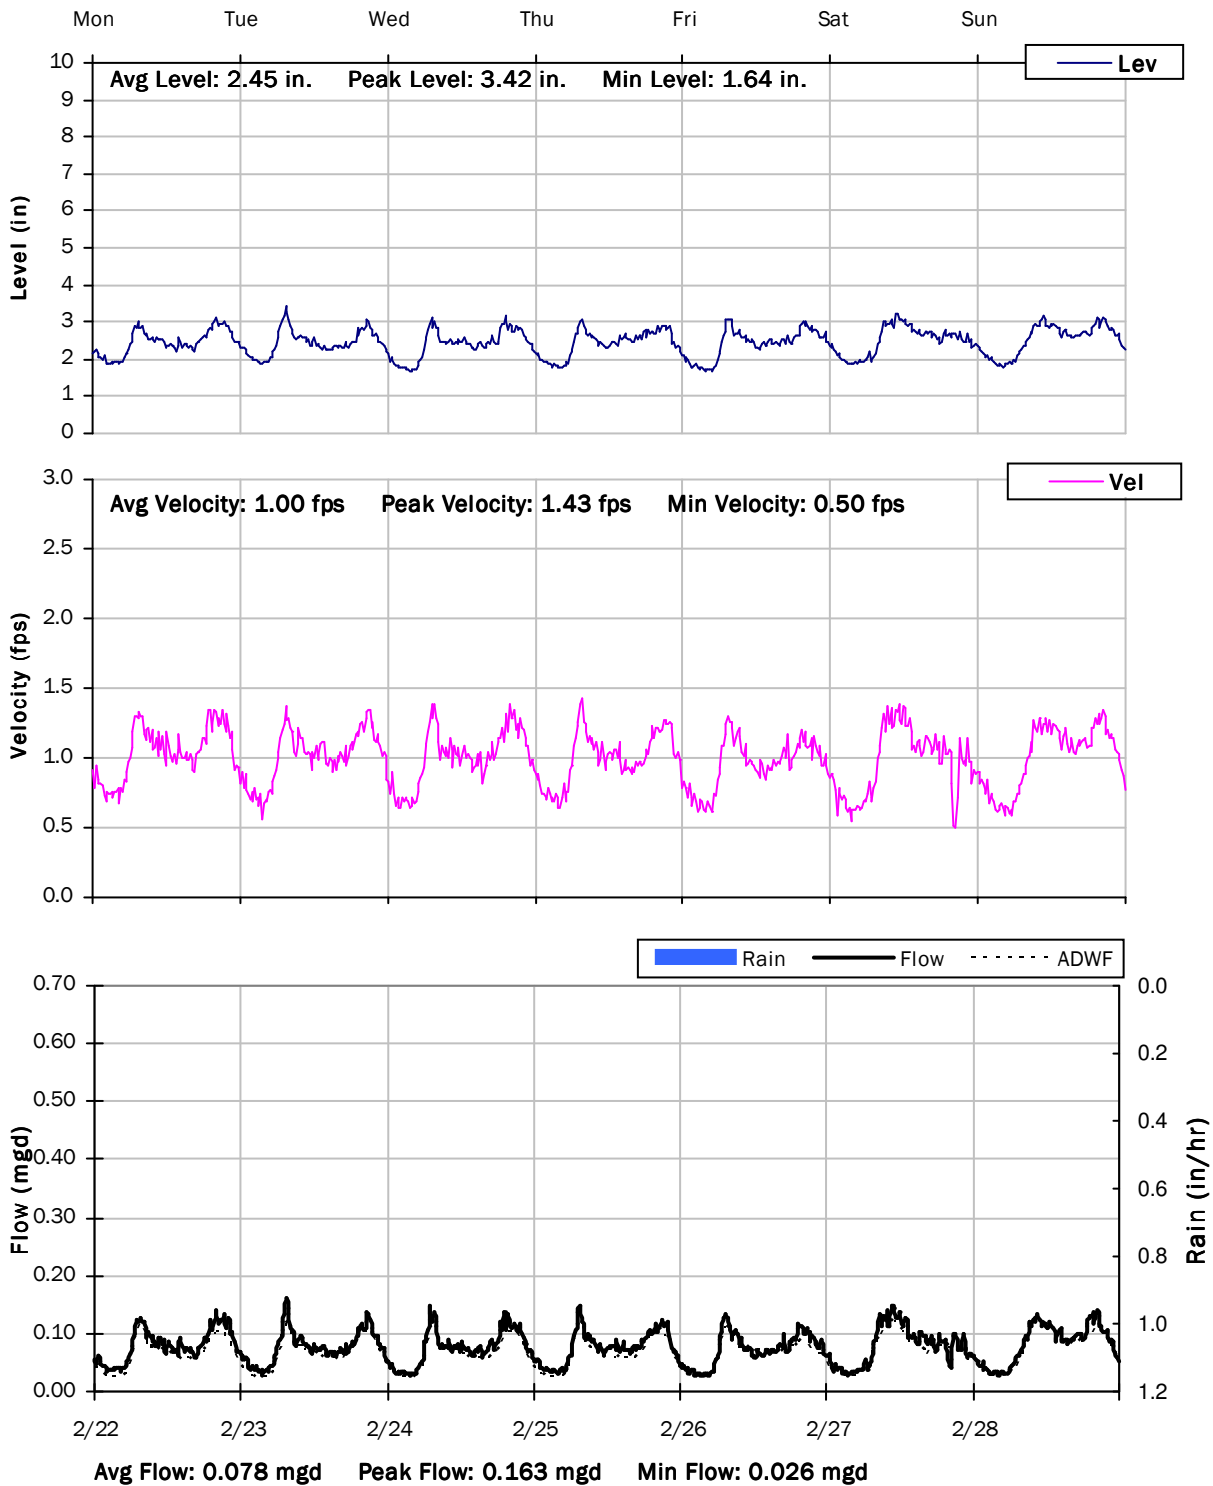
SITE 5
Weekly Level, Velocity and Flow Hydrographs
2/22/2016 to 2/29/2016

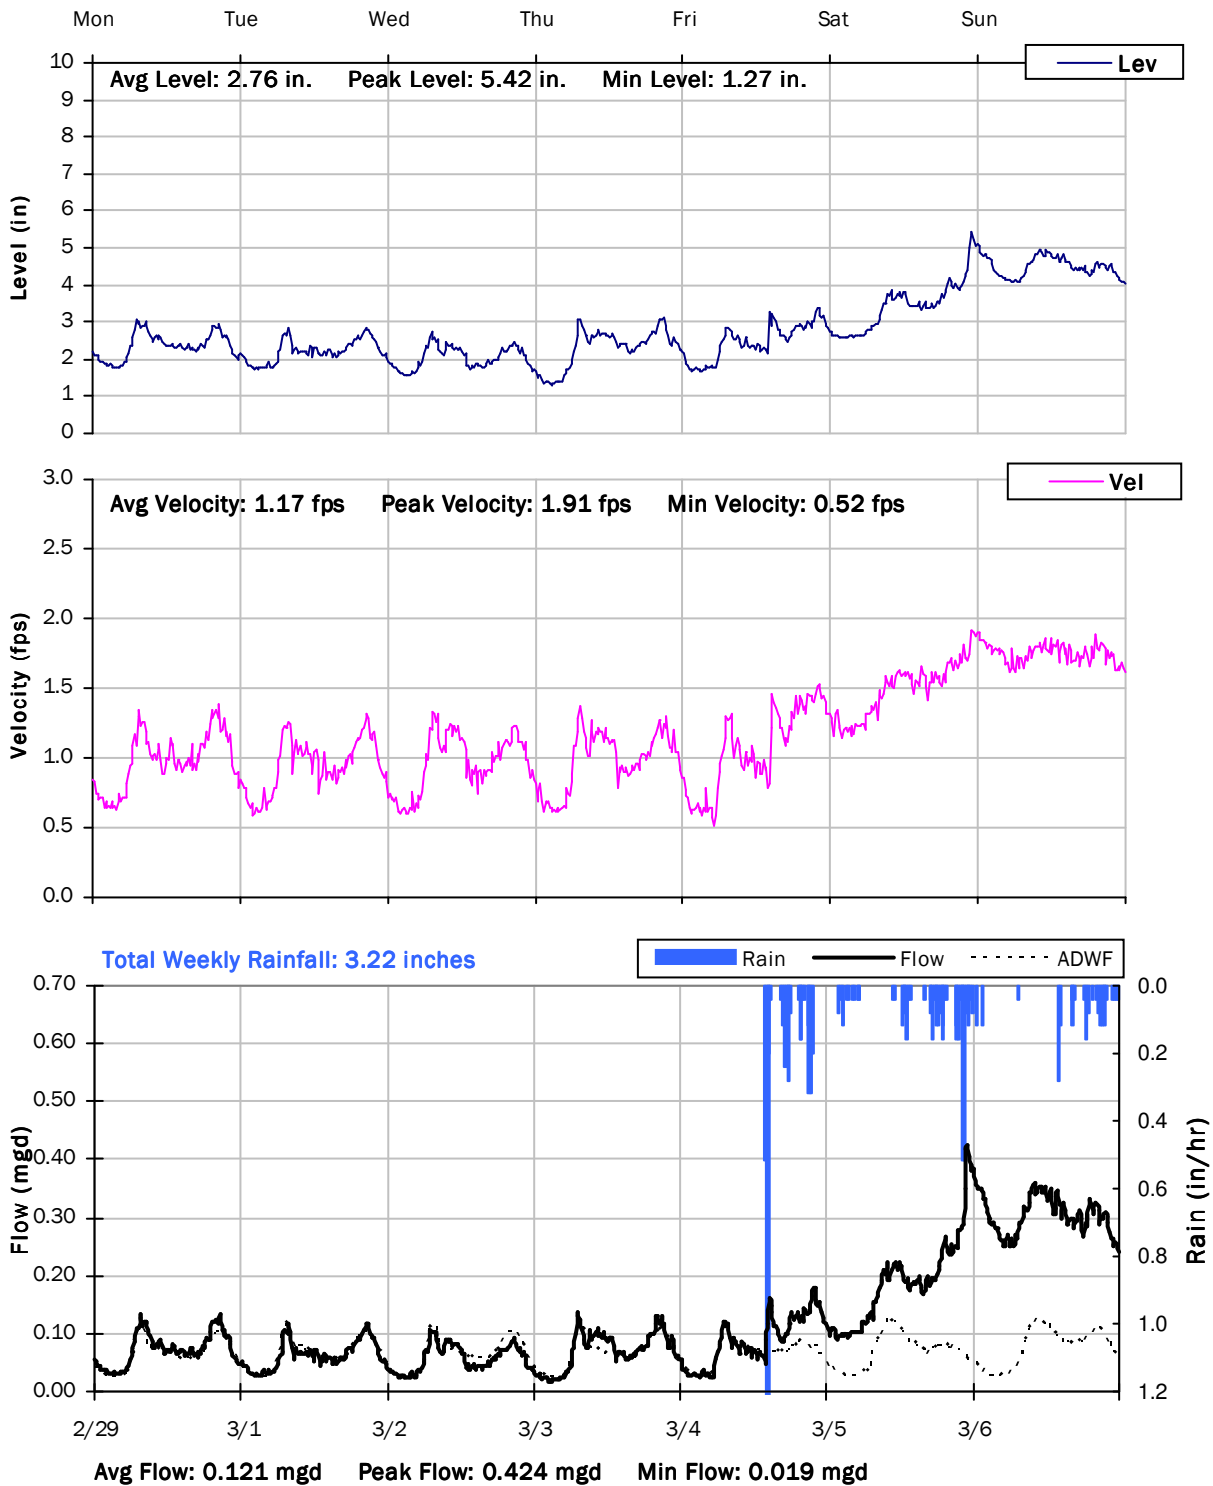
SITE 5
Weekly Level, Velocity and Flow Hydrographs
2/29/2016 to 3/7/2016

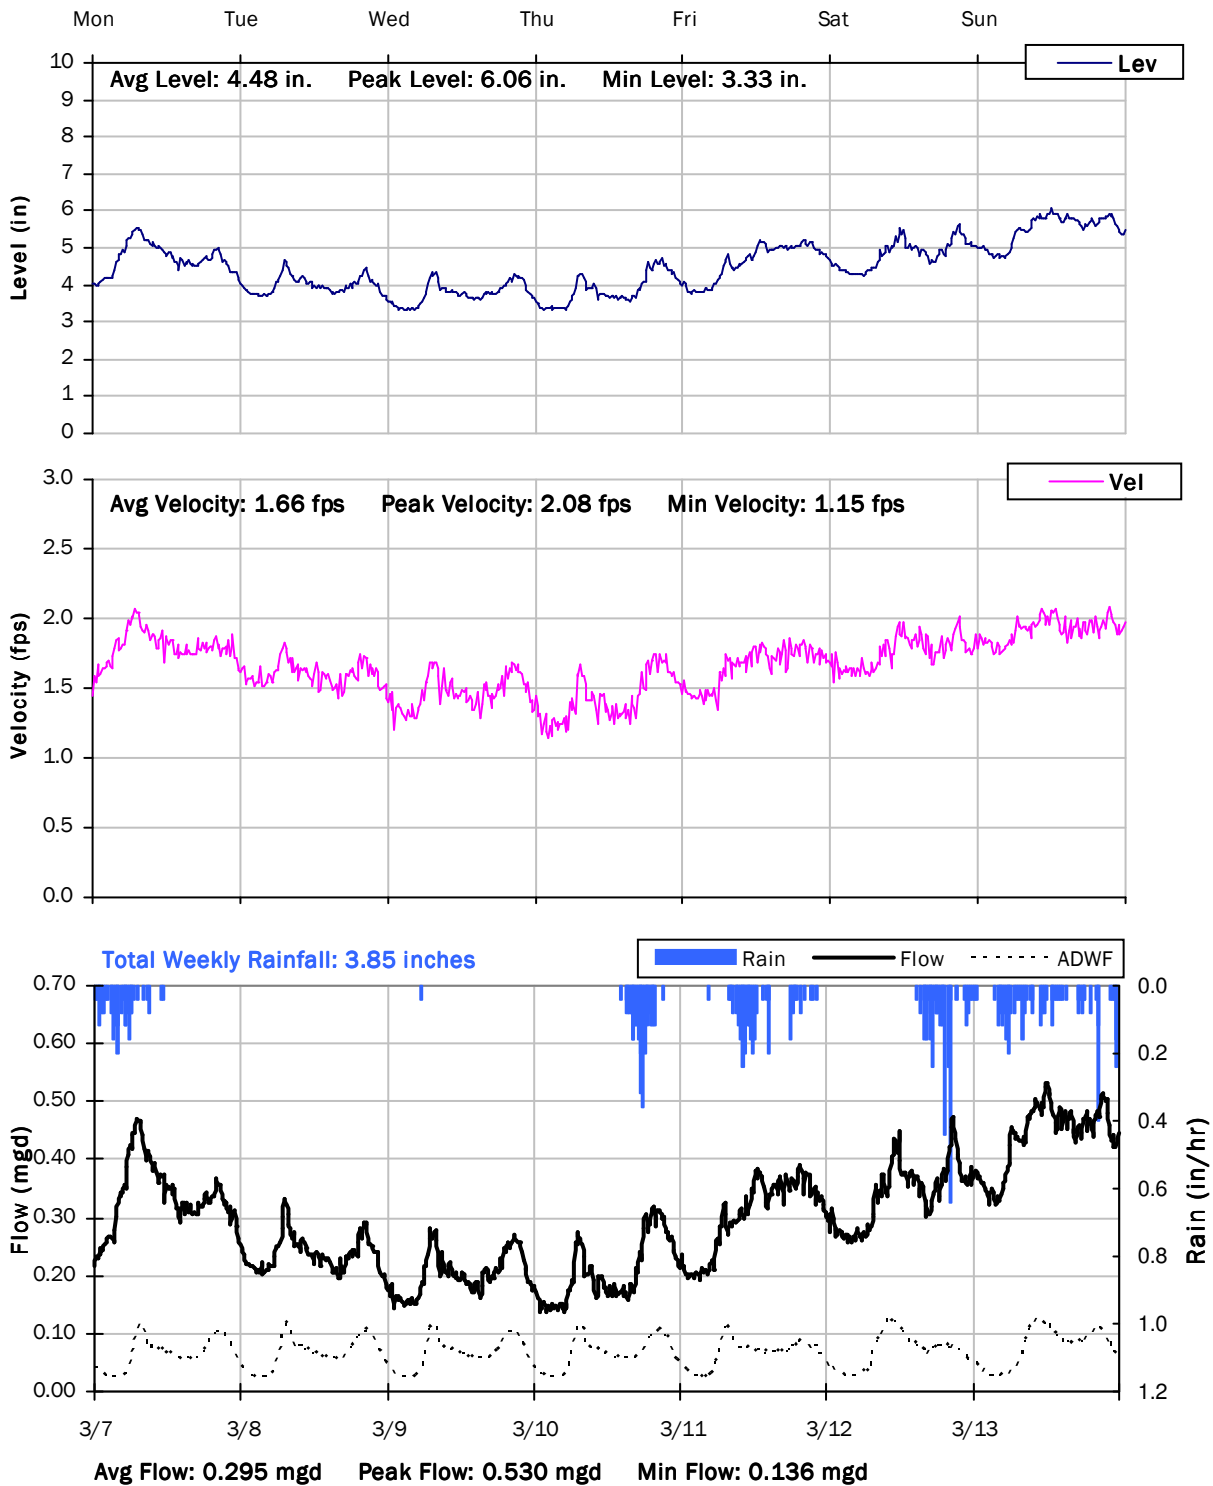
SITE 5
Weekly Level, Velocity and Flow Hydrographs
3/7/2016 to 3/14/2016

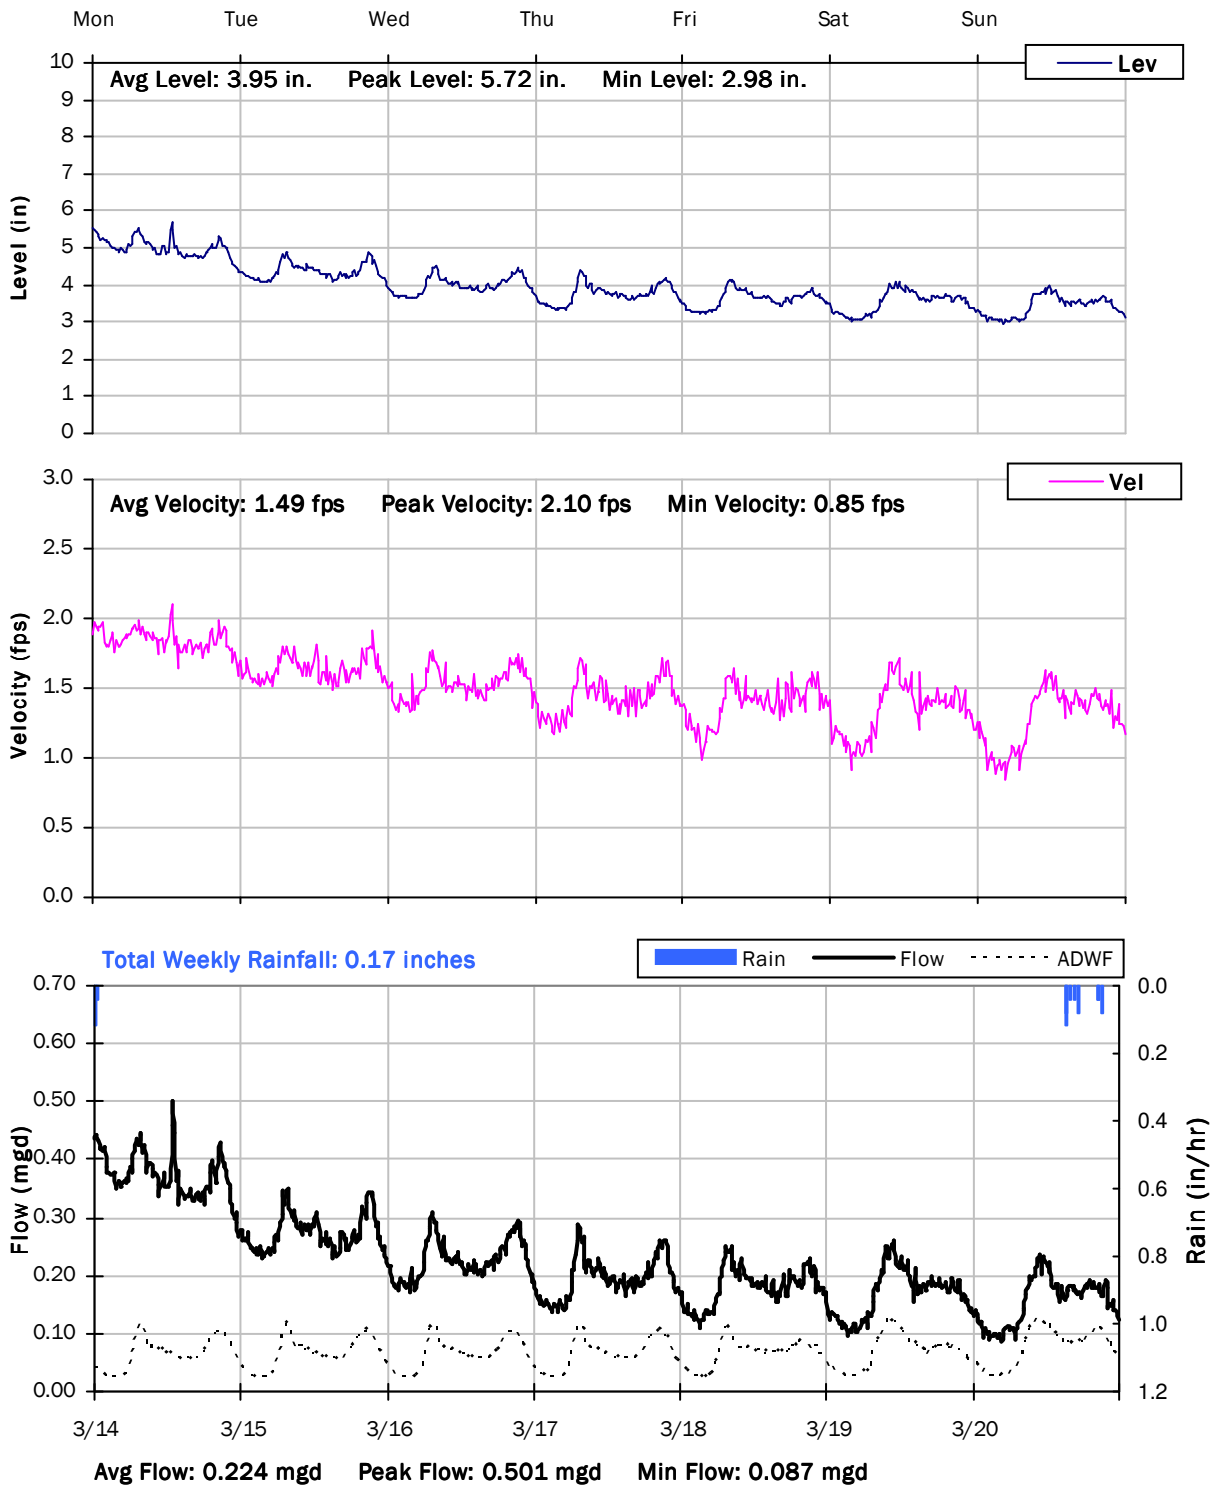
SITE 5
Weekly Level, Velocity and Flow Hydrographs
3/14/2016 to 3/21/2016

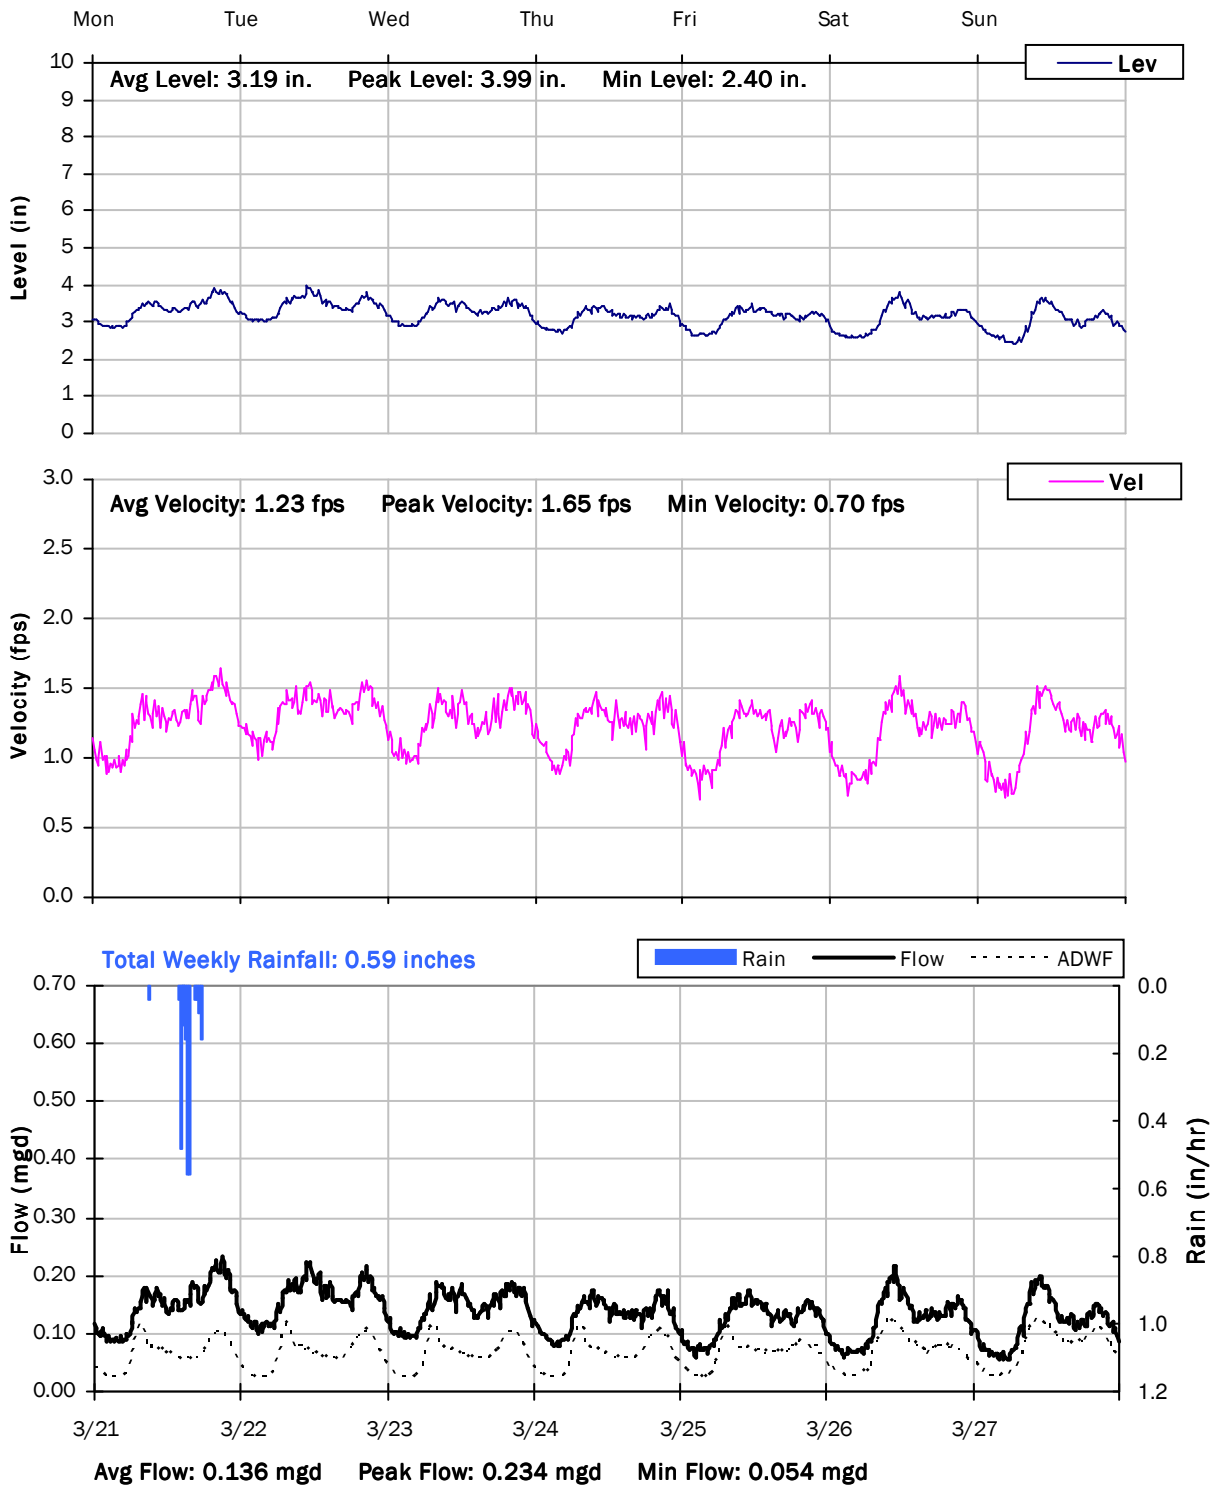
SITE 5
Weekly Level, Velocity and Flow Hydrographs
3/21/2016 to 3/28/2016

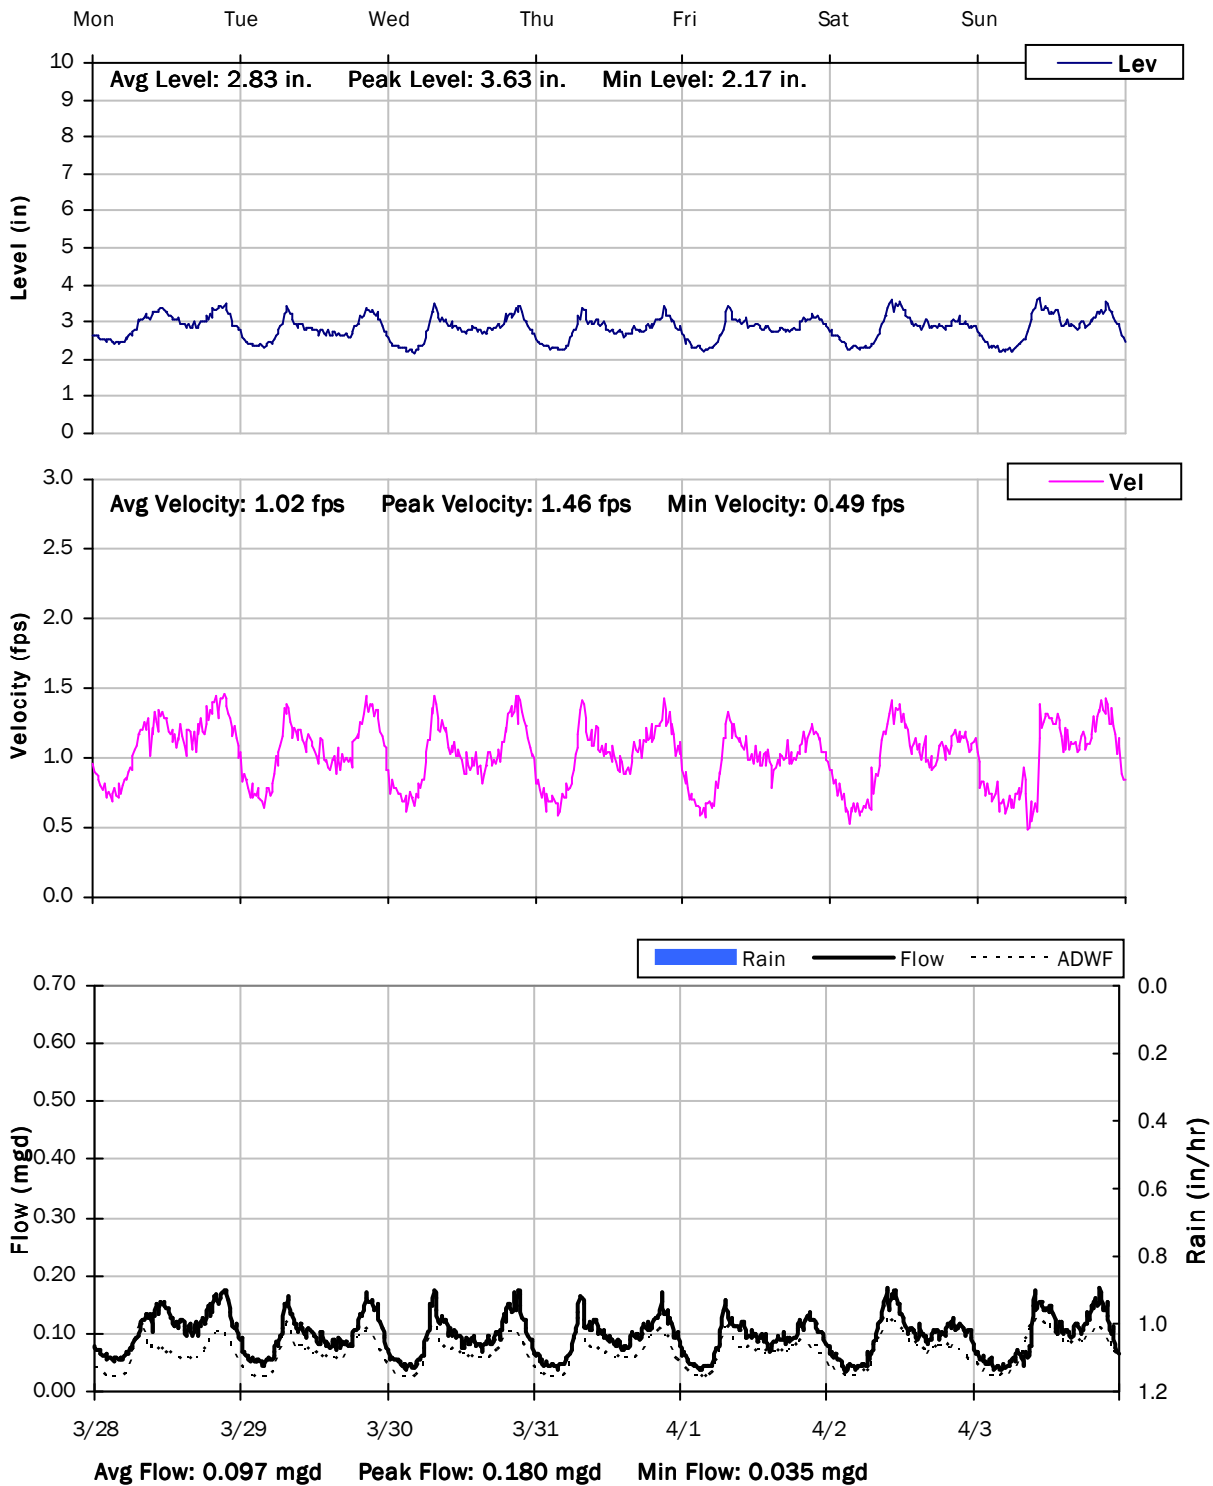
SITE 5
Weekly Level, Velocity and Flow Hydrographs
3/28/2016 to 4/4/2016

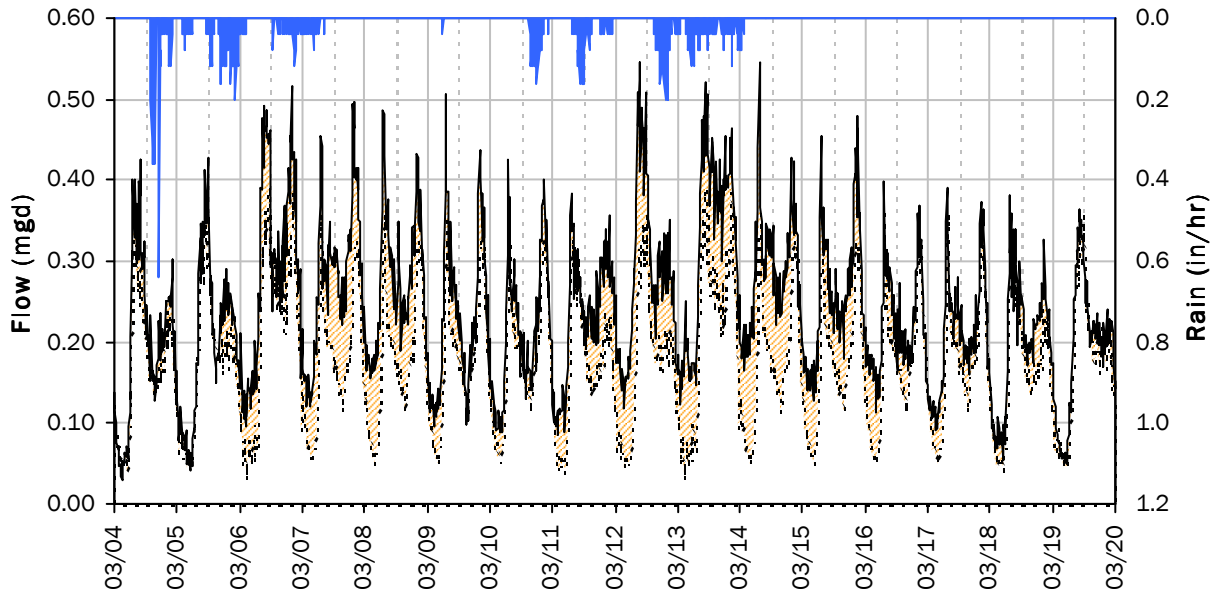
Event 1 Detail Graph

Storm Event I/I Analysis (Rain = 5.07 inches)

<u>Capacity</u>		<u>Inflow / Infiltration</u>	
Peak Flow:	0.55 mgd	Peak I/I Rate:	0.25 mgd
PF:	3.10	Total I/I:	1,050,000 gallons
Peak Level:	6.40 in		
d/D Ratio:	0.53

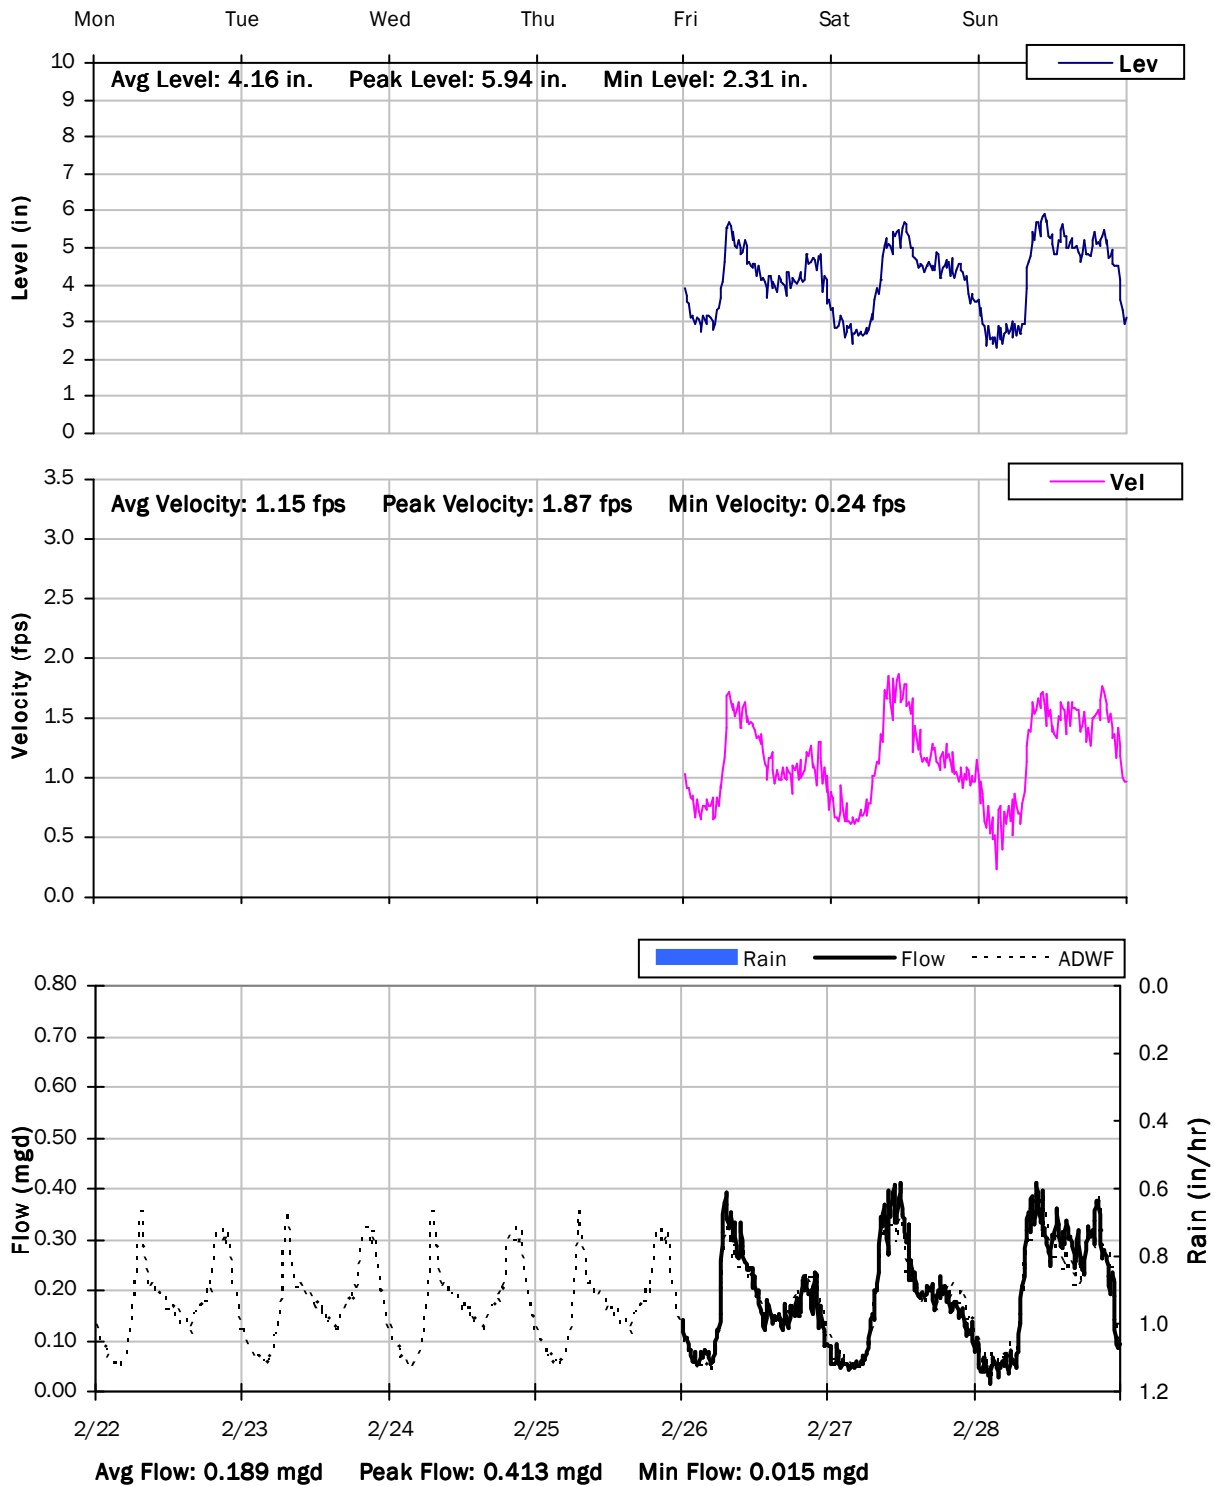
SITE 6
Weekly Level, Velocity and Flow Hydrographs
2/22/2016 to 2/29/2016

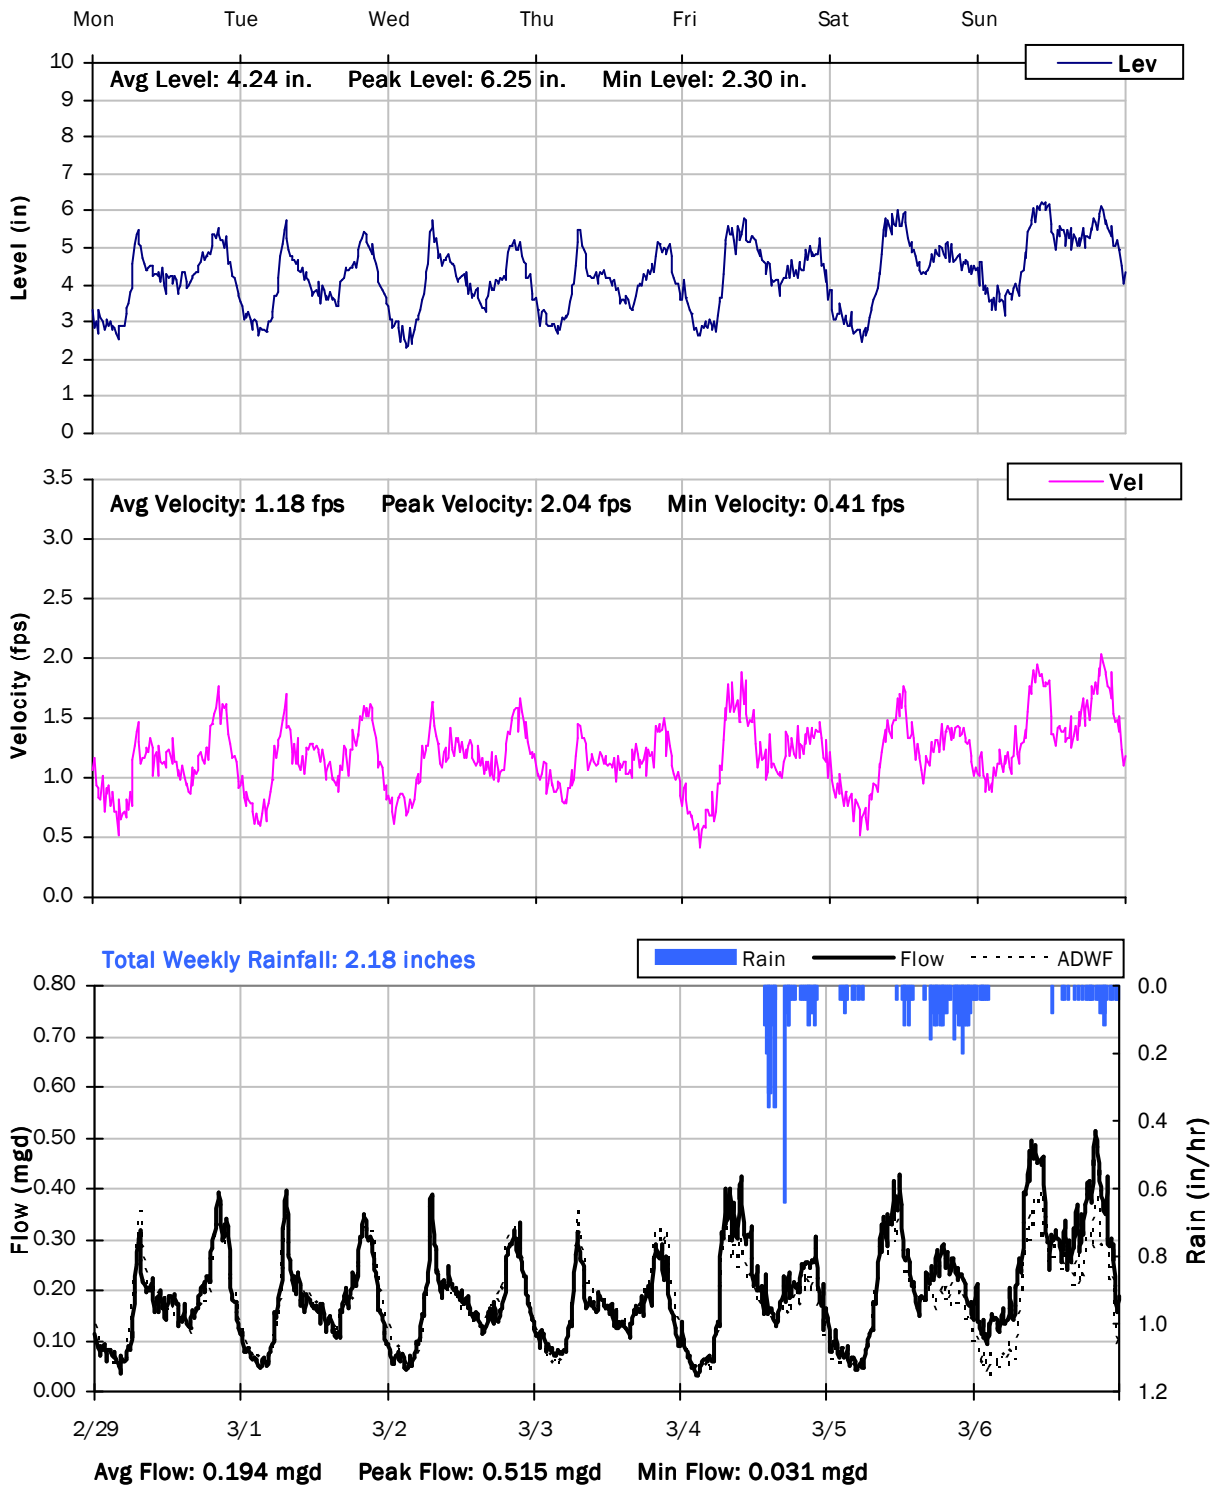
SITE 6
Weekly Level, Velocity and Flow Hydrographs
2/29/2016 to 3/7/2016

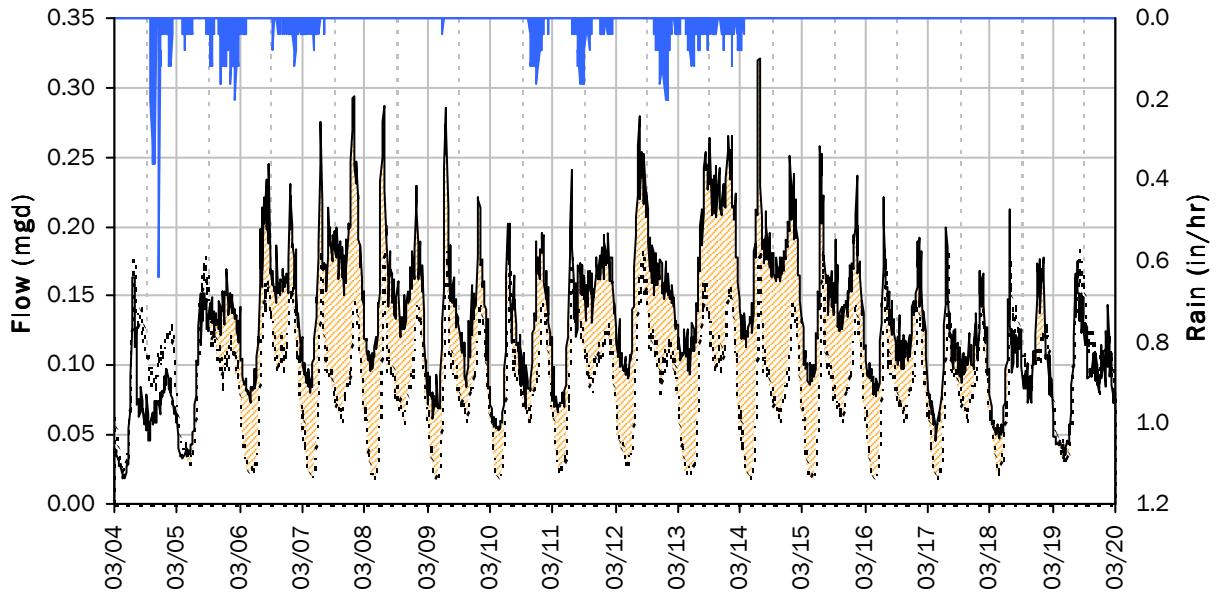
Event 1 Detail Graph

Storm Event I/I Analysis (Rain = 5.07 inches)

<u>Capacity</u>		<u>Inflow / Infiltration</u>	
Peak Flow:	0.32 mgd	Peak I/I Rate:	0.15 mgd
PF:	3.68	Total I/I:	734,000 gallons
Peak Level:	3.96 in		
d/D Ratio:	0.40

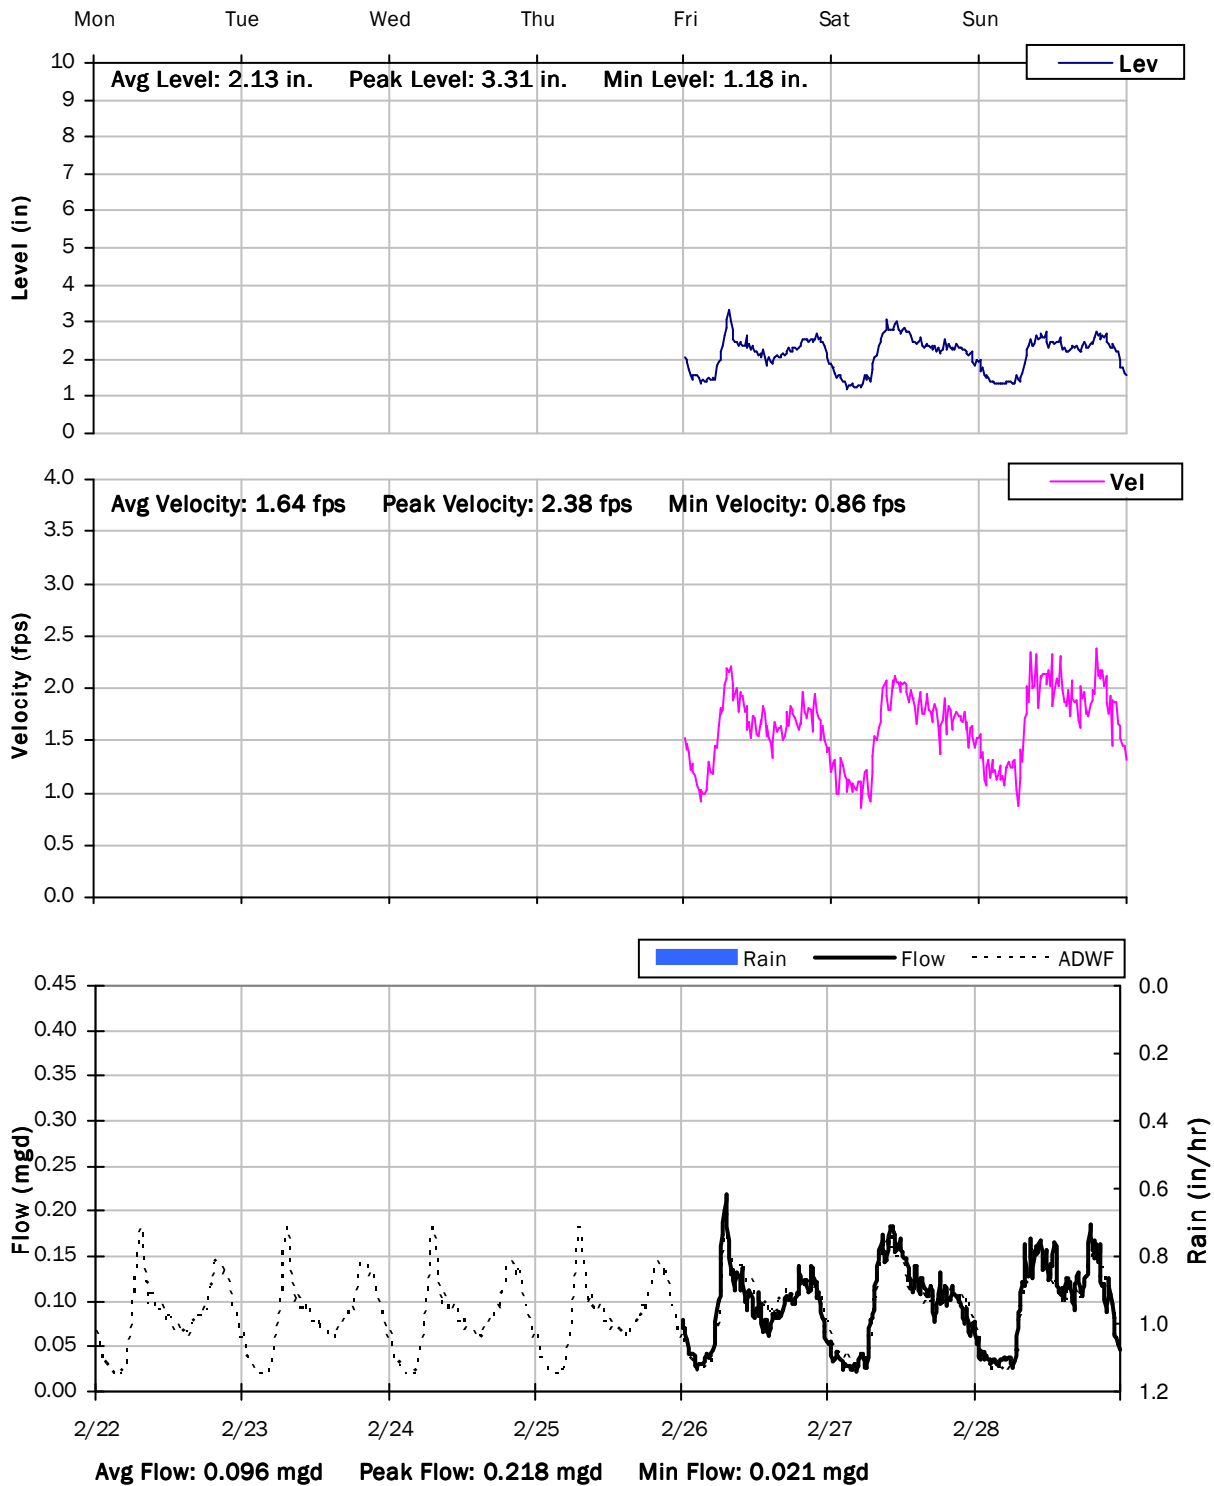
SITE 7
Weekly Level, Velocity and Flow Hydrographs
2/22/2016 to 2/29/2016
