APPENDIX A. FLOW MONITORING SITES: DATA, GRAPHS, INFORMATION

City of Lincoln

Sanitary Sewer Flow Monitoring

Temporary Monitoring: January 23 to April 3, 2016

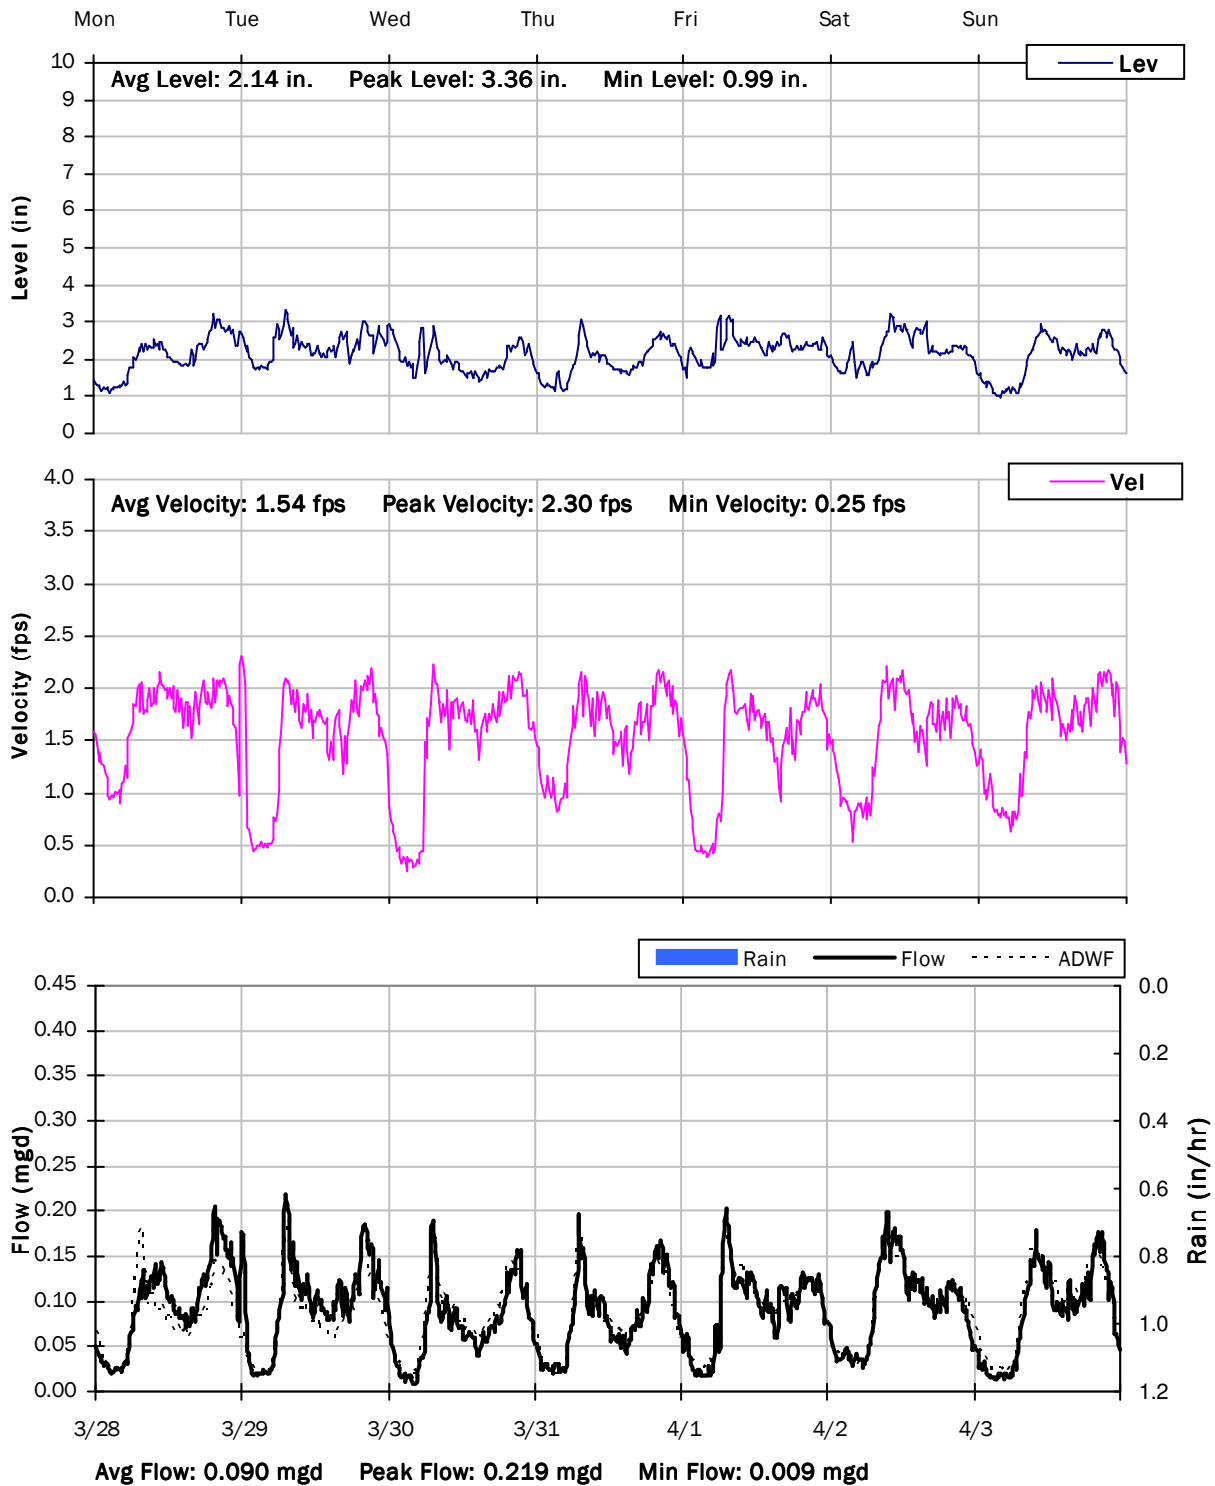
SITE 7
Weekly Level, Velocity and Flow Hydrographs
3/28/2016 to 4/4/2016

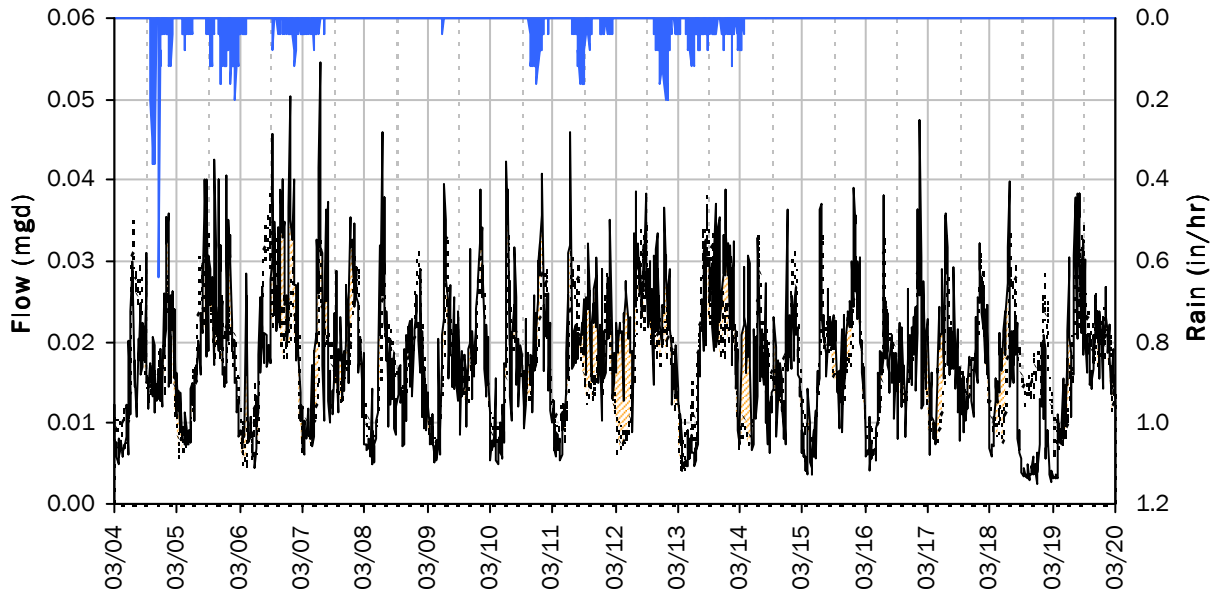
Event 1 Detail Graph

Storm Event I/I Analysis (Rain = 5.07 inches)

<u>Capacity</u>		<u>Inflow / Infiltration</u>	
Peak Flow:	0.05 mgd	Peak I/I Rate:	0.03 mgd
PF:	3.10	Total I/I:	12,000 gallons
Peak Level:	3.34 in		
d/D Ratio:	0.33

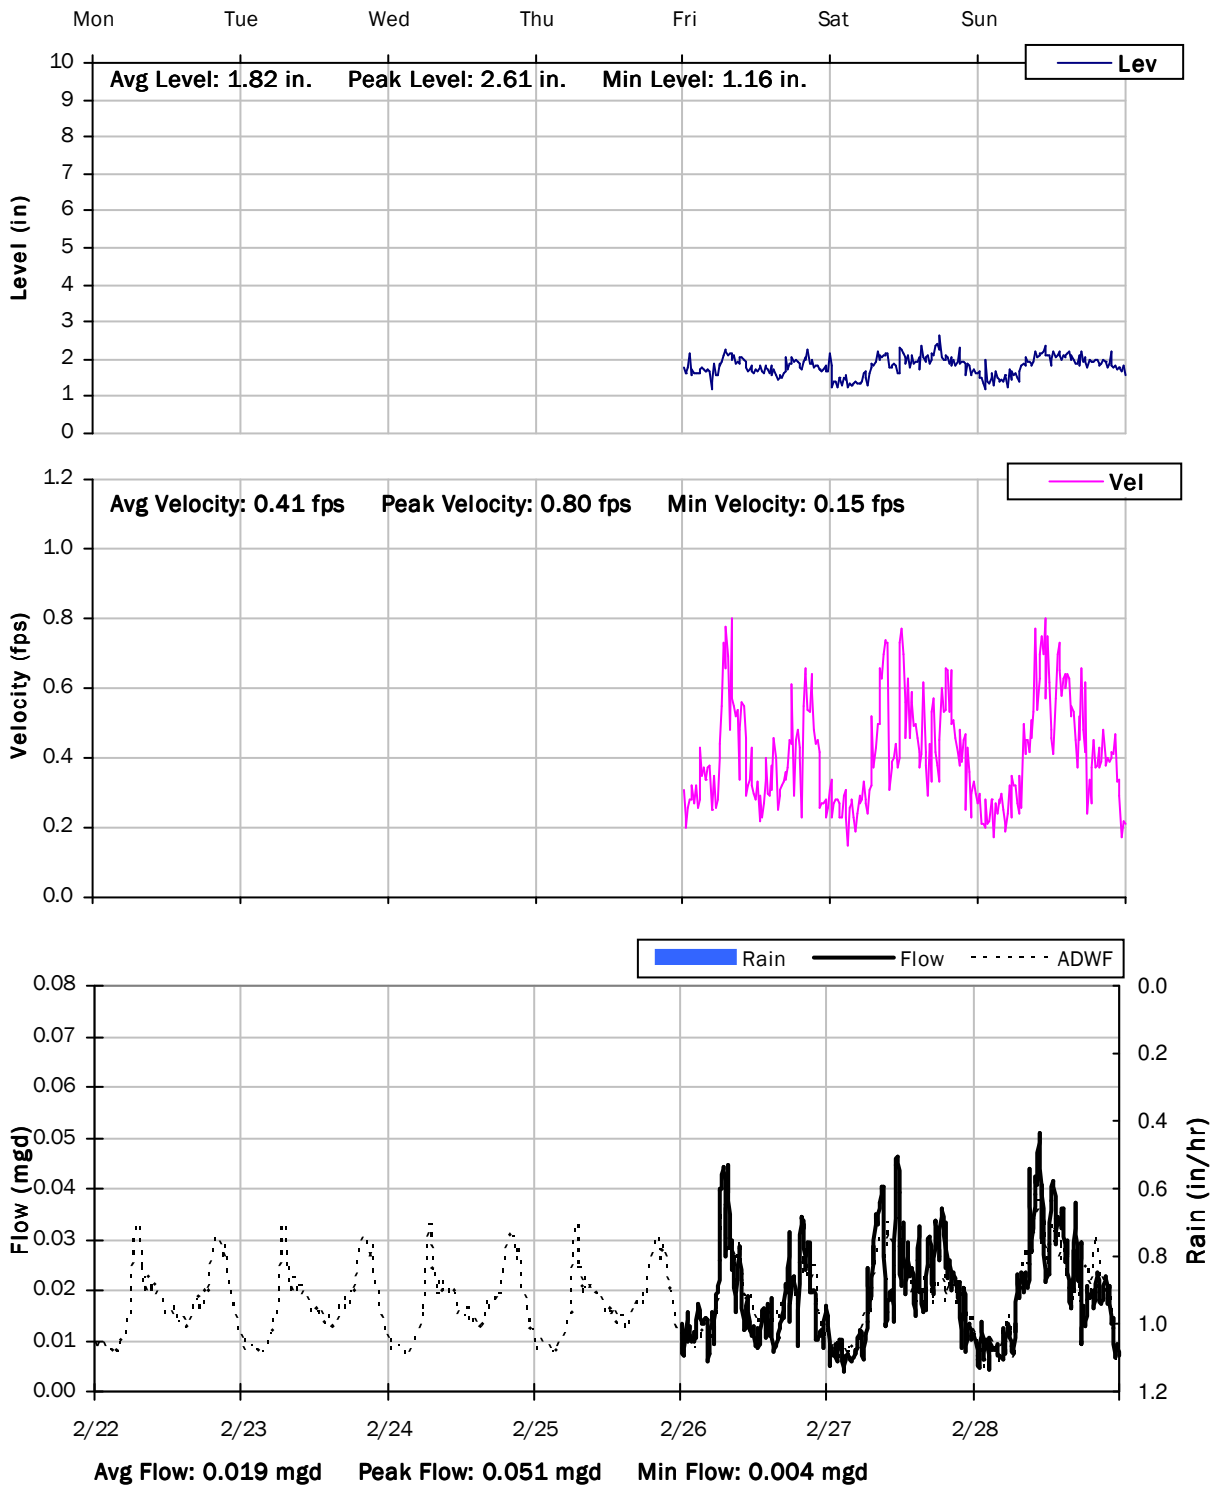
SITE 8
Weekly Level, Velocity and Flow Hydrographs
2/22/2016 to 2/29/2016

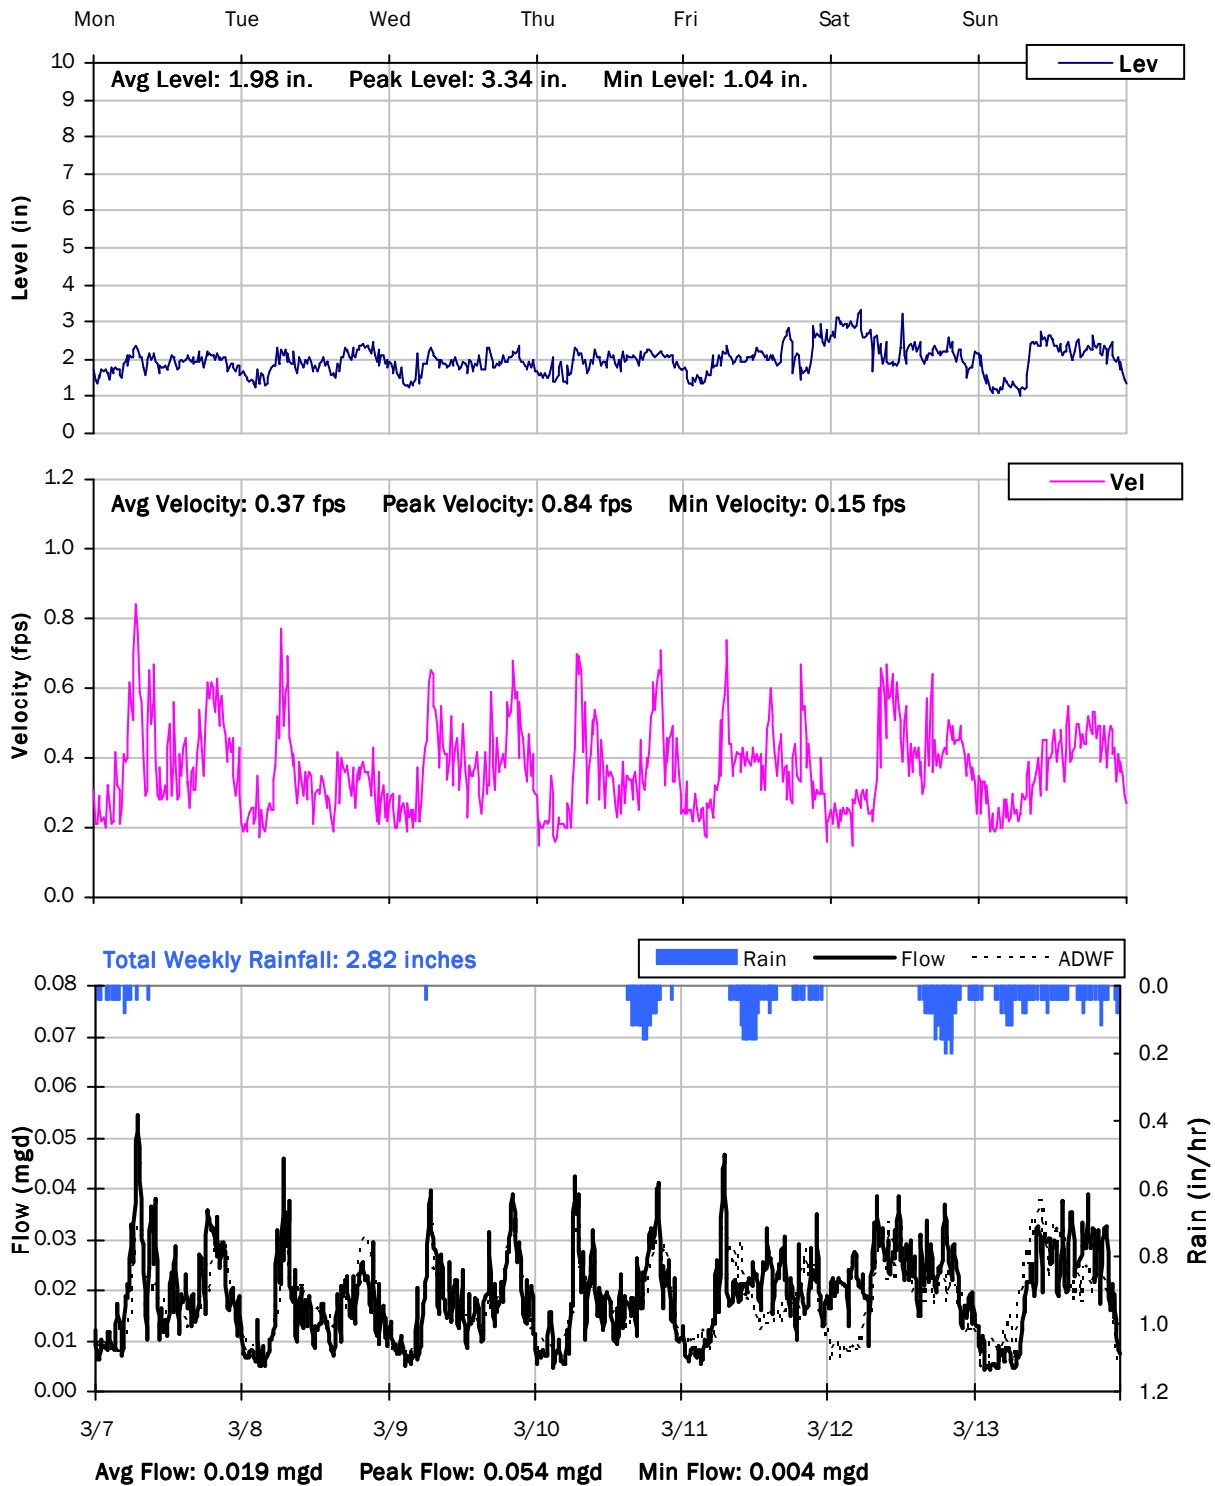
SITE 8
Weekly Level, Velocity and Flow Hydrographs
3/7/2016 to 3/14/2016

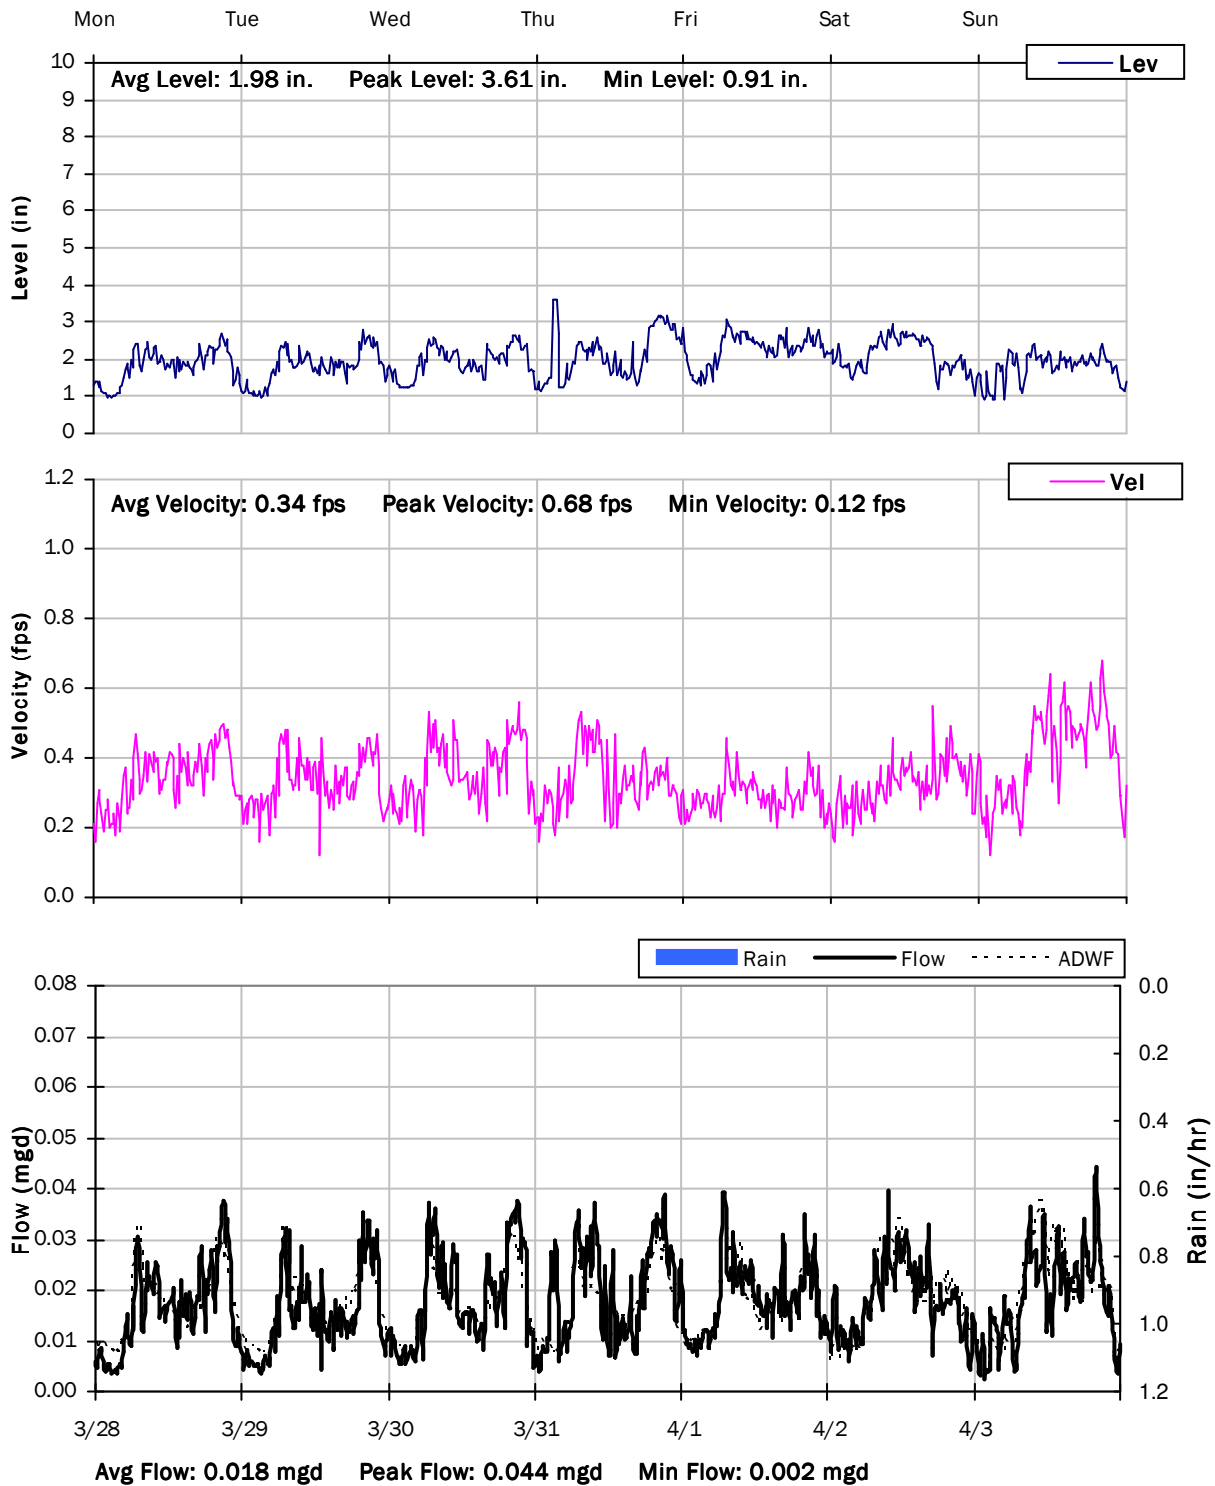
SITE 8
Weekly Level, Velocity and Flow Hydrographs
3/28/2016 to 4/4/2016
